# Service Campaign Bulletin

Campaign No. 2007060001, June 2007

SUBJECT: **MODEL 211, 216, 219, 221, 230**  
**MODEL YEAR 2007**  
**CHECK STARTER WIRING HARNESS ROUTING AND RE-ROUTE IF NECESSARY**  
**(M273 ENGINE)**

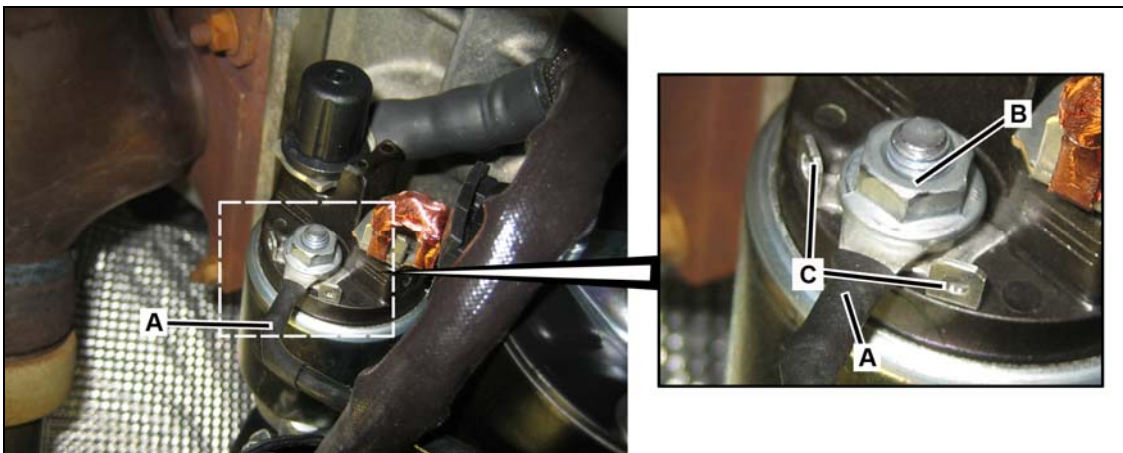
Figure 1

This Service Campaign has been initiated because DCAG has determined that on the affected vehicles it is possible that the routing of the starter wiring harness may not meet specifications. Failure of the starter, in isolated cases, may occur if this condition exists and is left uncorrected. Dealers will check the starter wiring harness routing and correct if necessary.

1. Raise vehicle on lift; refer to appropriate WIS document AR00.60-P-1000 based on vehicle model.
2. Remove center and rear engine compartment paneling.
3. Check insulation of starter wiring harness circuit 50 (A, Figure 1).
4. Perform one of the following, depending on results of step 3:
  - If insulation **is not** damaged: Perform Procedure B.
  - If insulation **is** damaged: Perform Procedures B and C.

4. Position starter wiring harness connector (B) as shown in Figure 1—between two metal tabs (C)—and reinstall M6 nut.
  - Torque nut to 8 Nm.
5. Reconnect battery ground cables, again referring to appropriate WIS document from step 1.
  - Perform basic programming.

1. Install heat-shrink tube (A, Figure 1) at electrical connector of starter wiring harness.
  - Use 3/8" (9.5 mm) wide, 1" (25 mm) long tube.

2. Position starter wiring harness connector (B) as shown in Figure 1—between two metal tabs (C)—and reinstall M6 nut.
  - Torque nut to 8 Nm.
3. Reconnect battery ground cables, again referring to appropriate WIS document from Procedure **B**, step 1.
  - Perform basic programming.
