Service Campaign Bulletin

Campaign No. 2019030005, April 2019

SUBJECT: **Model S-Class and S-Class Coupe vehicles (217 and 222 platforms)
Model Year 2018-2019**

Check lock for trunk lid, replace if necessary

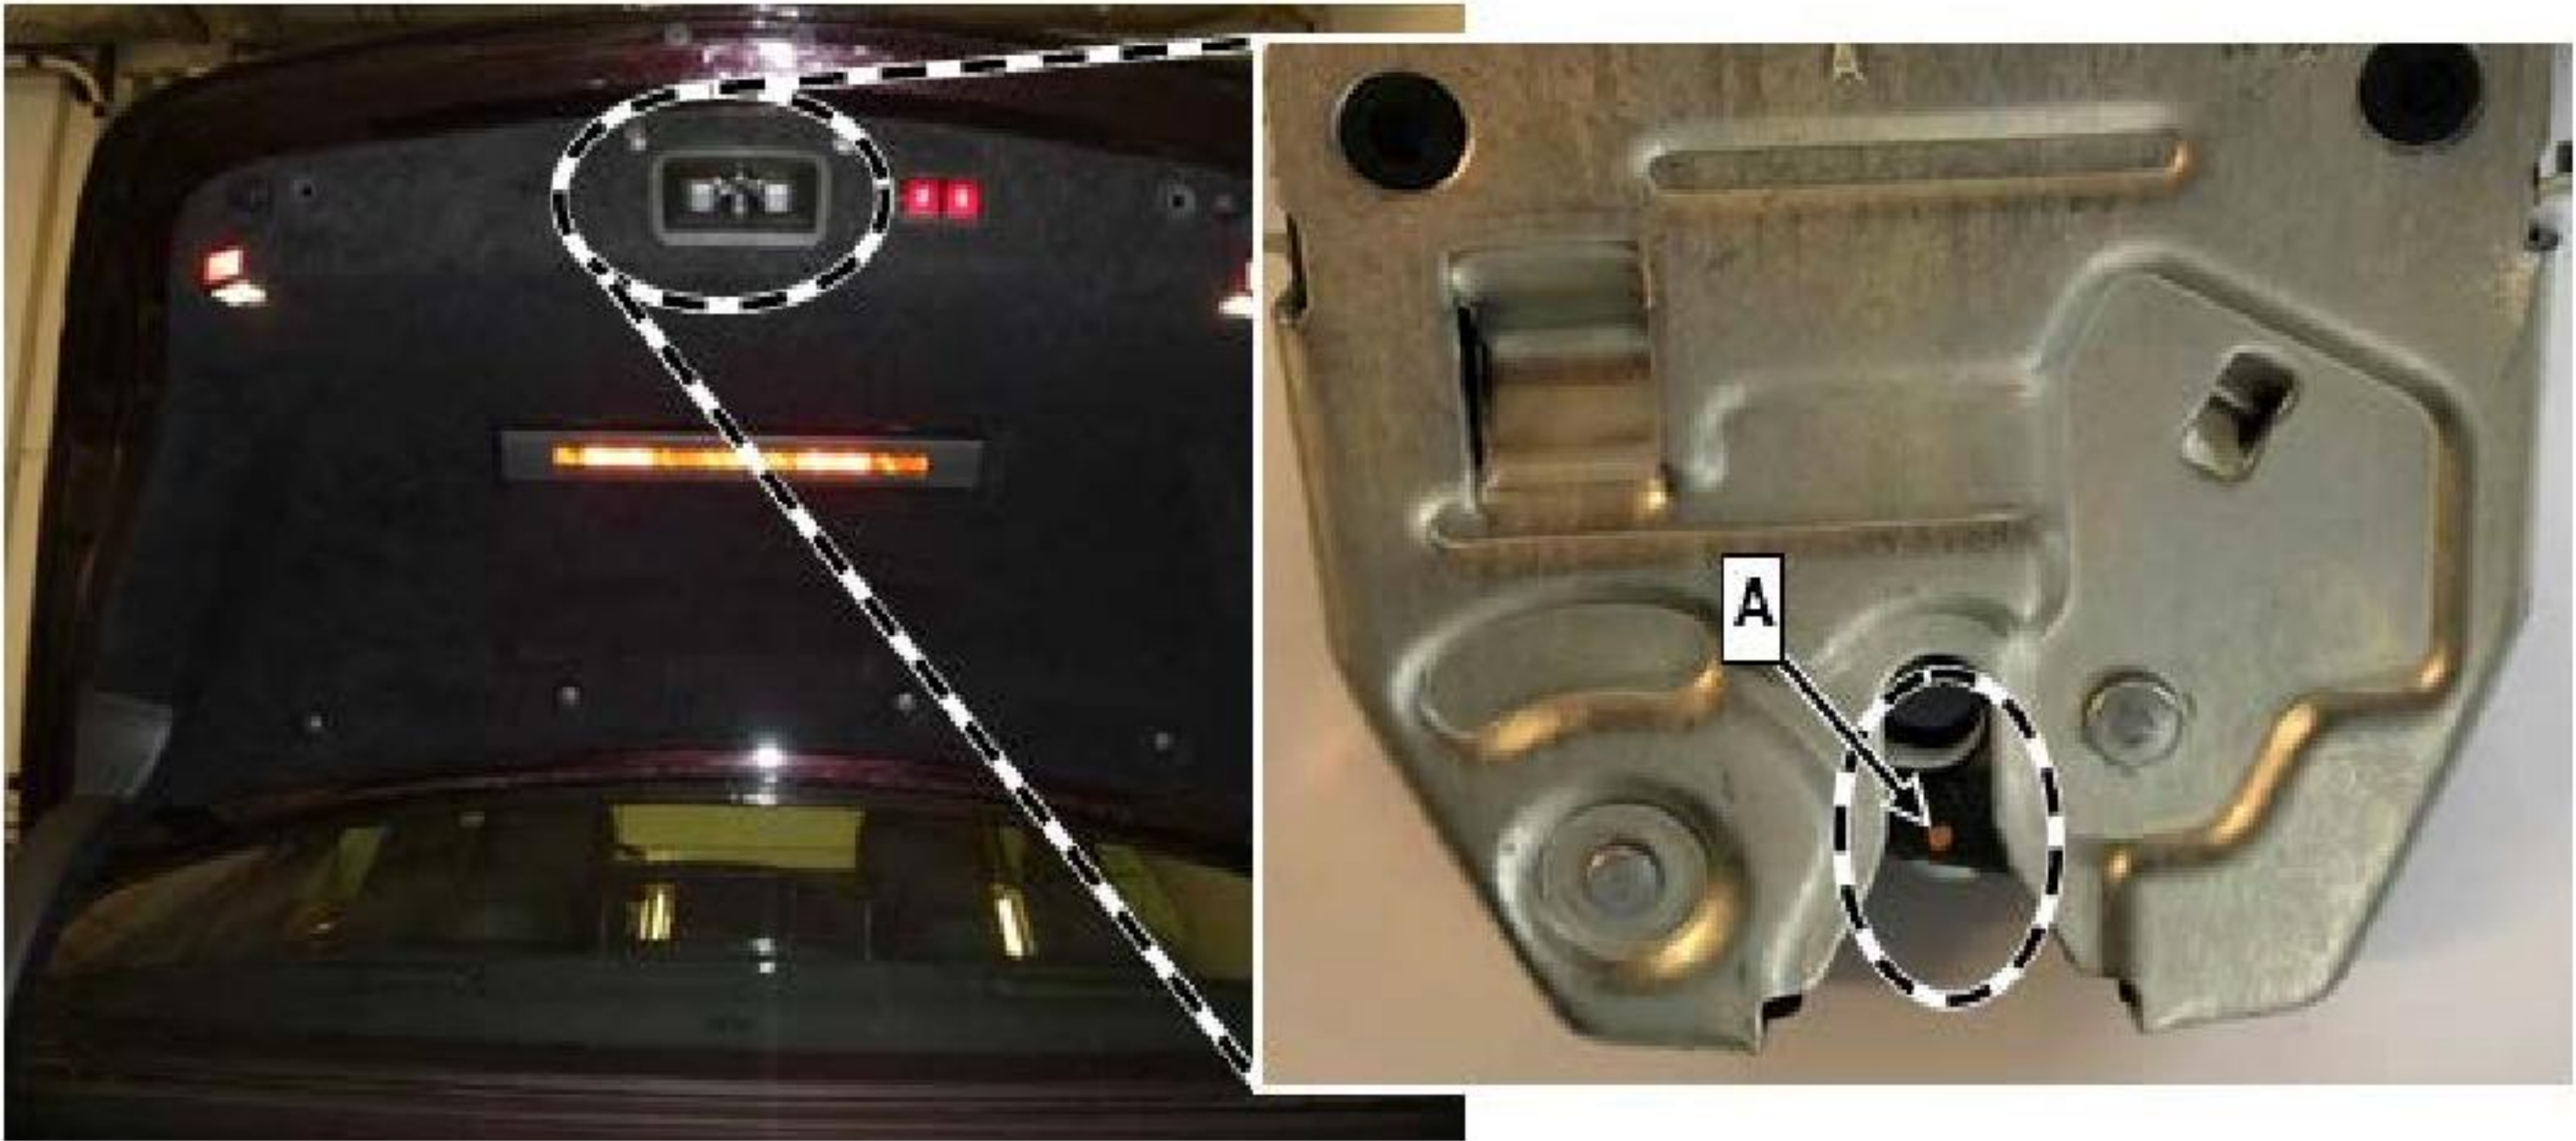
**Figure 1**

1. Open the trunk lid and check the **orange** marking (A, figure 1) on the lock for the trunk lid.
i To carry out the check, the lock must be locked using a suitable tool.

- a. **Orange** mark (A) on lock **not** present: Carry out **work procedure**.
- b. **Orange** mark (A) present on lock: **End measure**.
