Conditions causing fueling station nozzle to disengaging prematurely

MBUSA Product Technical Support Support document for LI47.00-P-058235 01/24/2014

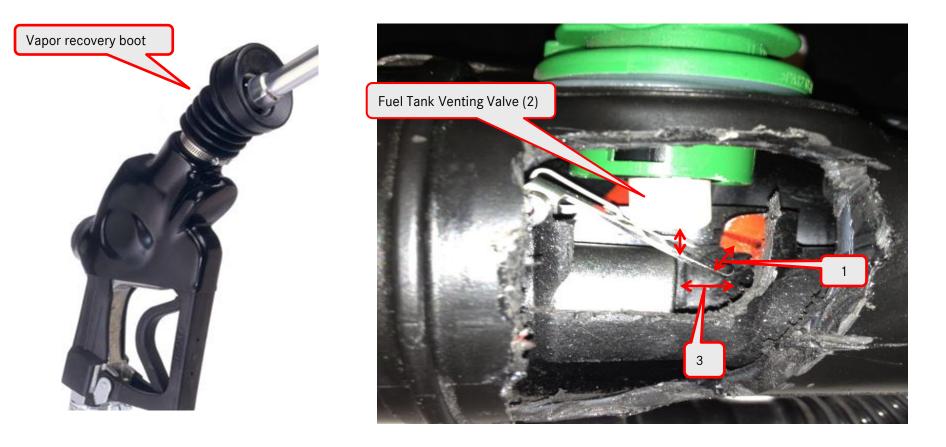
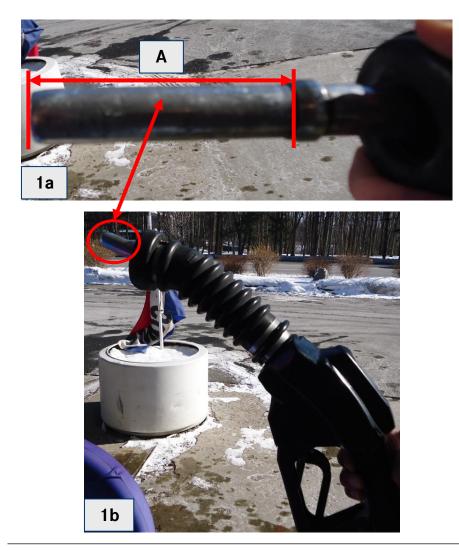
Identifying filling station nozzles which will <u>not</u> cause premature disengagement

Different nozzle manufacturers use different length nozzles (A) as shown in pictures below

- Nozzles in photos 1 and 2 will meet all preconditions needed to prevent premature disengagement
- Nozzle in photo 3 will **<u>not</u>** meet the preconditions resulting in premature disengagement
