Date: June 4, 2009
Order No.: P-B-46.20/60b
Supersedes: P-B-46.20/60a dated January 26, 2009
Group: 46

**SUBJECT: Model 230.470/471/472/474/475/476/479, All Model Years
Cracking Noise when Steering Left or Right**

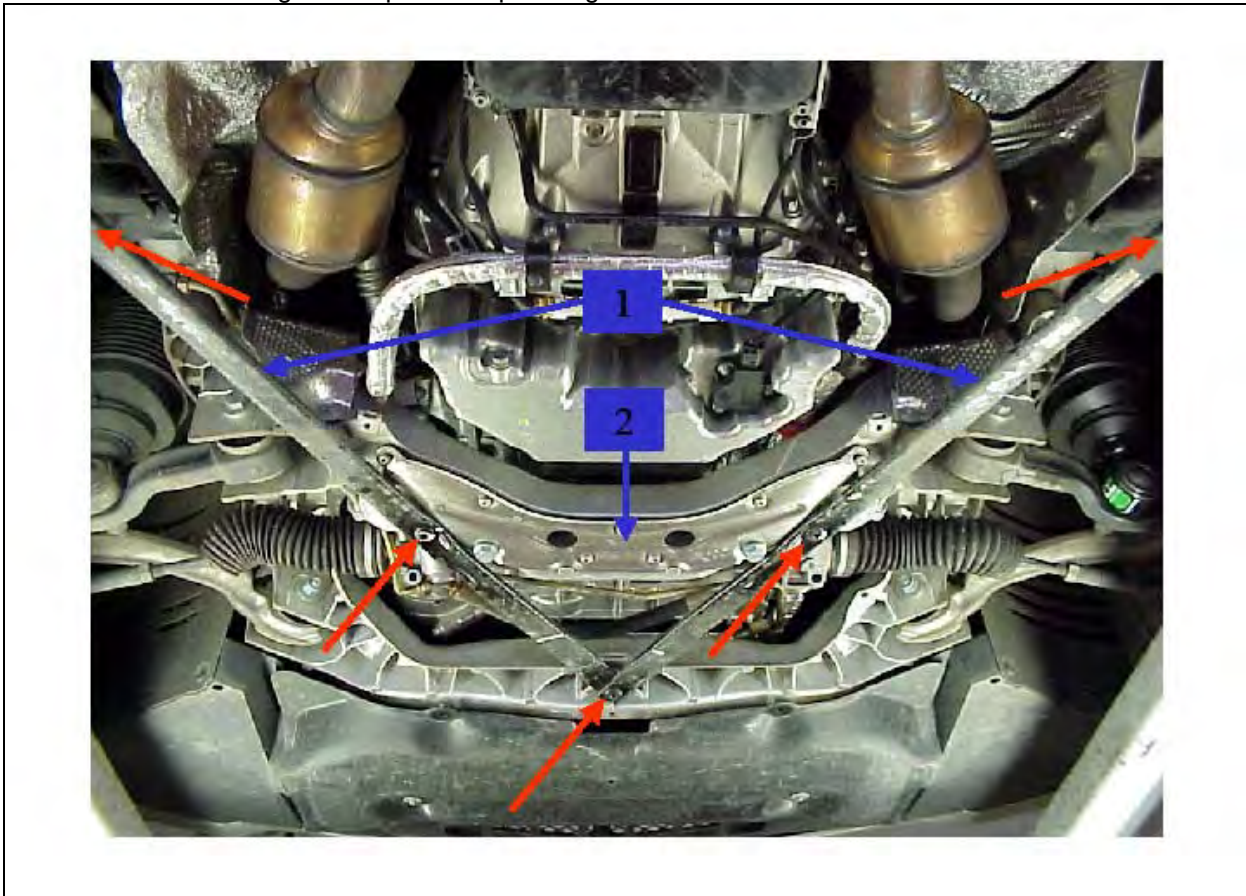
Figure 1

If you receive customer reports of cracking noise when steering left or right at low speeds just before limit stops, noticeable also at steering wheel this may be caused by lost preload and settling or poor contact surface between diagonal struts (Figure 1, 1) or the reinforcement plate (Figure 1, 2) and the front axle carrier. The cracking movement is noticeable on the steering gear on a stationary vehicle with wheels on the ground when steering to left or right. To resolve it is necessary to clean bolted contact surfaces between diagonal struts, reinforcement plate and the front axle carrier.

Note: The steering rack is not the cause of the cracking noise. **Do not replace steering rack!**

1. Remove lower engine compartment paneling. Refer to WIS document AR61.20-P-1105R.
2. Unclip cover on diagonal struts at front.
3. Remove diagonal struts (Figure 1, 1).
4. Check and clean thoroughly contact surfaces if necessary on the struts and on the front axle carrier to ensure firm connection when attached.
5. Remove reinforcement plate (Figure 2, 2) from front axle carrier.
6. Check and clean contact surfaces if necessary on the plate and on the front axle carrier to ensure firm connection when attached.
7. Install reinforcement plate (Figure 1, 2) on front axle carrier. Torque retaining bolts to 12 Nm. Refer to BA62.30-P-1006-01A entry in WIS doc BA62.30-P-1000-01A.

8. Install diagonal struts (Figure 1, 1) and torque retaining bolts to 70 Nm. Refer to BA62.30-P-1004-01A entry in WIS doc BA62.30-P-1000-01A.
9. Reinstall strut covers
10. Install lower engine compartment paneling. Refer to AR61.20-P-1105R.
