Date: January 19, 2007
 Order No.: T-B-27.00/48e
 Supersedes: T-B-27.00/48d dated May 1, 2006
 Group: 27

**SUBJECT: All Model 163 / 463 with 722.6 Automatic Transmission
 Leaking Oil in the Area of the Electric Connection**

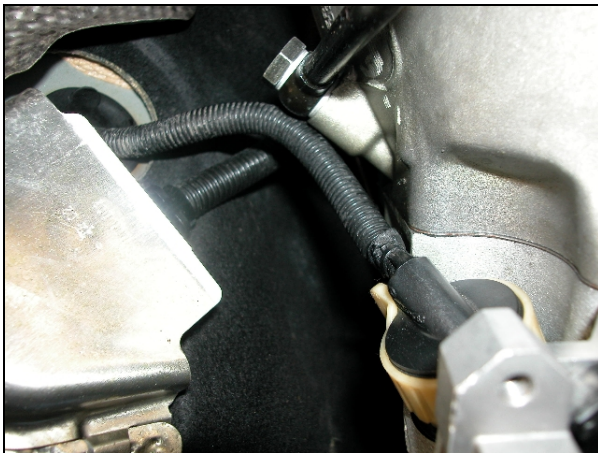
Figure 1

i Note: When connecting the wiring harness to the transmission, ensure that the harness is routed in a tension free path (Figure 1) and that no tension is applied to the electrical connector from the harness (Figure 2).
