**DTB**

Date: February 13, 2004  
Order No.: P-B-54.18/108  
Supersedes:  
Group: 54

**SUBJECT: Model 211.065/070/076/082/083/265/282/283  
All Model Years  
Engine Does Not Start**

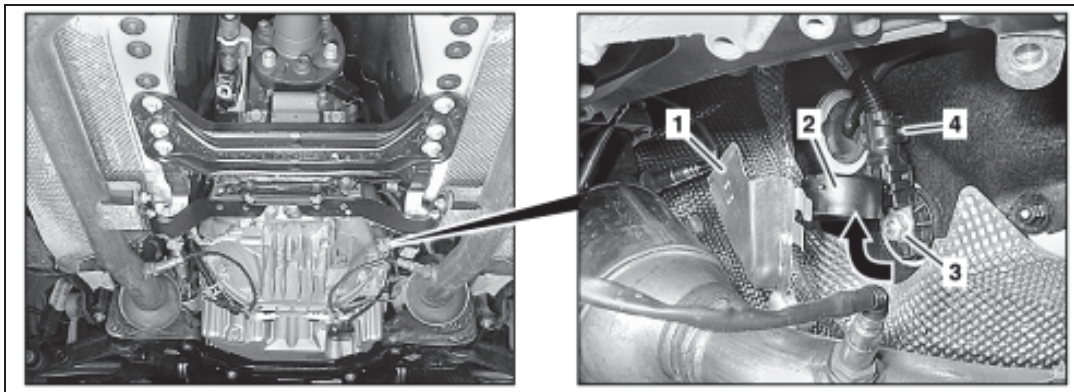
Figure 1

If you receive customer reports in the above model vehicles of the engine not starting, the starter cable harness lug may be providing insufficient contact. The following procedure must be followed.

- 1) Disconnect ground cable from battery, as per WIS document AF54.10-P-0003T (sedan) and AF54.10-P-003TA (wagon).
- 2) Remove footwell paneling in passenger footwell, as per WIS document AR68.20-P-2070T.
- 3) Disconnect starter cable harness on the vehicle under side from (F32) prefuse box (Figure 1, 3).

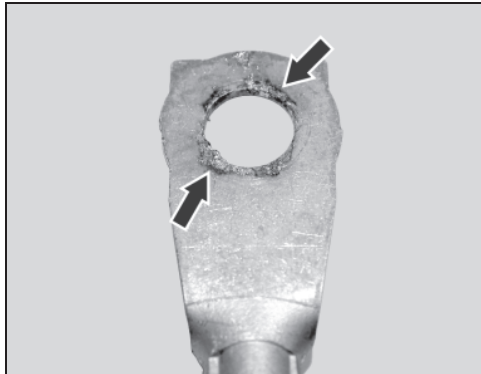
**i** **Note:** If the starter cable harness lug cannot be properly connected to the terminal point on the front prefuse box (F32) (outside part of passenger footwell), this may cause pitting of the contacts (Figure 2 & 3).

Figure 2 P-B-54.18/108  
Arrows pitting on starter cable harness lug.

- 4) Perform a visual inspection of the contact surfaces of the starter cable harness and of the prefuse box, clean the contacts and coat with a preserving agent.

**i** **Note:** If there is damage to the cap of the starter cable harness, in the form of a burnt or pitted surface, replace with a new cap.

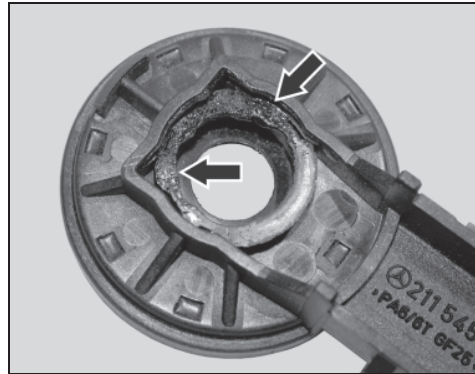
Figure 3 P-B-54.18/108  
Arrows pitting on bottom part (flange) of front prefuse box cap (F32).

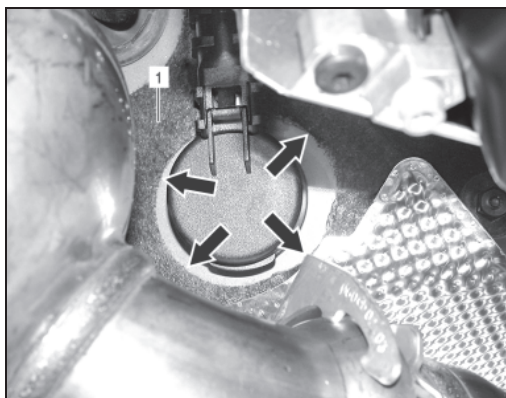
**i** **Note:** Ensure that the damping mat is not caught between the body and the cap (Figure 4). This tilted installation position may cause contact problems between the cap and the terminal point.

Figure 4 P-B-54.18/108  
1 – Insulation Mat

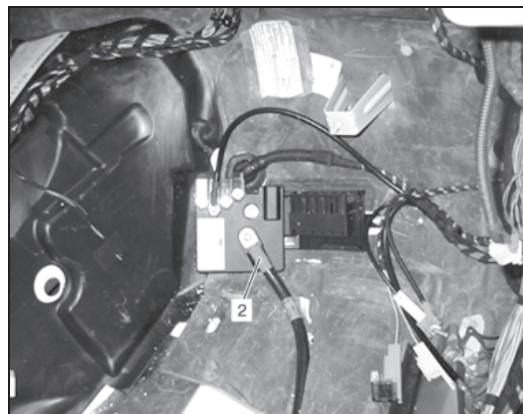
**i** **Note:** Ensure that the battery cable in the interior of prefuse box is not under tension (Figure 5, 2). If the cable is under tension it can bend and/or misalign the terminal point in the interior of the prefuse box. A tilted installation position can also lead to contact problems in this case. Figure 5 shows the correct installation position of the battery cable.

Figure 5 P-B-54.181/08  
2 – Battery cable at front prefuse box (F32) in passenger footwell
