**DTB**

Date: February 22, 2008
Order No.: P-B-63.20/15
Supersedes:
Group: 63

**SUBJECT: Model 211.026/065/070/076/082/083/265/276/282/283
Water Entry at A-Pillar**

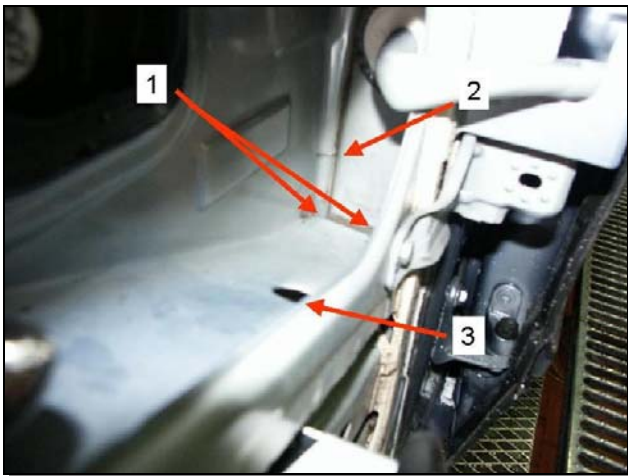
Figure 1

1. Blocked water drain in the upper longitudinal member under the front fender (blocked by debris) (Figure 1, callout 1).
2. Rising water penetrates the interior compartment because of a lack of seam sealer on the double panel of the firewall/longitudinal member on the inside at the top (Figure 1, callout 2).
3. Mounting hole for the tilting/sliding roof drain hose, water may back up and over flow into interior.

- 1 – Water drain upper longitudinal member
- 2 – Lack of seamsealer on the double panel
- 3 – Roof drain hose hole

1. Remove front fenders. Refer to WIS document AR88.10-P-1000T.
2. Clean the areas of the upper longitudinal member under front fender.
3. Apply seam sealing to the double panel of the firewall/longitudinal member toward the cross member under the wind deflector (Figure 1, callout 2).
4. To permanently fix the water drain problem mentioned in possible cause 1, a water drain hole with reinforcement plate must be made (Figure 2).
5. Drill the additional drain hole
6. Remove the lower bolt on the fender bracket (Figure 3, arrow) and bend the bracket upwards.
7. Mark the position for the additional water drain hole 7mm away from the edge of the seam sealer. Drill a 10mm hole in incremental steps reference Figure 4.
8. Make a 1.5mm thick metal plate, using mild sheet steel (locally purchased), with 6.5mm holes drilled for 5 rivets. Reference Figure 6 (page 4) for actual size template.
