то: Mercedes-Benz Dealer Principals, General Managers, Sales Managers, Service Managers, Parts Managers	FROM: Thomas Brunner, Department Manager, Vehicle Compliance and Analysis, Engineering Services	
RE:Recall Campaign with Stop-Sale Order— Secondary Rubber Hood Seal. Model 212 (E-Class), 218 (CLS-Class) Model Years 2013-2015	DATE: February 11, 2015	7

IMPORTANT RECALL INFORMATION AND STOP SALE ORDER

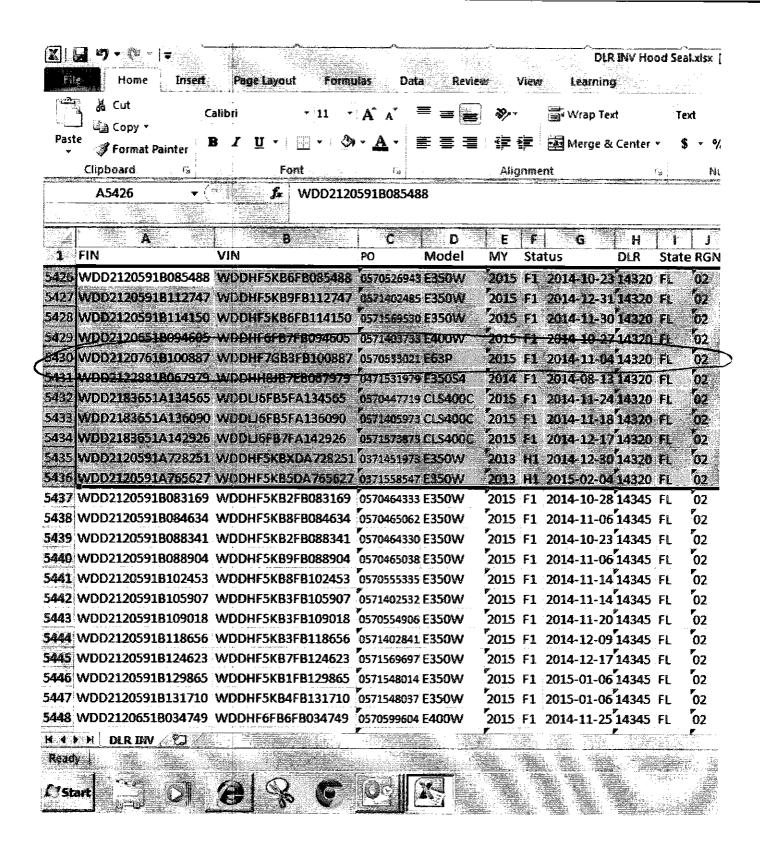
Daimler AG (DAG) has determined that on approximately 147,224 Model Year 2013 - 2015 E-Class and CLS vehicles, the rubber seal on the top edge of the secondary bulkhead in the engine compartment may not be secured properly (see diagram below). In the event the rubber seal is not properly secured to the secondary bulkhead, it is possible for the seal to temporarily adhere to the engine hood when the hood is opened. Should this occur, the seal might be partially lifted from the secondary bulkhead, and under adverse circumstances, may drop into the area between the engine and the secondary bulkhead. Should a sufficient length of seal be displaced from the bulkhead and drop down, it is possible that the loose end of the seal might contact parts of the exhaust system, specifically the catalytic converter. Should the catalytic converter be sufficiently hot at the time of contact with the rubber seal, the potential risk of fire cannot be excluded. To correct this condition an authorized Mercedes-Benz dealer will attach four additional retaining clips on the rubber seal in the engine compartment.

MBUSA has initiated a voluntary recall of all potentially affected vehicles described above. The recall will be conducted to attach four additional retaining clips on the rubber seal in the engine compartment. MBUSA notified the NHTSA on February 9, 2015 of this new recall, which may generate questions from your customers.
