2018 Mercedes Benz E63S AMG 4MATIC Sed (213.089) V8-4.0L Turbo (177.980)

## ADS INDICATOR LAMP ILLUMINATED AFTER INSTRUMENT CLUSTER REPLACEMENT OR SOFTWARE UPDATE

Topic number	LI54.30-P-070378
Version	1
Function group	54.30 Instrument cluster, display instruments, hazard warning device
Date	10-29-2019
Validity	Model series 213
Reason for change

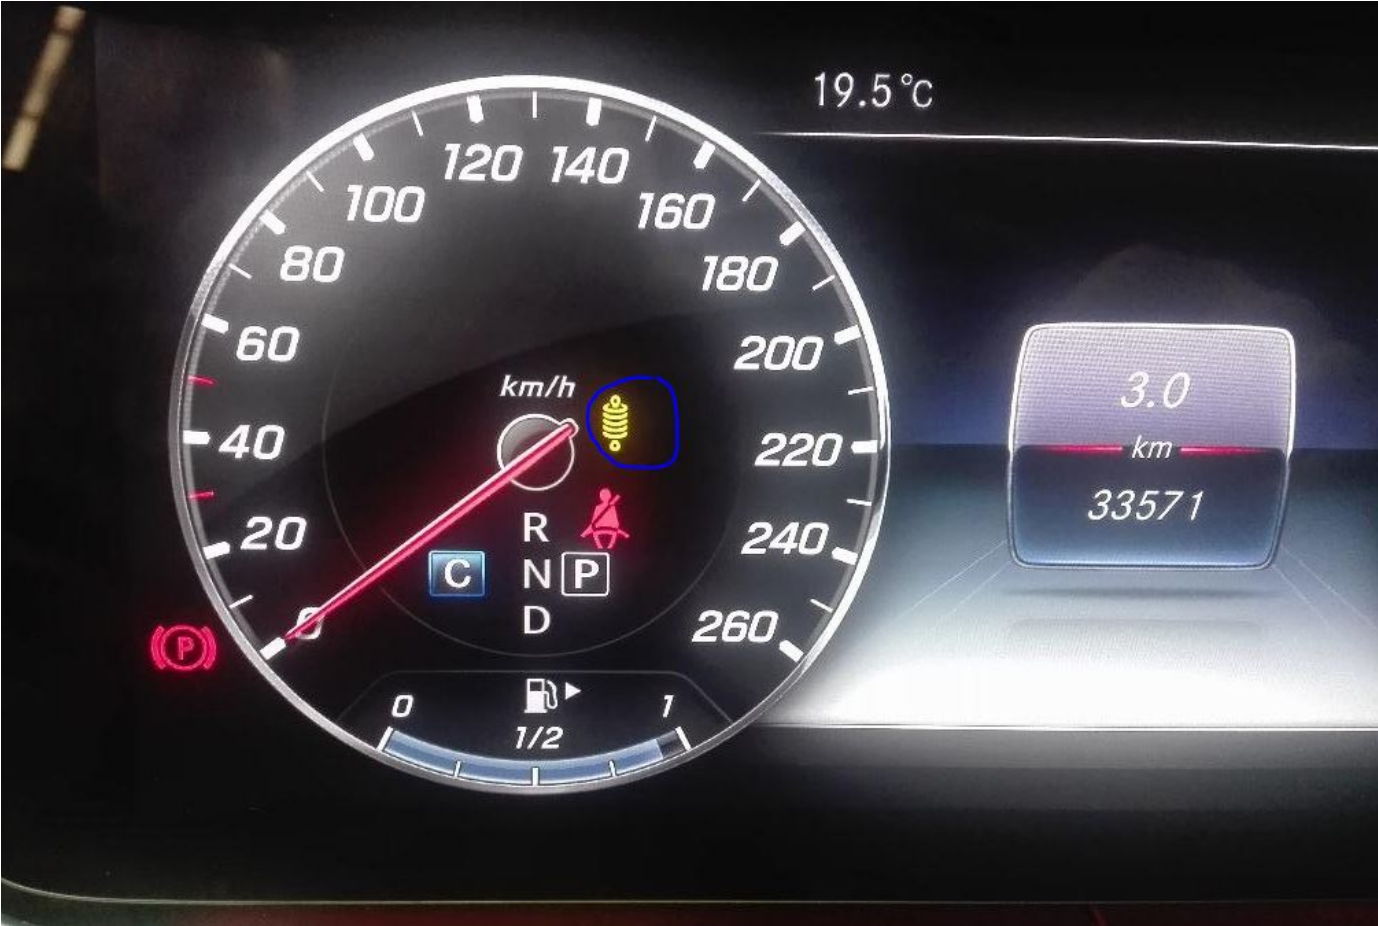
**ADS indicator lamp**

After the instrument cluster has been replaced, or the instrument cluster (A1) software has been updated, the indicator lamp for the ADS suspension system may be illuminated.

ADS indicator lamp illuminated

Previous software releases for the Instrument Cluster (A1) and Adaptive Damping System suspension control unit (N51/5) are not compatible.

After replacing or performing a software update on the Instrument Cluster (A1), update the ADS suspension control unit (N51/5) software.
