2018 Mercedes Benz E63S AMG 4MATIC Sed (213.089) V8-4.0L Turbo (177.980)

BR213 - WRINKLING IN LEFT AND RIGHT SEAT CUSHION COVERS ON REAR BENCH SEAT

Topic number	LI91.12-P-066074
Version	2
Function group	91.12 Rear seats
Date	06-15-2020
Validity	Equipment code: P22 (EXCLUSIVE interior) and 801 or 814 or 815
Reason for change	New optimized rear seat cushion covers available.

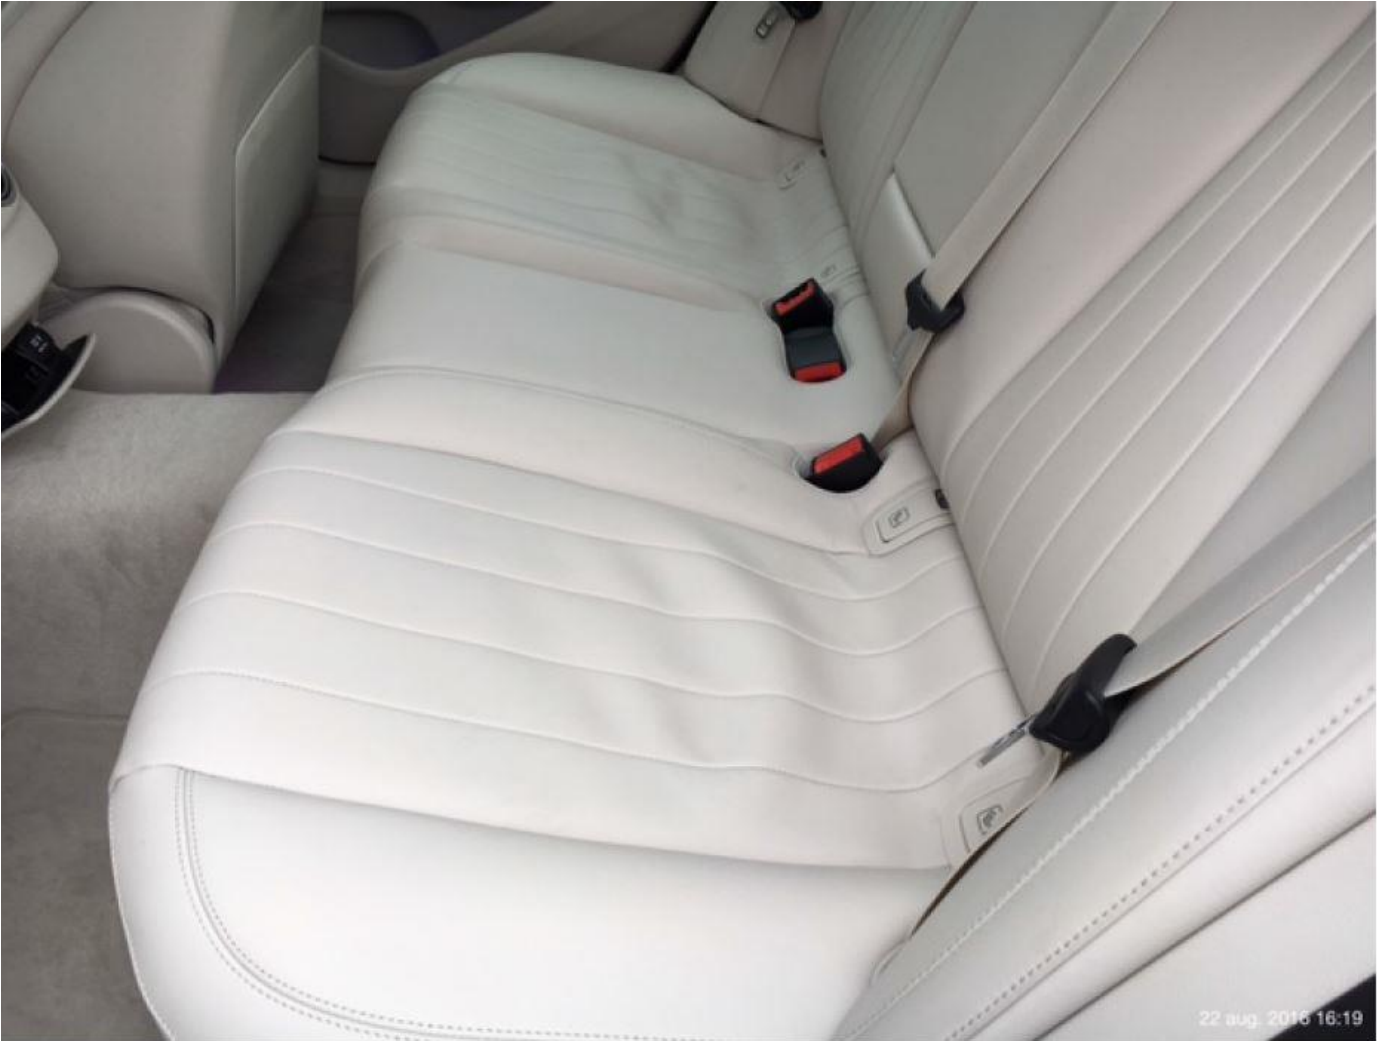
BR213_faltige_Fond_bezuege

Wrinkling in left and right seat cushion covers on rear bench seat with Exclusive Leather special equipment

Example of the complaint: Wrinkled rear seat covers

Due to the casual seat covering concept (floating, without stapling at the rear of the surface) and the extremely soft material used (nappa leather), stretching of the material may occur even with normal customer use. This stretching of the material appears in the form of a dent in the surface of the seat cushion.

Replacement of the rear seat cover.

The optimized rear seat cover with additional stitching (transverse seam) can be ordered through the EPC.
