Initial startup not possible after replacement of TRANSMISSION 725.0 or of electrohydraulic controller unit

Topic number	LI27.00-P-068206
Version	2
Function group	27.00 - General
Date	10/27/22
Validity	All vehicles with TRANSMISSION 725.0
Reason for change	Clarify Wording

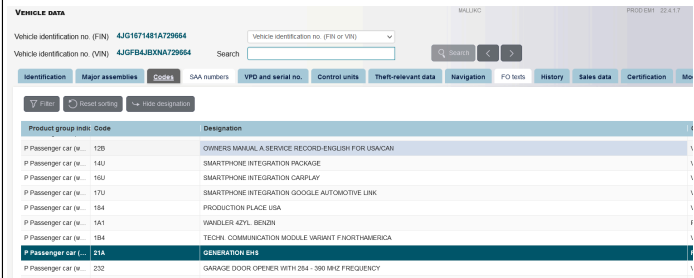
Attachments	
File	Description
VeDoc Code Location.PNG	Example of SA code as seen in VeDoc

Redocument the new SA code in VeDoc according to the EPC footnote for the transmission or electrohydraulic controller unit (EHS) ordered, and then perform initial startup.
