2018 Mercedes Benz E63S AMG 4MATIC Sed (213.089) V8-4.0L Turbo (177.980)

## NOISES FROM DOOR PANEL IN AREA OF BELTLINE - BR213

Topic number	LI72.10-P-071097
Version	1
Function group	72.10 Front door
Date	03-06-2020
Validity	BR213
Reason for change

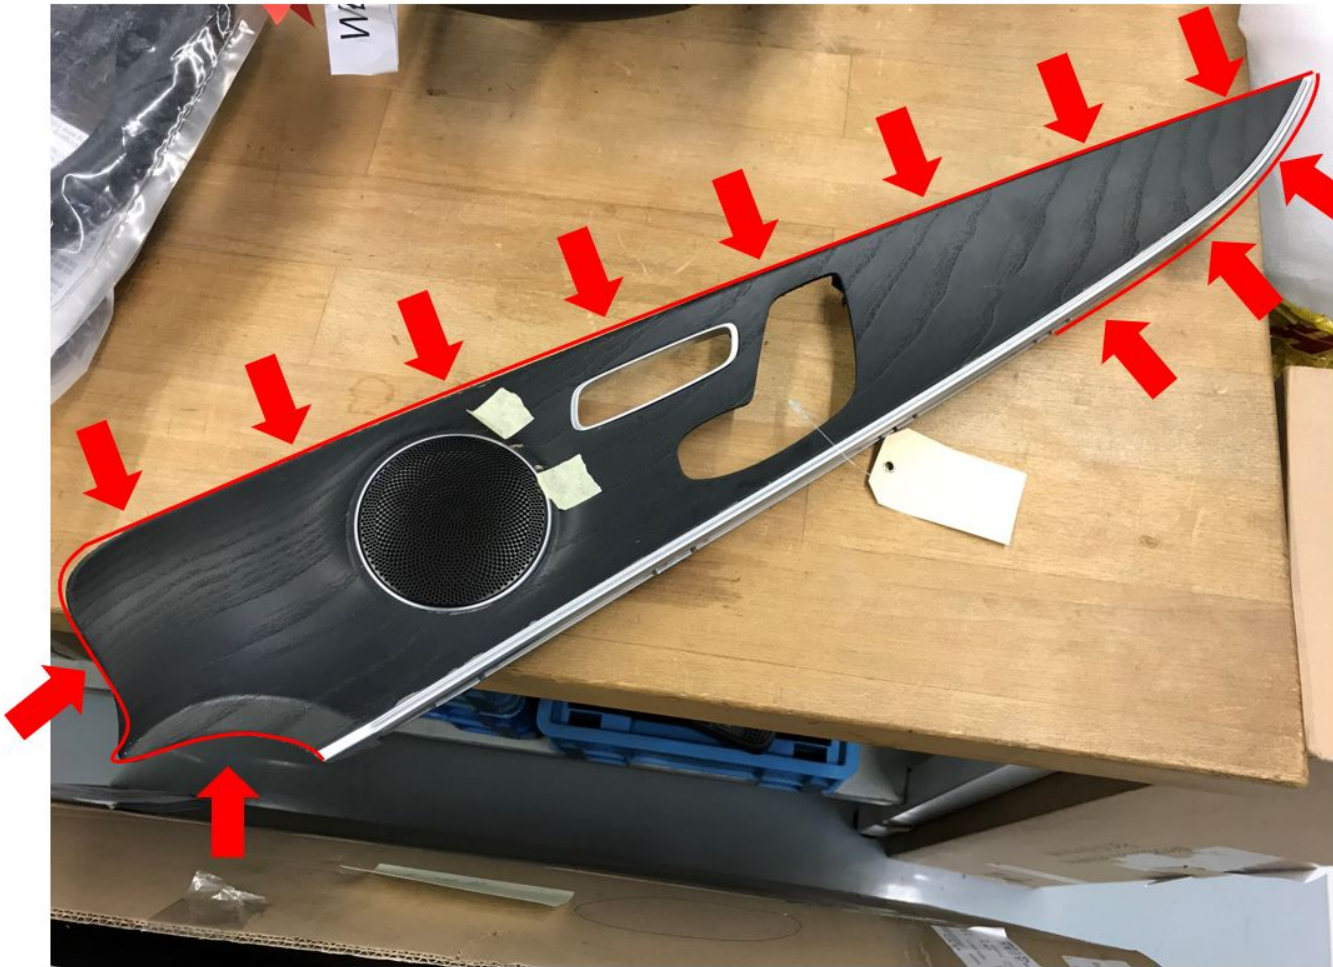
Zierteil

There may be contact points between the trim element and the door panel. The contact between the components can produce creaking noises in the area of the beltline.

Trim element - Areas to be treated marked in red

Treat the outer edges of the trim element with special lubricant A 000 989 36 60. To do this, remove the trim element. Pictures of the areas to be treated are included in the attachment and are marked in color.
