2018 Mercedes Benz E63S AMG 4MATIC Sed (213.089) V8-4.0L Turbo (177.980)

POWER REDUCTION FROM 4000 RPM

Topic number	LI49.10-P-068745
Version	1
Function group	49.10 Exhaust pipes, catalytic converter, mufflers
Date	09-07-2018
Validity	Model 213.x88/x89 Model 222.187/188 Model 463.276/277 (G63 facelift) Model 463.260/261 (G500 facelift)
Reason for change

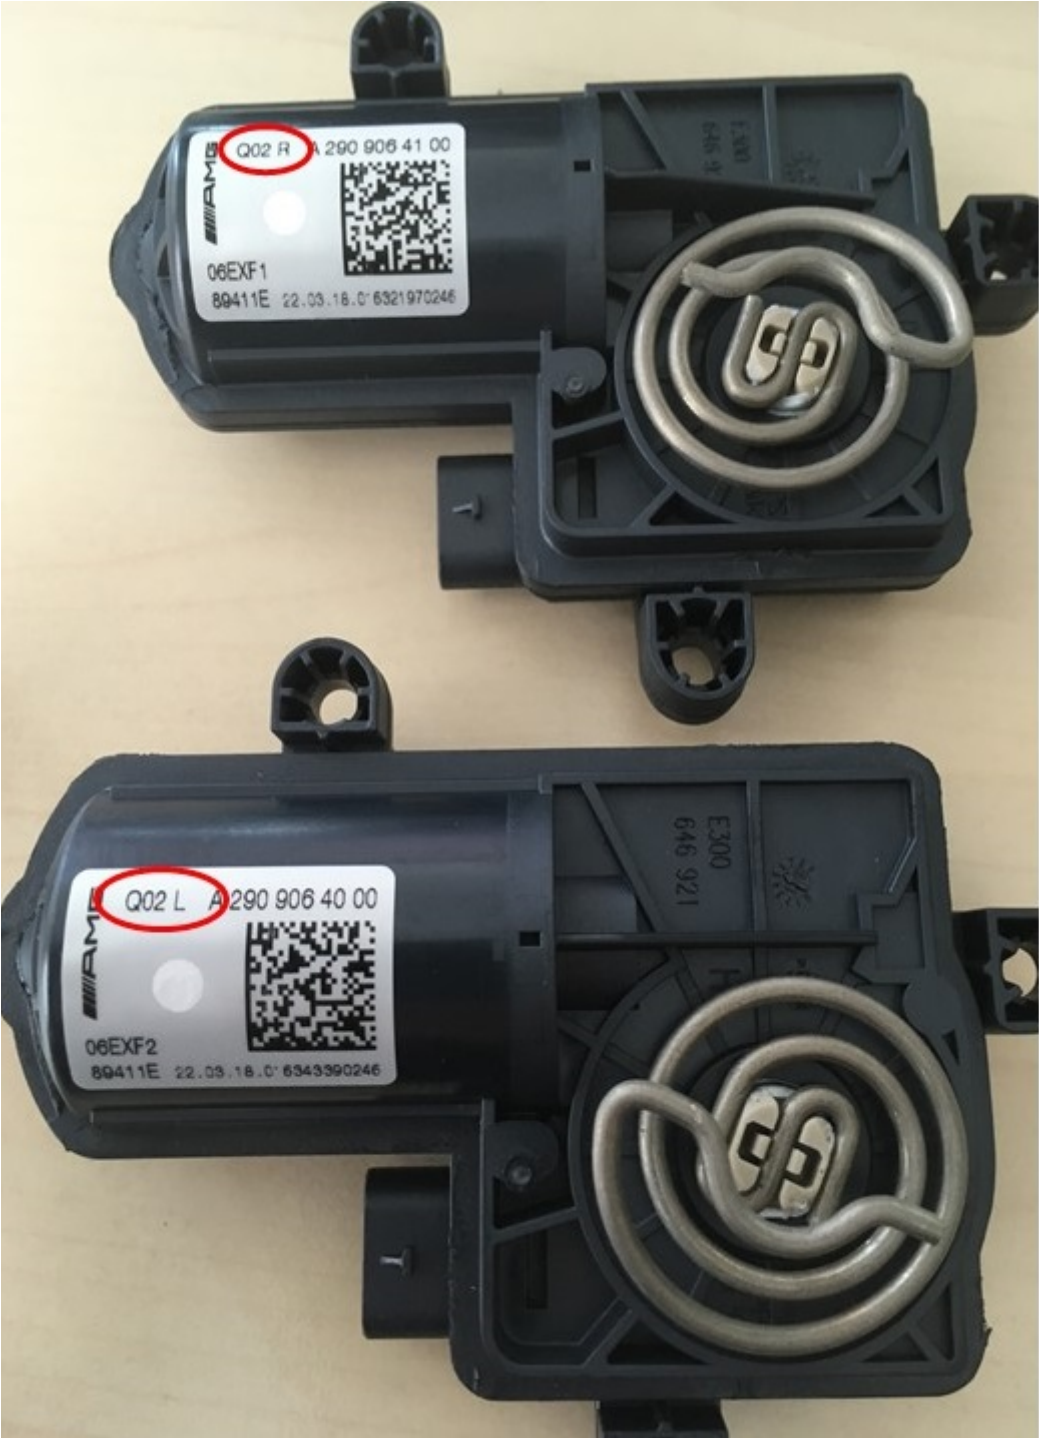
Präsentation1

1. Check Q-status of actuators (see attachment)
2. If Q1 status actuators are installed, they must be replaced
3. If Q2 status (or higher) actuators are installed, alert the relevant MBUSA service engineer by opening a PTSS case and having it escalated directly to them

Designation
Q-status OK
