Throttle lift-off clunking noises at drive shafts of front axle

Topic number	LI33.30-P-056665
Version	7
Function group	33.30 - Final drive, differential, drive shaft
Date	12/7/22
Validity	Models: All Mercedes-Benz cars with front-wheel drive and 4x4 vehicles
Reason for change	Add Op code

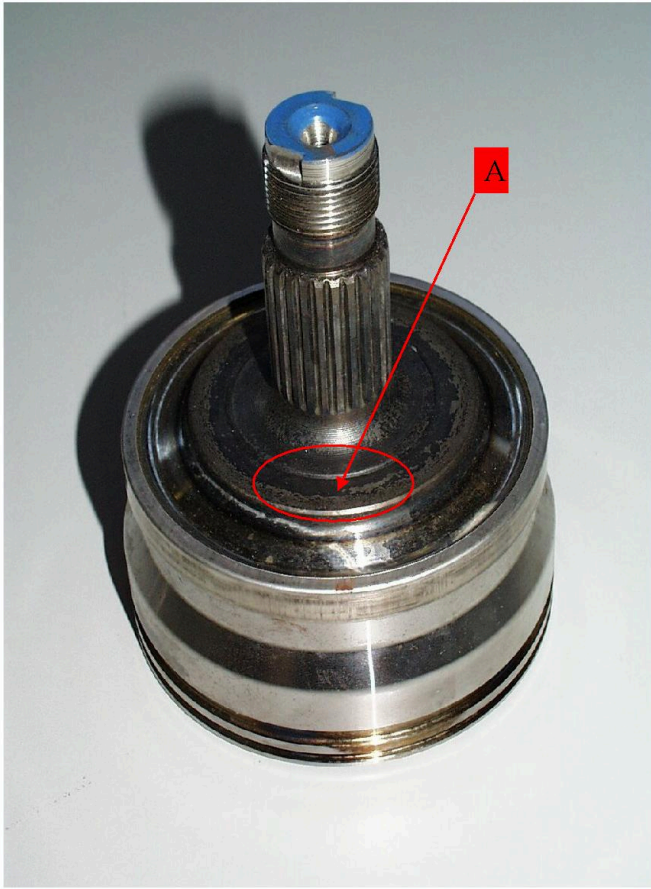
Attachments	
File	Description
Gelenkgehäuse aussen vor.jpg	Before coating with Molykote paint

If the complaint is eliminated by experimentally loosening the outboard collar nut (by 1 turn), the concern is due to micromovement in the connection between the wheel bearing inner race and the joint housing of the side shaft.

Coat contact surface of side shaft with wheel bearing with Molykote paint. To do this, proceed as follows:

1. Remove outboard side shafts (extract outer joint gearing from wheel hub)
2. Clean contact surface A (see image file in attachment "Outer joint housing before") before coating with Molykote paint (free of dust and grease)
3. Coat contact surface A (see image file in attachment "Outer joint housing after") with Molykote and leave to dry for one hour in removed condition
4. Reinstall side shafts

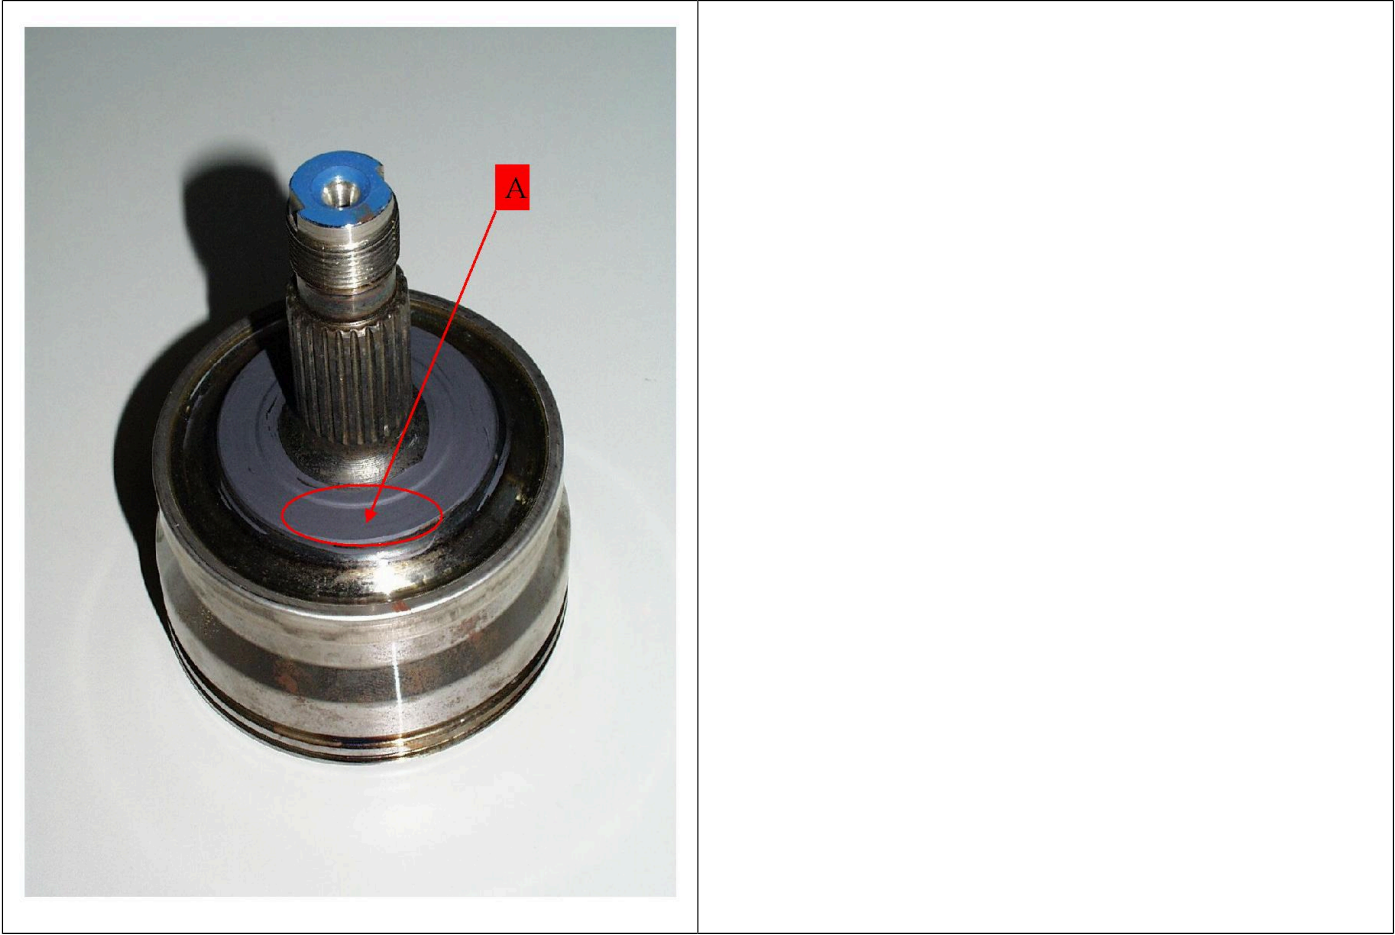
[Gelenkgehäuse aussen nach.jpg](#)

After coating with Molykote paint
