2018 Mercedes Benz E63S AMG 4MATIC Sed (213.089) V8-4.0L Turbo (177.980)

THROTTLE LIFT-OFF CLUNKING NOISES AT DRIVE SHAFTS OF REAR AXLE

Topic number	LI35.30-P-058566
Version	6
Function group	35.30 Final drive, drive shafts
Date	10-12-2020
Validity	Model 171,172,203,204,205,207,209,211,212, 213,215,216,217,218,219,220,221,222,223,230,231,238,253,257,164,166,167,292,293 For model 203, 209, 171, as of approx. calendar week 21/04 coated with Molykote paint as standard
Reason for change	Validity updated.

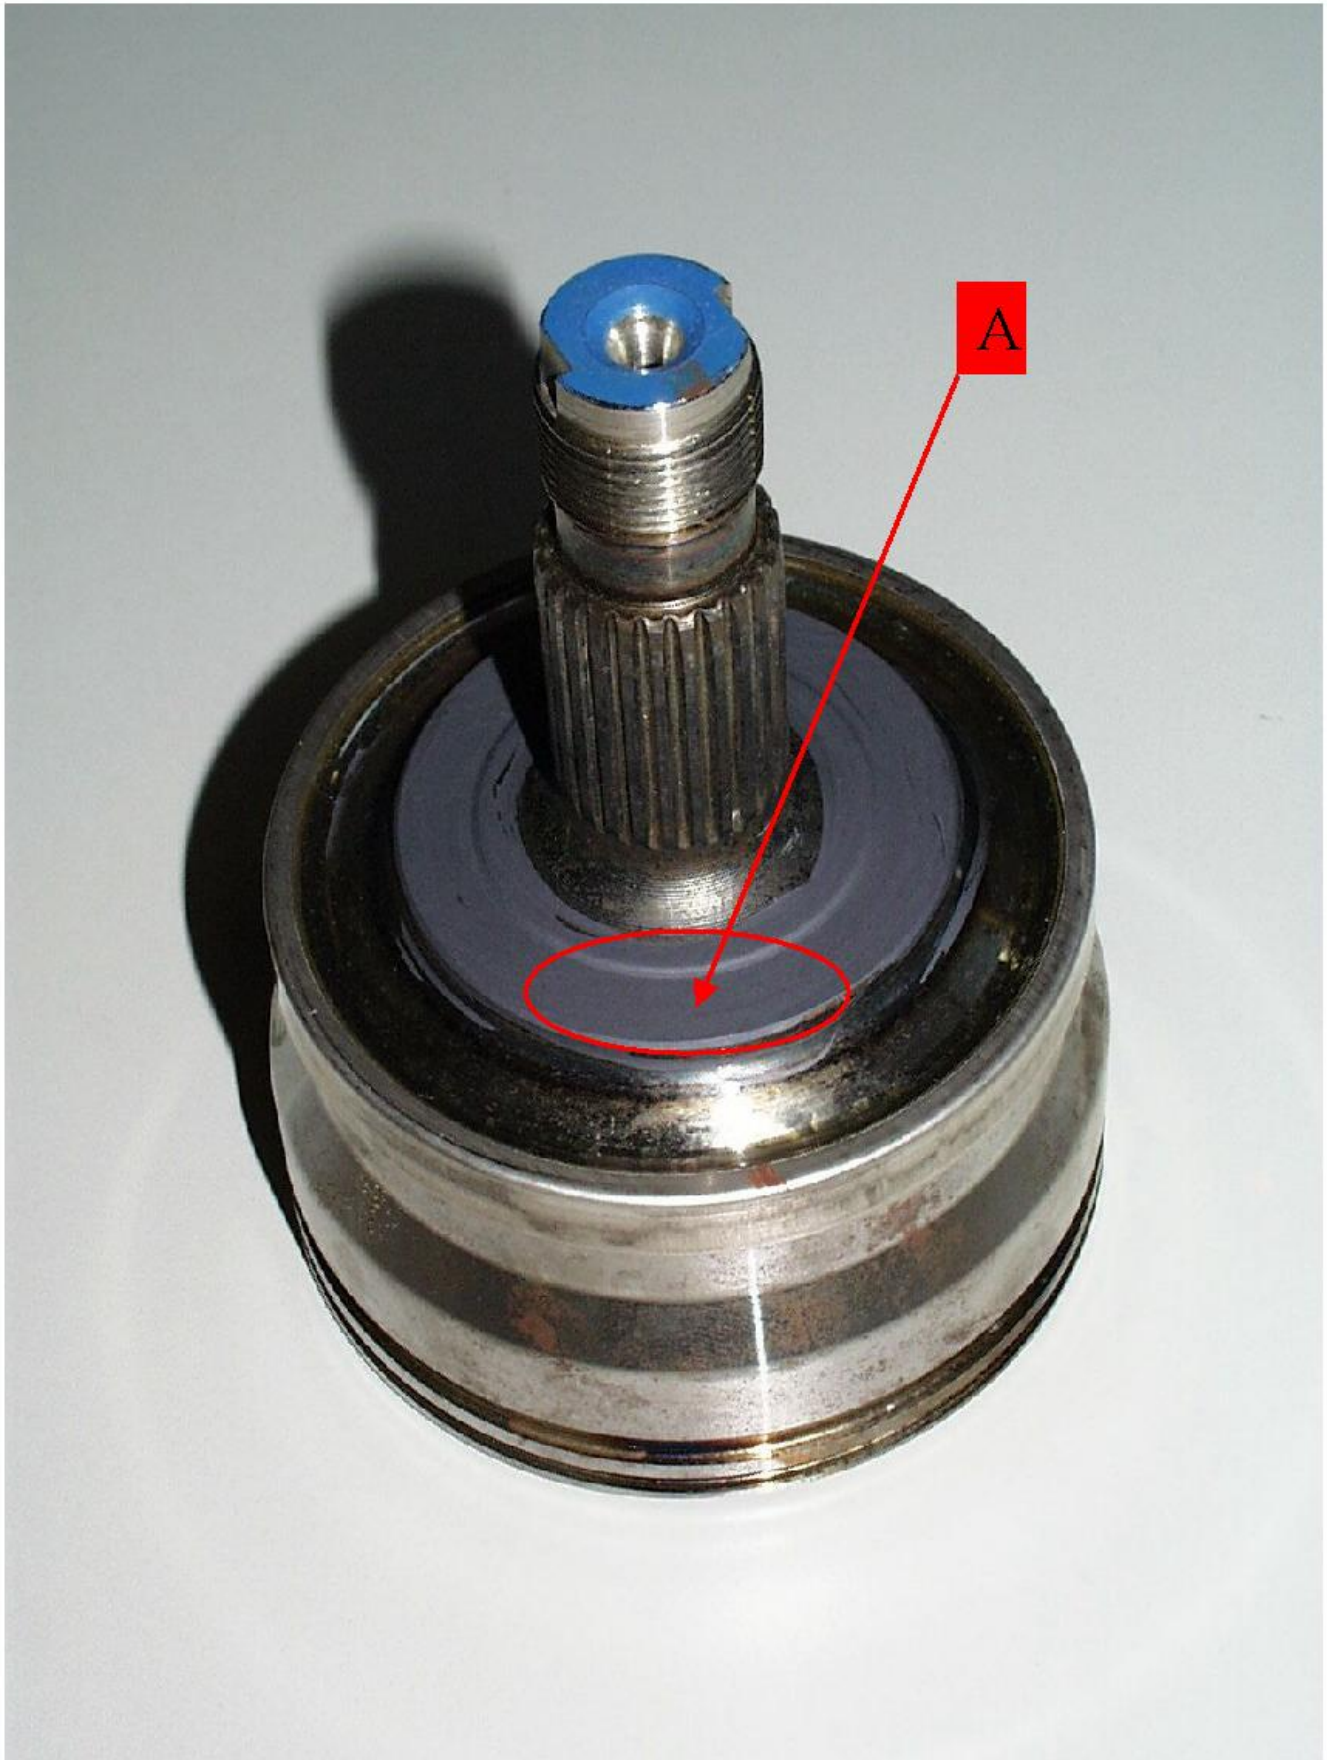
Gelenkgehäuse aussen nach

If the complaint is eliminated by experimentally loosening the outboard collar nut (by 1 turn), the problem is due to cracking of the microweld between the wheel bearing inner race and the joint housing of the side shaft.

After coating with Molykote paint

Coat contact surface of side shaft with wheel bearing with Molykote paint. To do this, proceed as follows:

1. Remove side shafts
2. Clean contact surface A (see image file in attachment "Outer joint housing before") before coating with Molykote paint (free of dust and grease)
3. Coat contact surface A (see image file in attachment "Outer joint housing after") with Molykote and leave to dry for "one hour" in removed condition
4. Reinstall side shafts

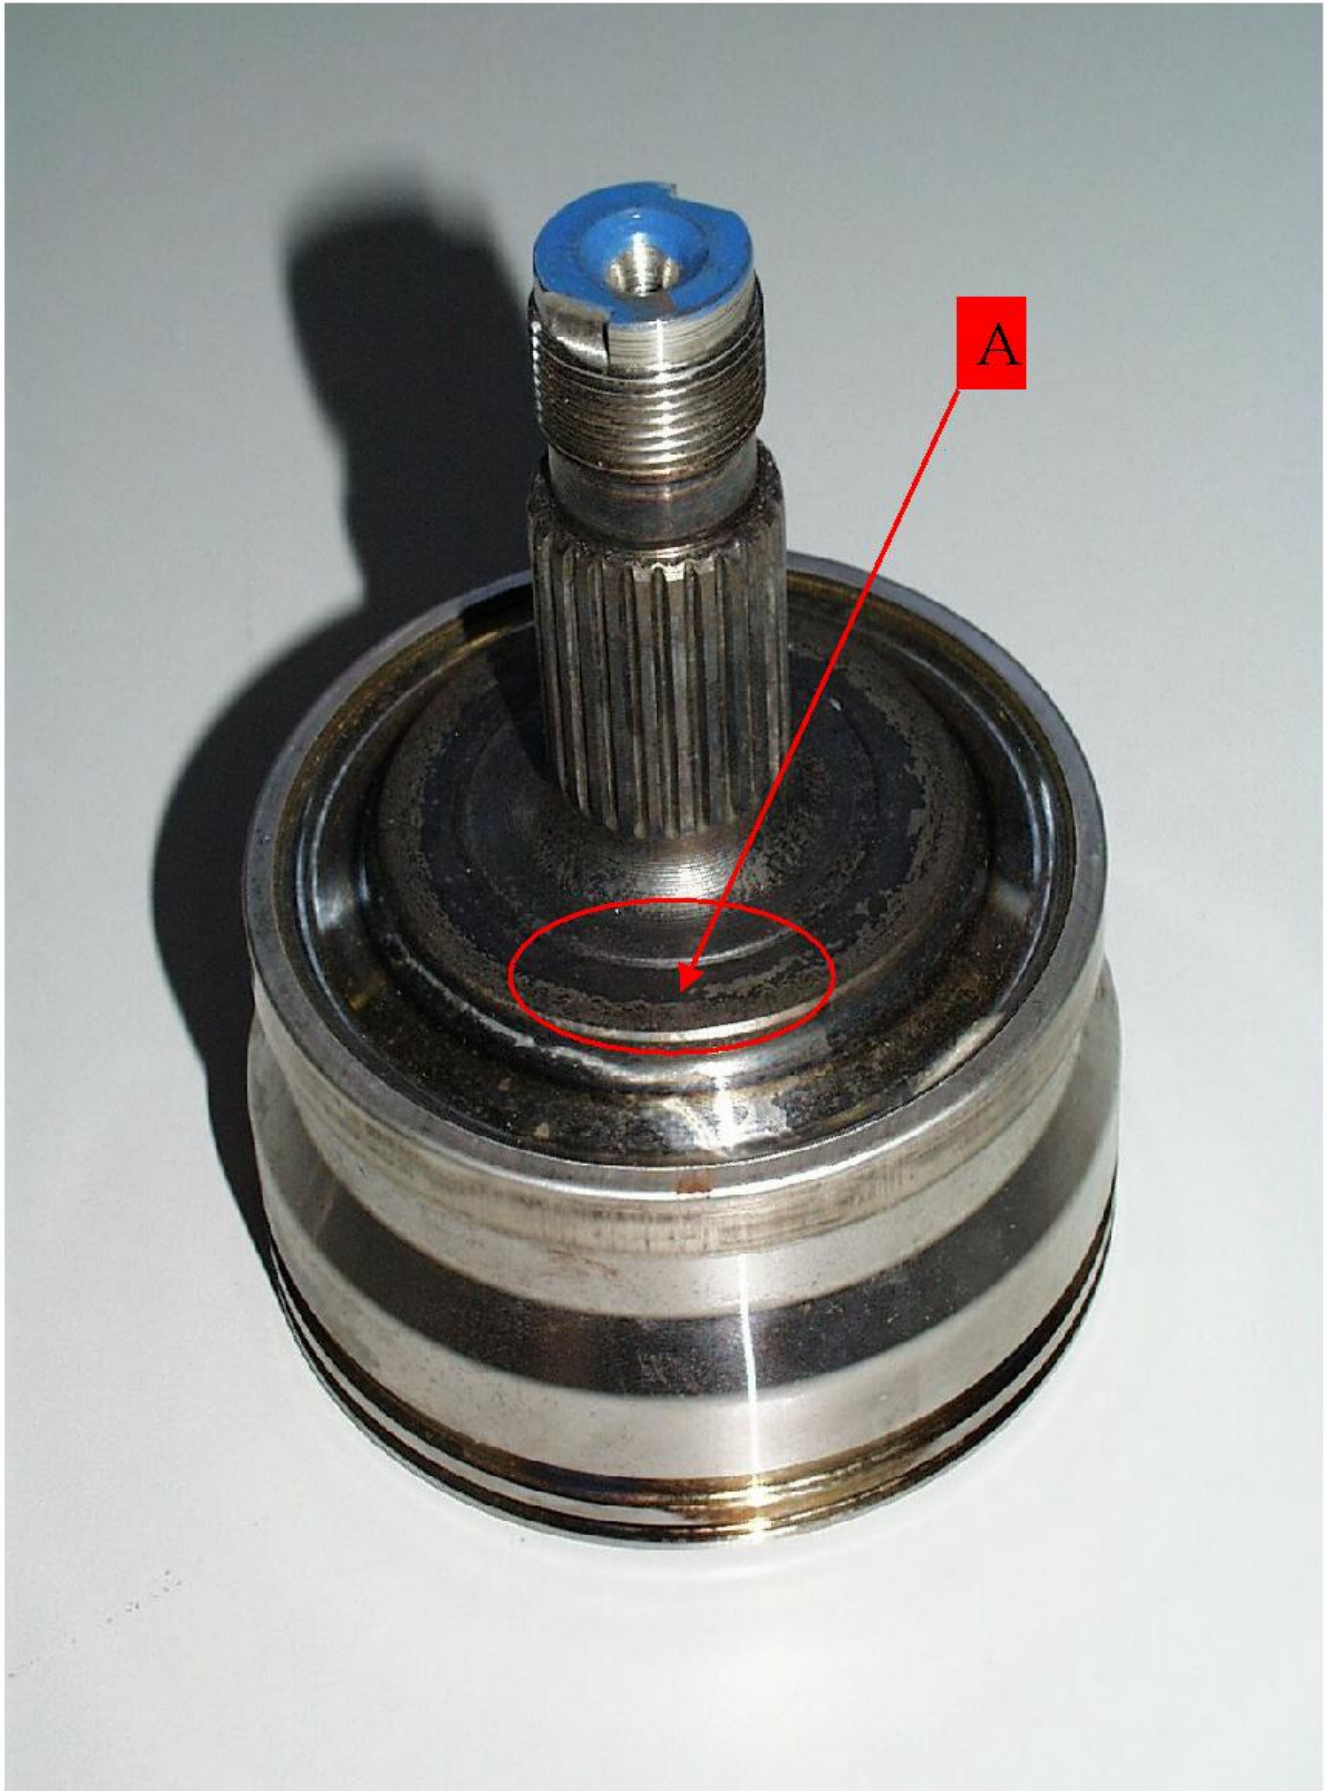
Gelenkgehäuse aussen vor

Before coating with Molykote paint
