2018 Mercedes Benz E63S AMG 4MATIC Sed (213.089) V8-4.0L Turbo (177.980)

CHECK SEAT TRAVEL LIMITER AT SEAT FRAME BASE OF FRONT PASSENGER SEAT

Campaign No. 2018090013, October 2018
Revision A

SUBJECT: Models AMG E63 S (213 platform)
Model Year 2018
Check seat travel limiter at seat frame base of front passenger seat

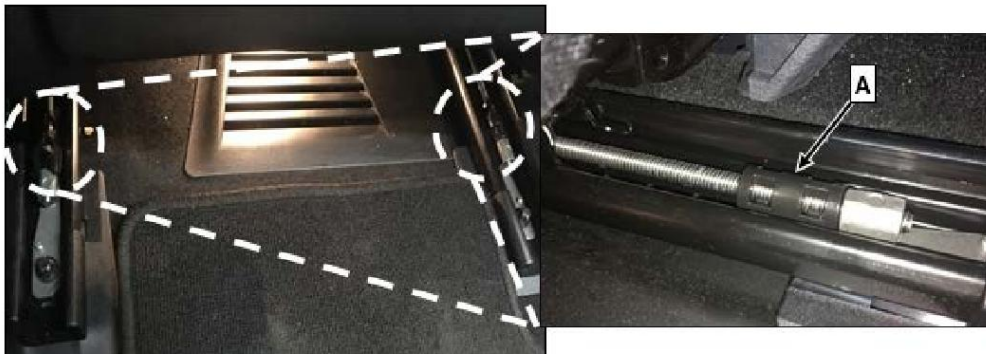
Figure 1

1. Check that seat travel limiter is present at front and rear of seat frame base of front passenger seat.
 - 1.1. Move front passenger seat to front-most position.
 - 1.2. Check for presence of seat travel limiter **(A)** (figure 1).

- a. Travel limiter **not** present: Perform **work procedure A and B**.
- b. Travel limiter **present**: Perform **work procedure B**.

- 1. Retrofit seat travel limiter at rear seat frame base of front passenger seat.
 - 1.1. Install seat travel limiter at rear left and right adjustment spindle.
 - 1.2. Position seat travel limiter at rear limit stop of adjustment spindle.
- 2. Retrofit seat travel limiter at front seat frame base of front passenger seat.
 - 2.1. Move front passenger seat to rearmost position.
 - 2.2. Install seat travel limiter at front left and right adjustment spindle.
 - 2.3. Position seat travel limiter at front limit stop of adjustment spindle.
