2018 Mercedes Benz E63S AMG 4MATIC Sed (213.089) V8-4.0L Turbo (177.980)

CLEARCOAT PEELING / FLAKING / BUBBLING

Topic number	LI98.00-P-058914
Version	10
Function group	98.00 General
Date	05-23-2018
Validity	All vehicles with 590 - Mars Red
Reason for change	Added PTSS feedback

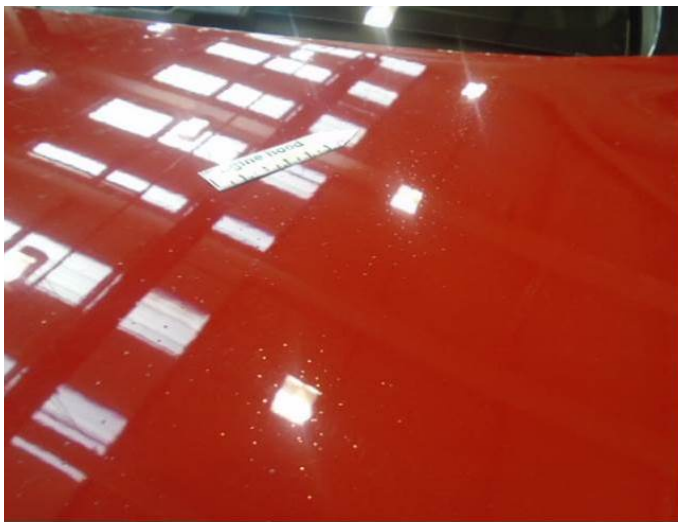
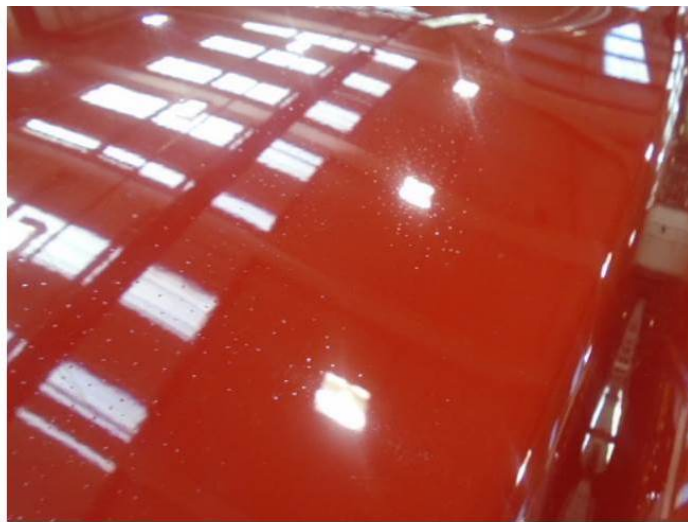
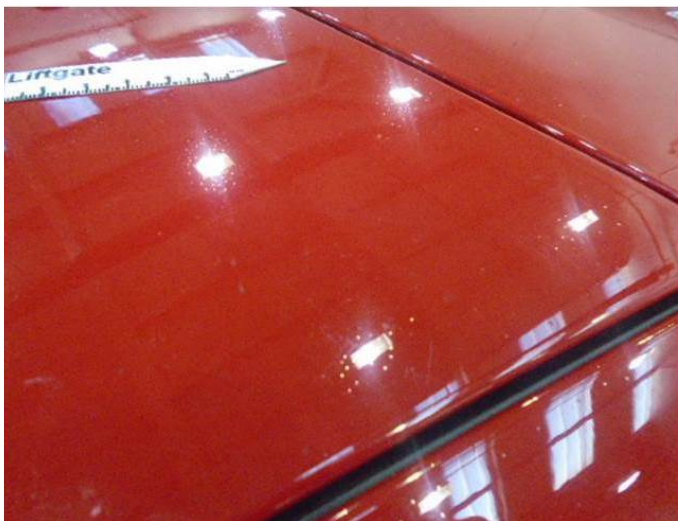
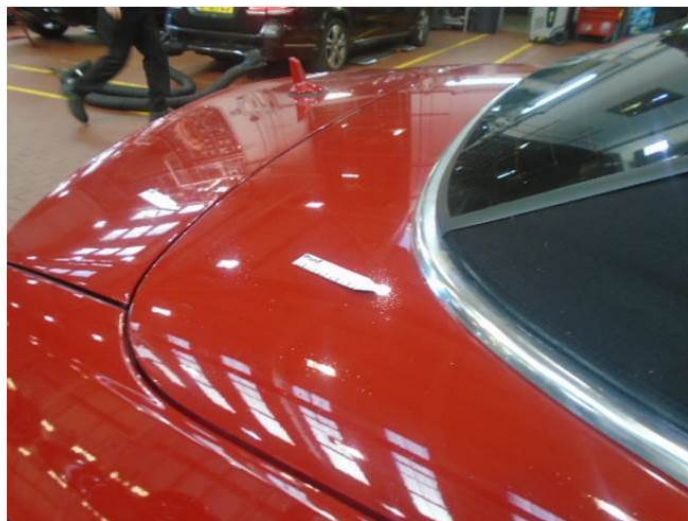
Improper adhesion of clearcoat. Exposure factors like humidity or solar radiation may cause adhesion problems between base coat and clearcoat.

Clearcoat bubbles

Refinish **affected areas only**, according to WIS and approved paint manufacturer instructions.

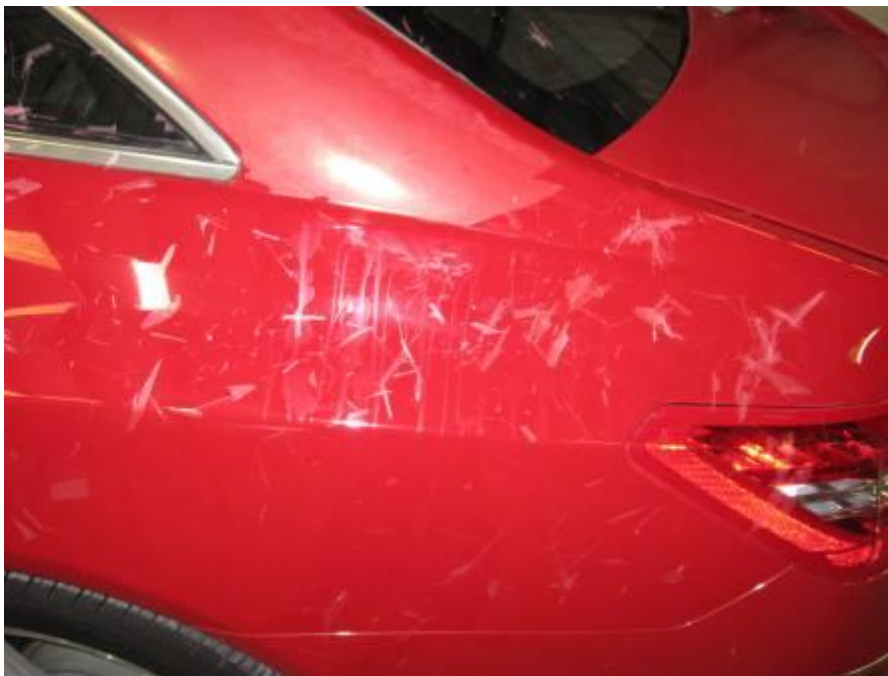
Clearcoat flaking

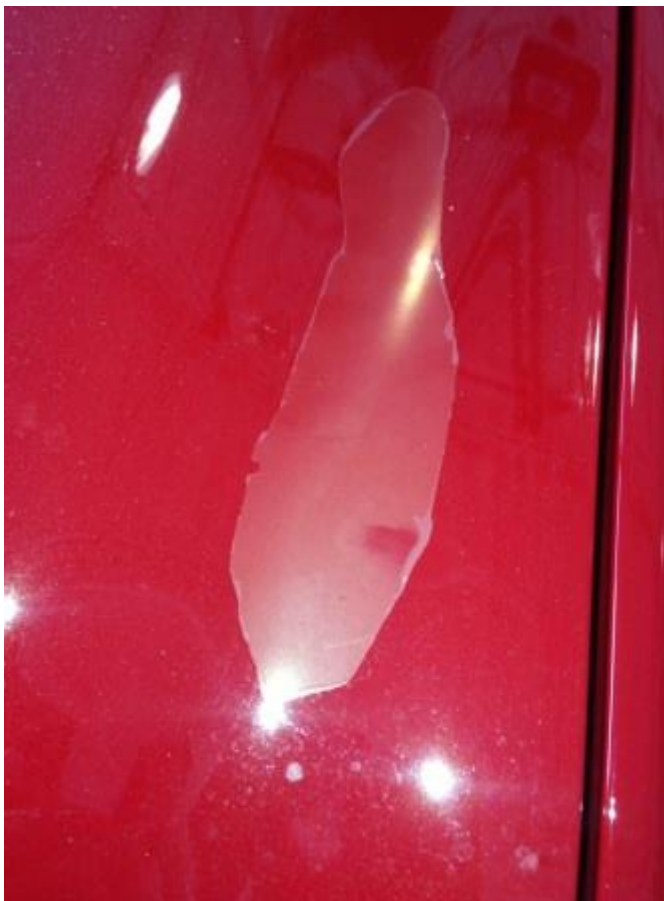
Peeling clearcoat

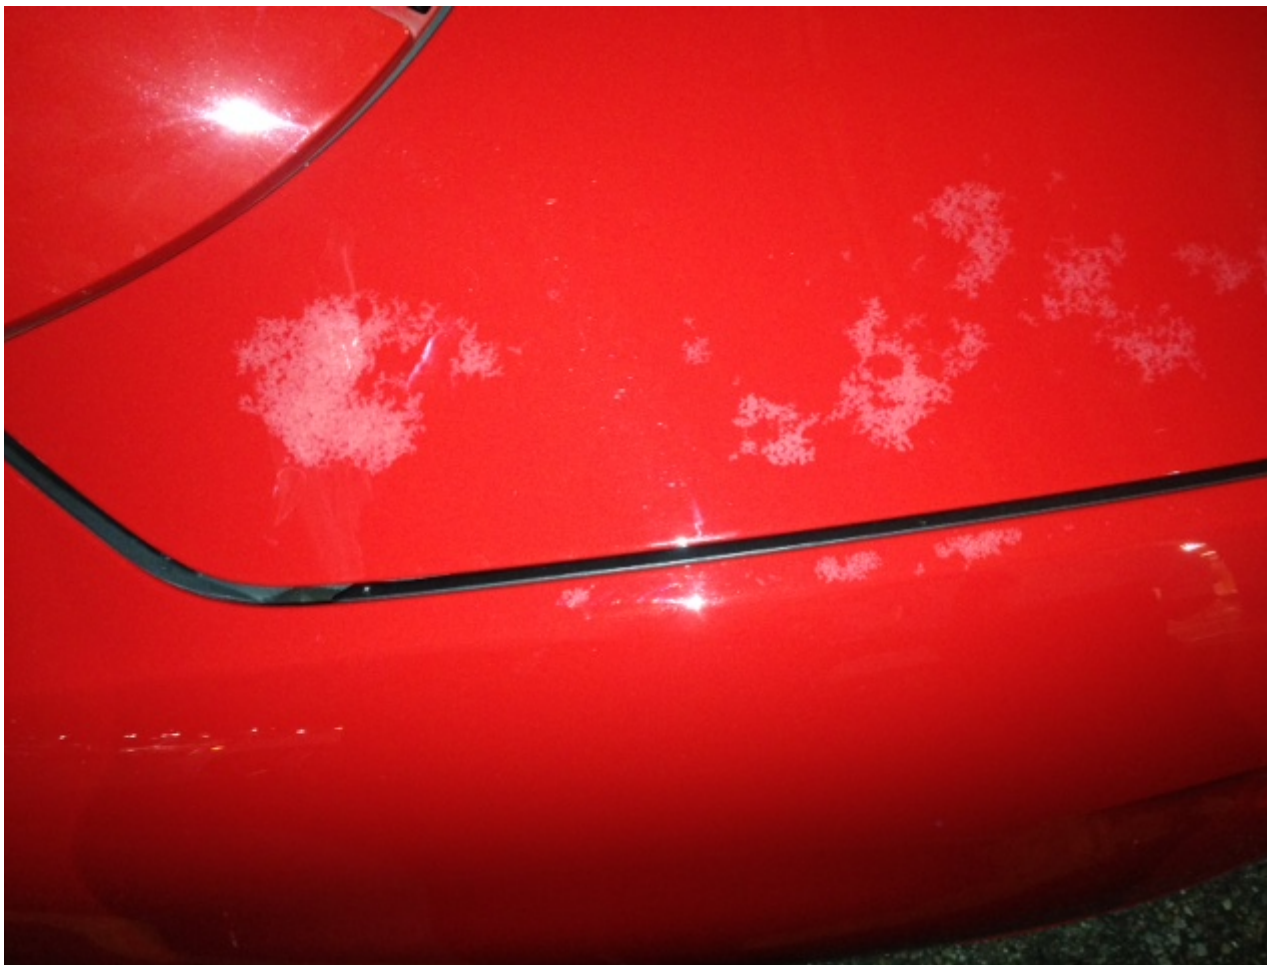
White flaking
