2018 Mercedes Benz E63S AMG 4MATIC Sed (213.089) V8-4.0L Turbo (177.980)

## CREAKING NOISE ON FRONT SEAT WHEN CORNERING

<b>Topic number</b>	LI91.10-P-067955
<b>Version</b>	2
<b>Function group</b>	91.10 Front seats
<b>Date</b>	04-09-2018
<b>Validity</b>	BR213
<b>Reason for change</b>	Pictures for remedy added.

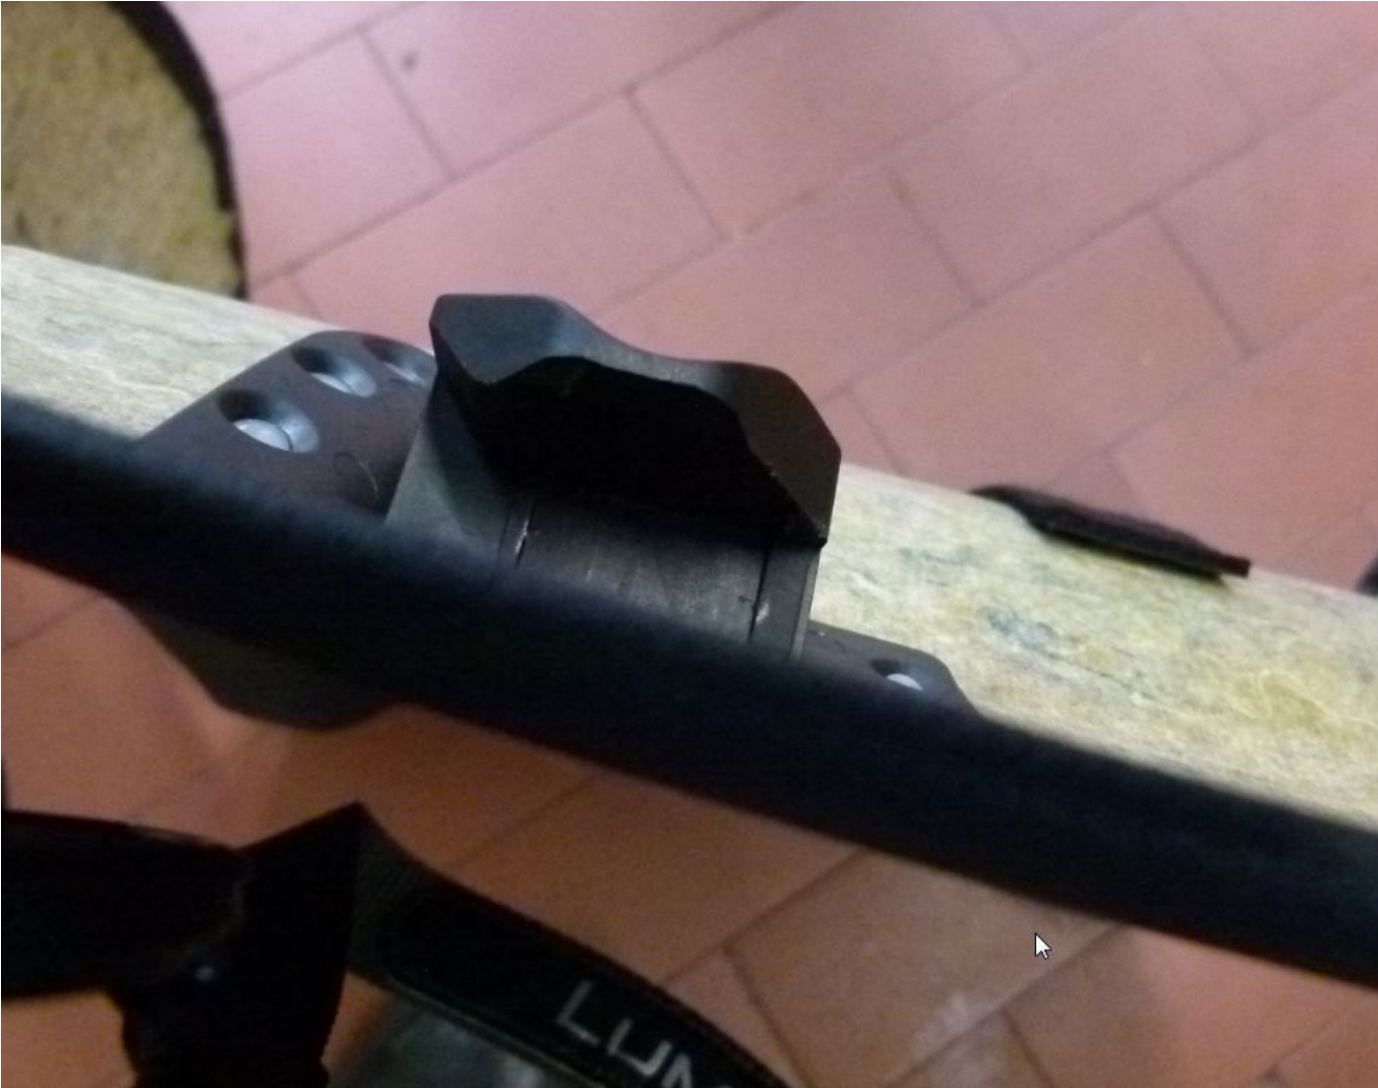
Pic1

The fastening hooks (Pic 1) on the seat-back lining rub up against the functional carrier hooks (Pic 2) and cause a noise.

Fastening hooks on seat-back lining without felt

3. Cut felt (A000 983 71 10) to size and fasten as in Pic 3.1, Pic 3.2 and Pic 4 on both fastening hooks on the seat-back lining.

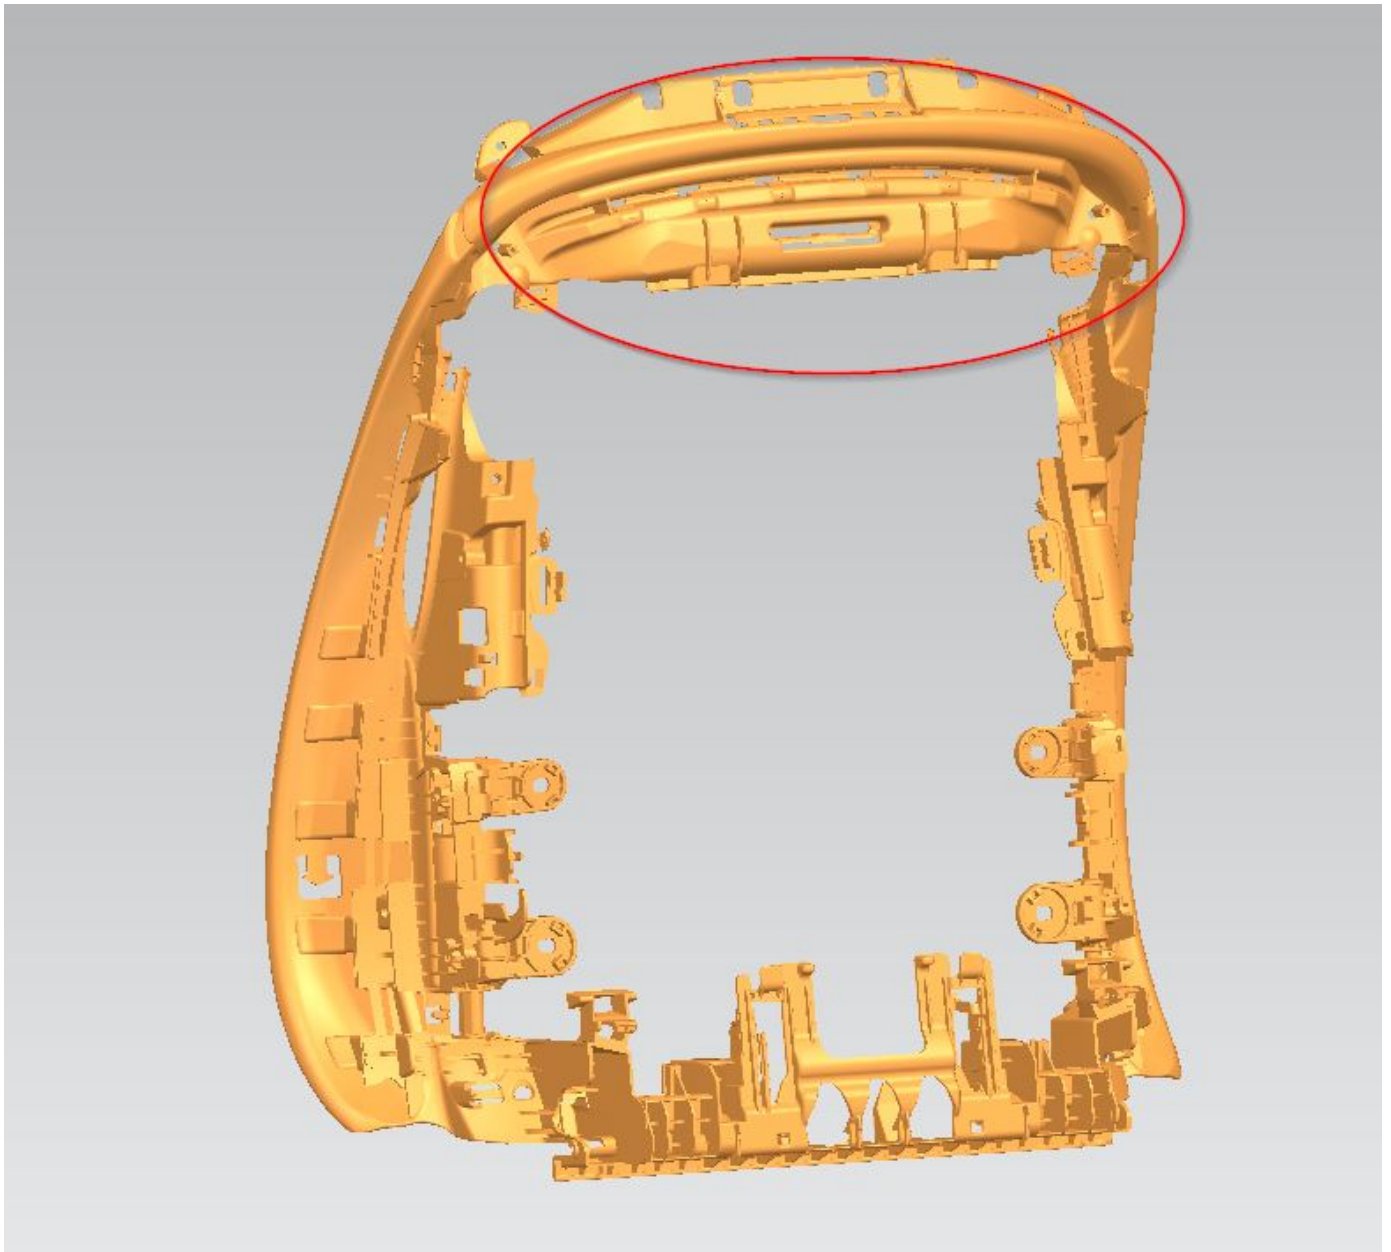
Pic2

Functional carrier

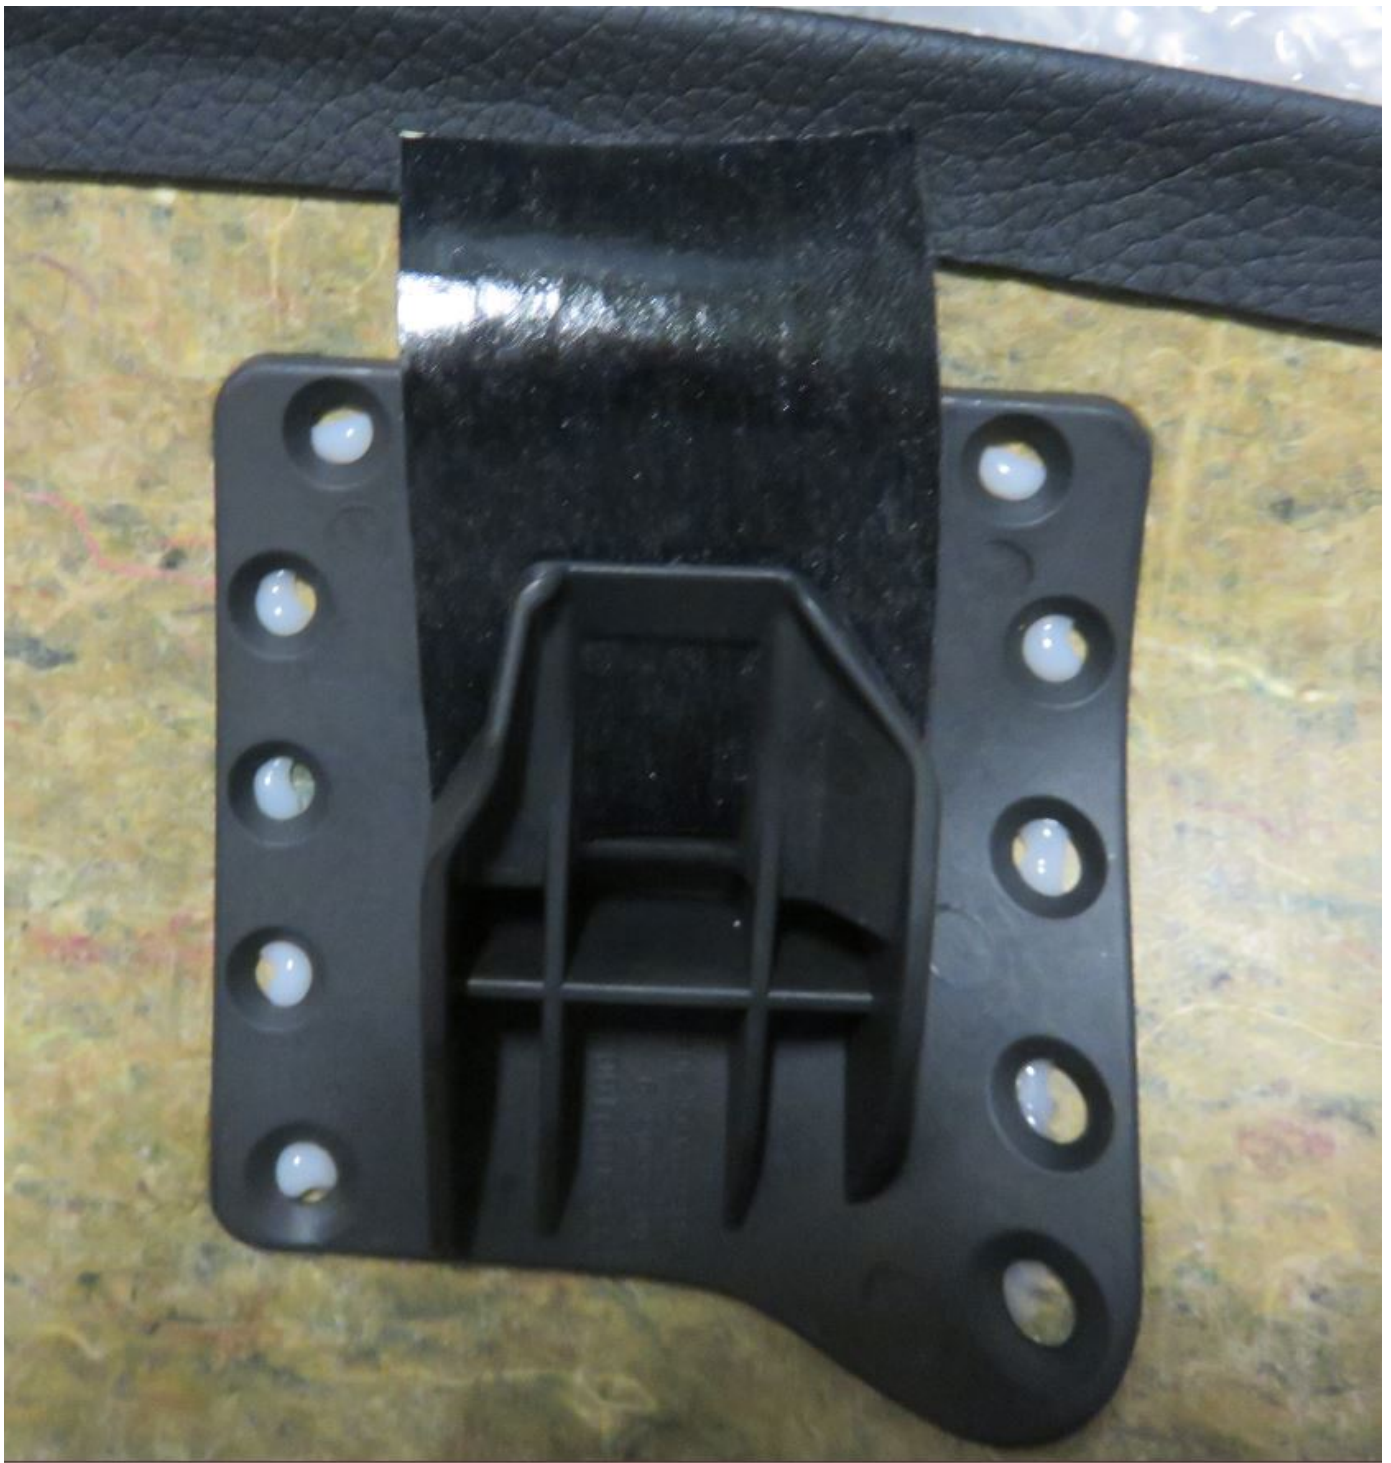
**Pic3.1**

Felt half mounted onto fastening hooks of seat-back lining

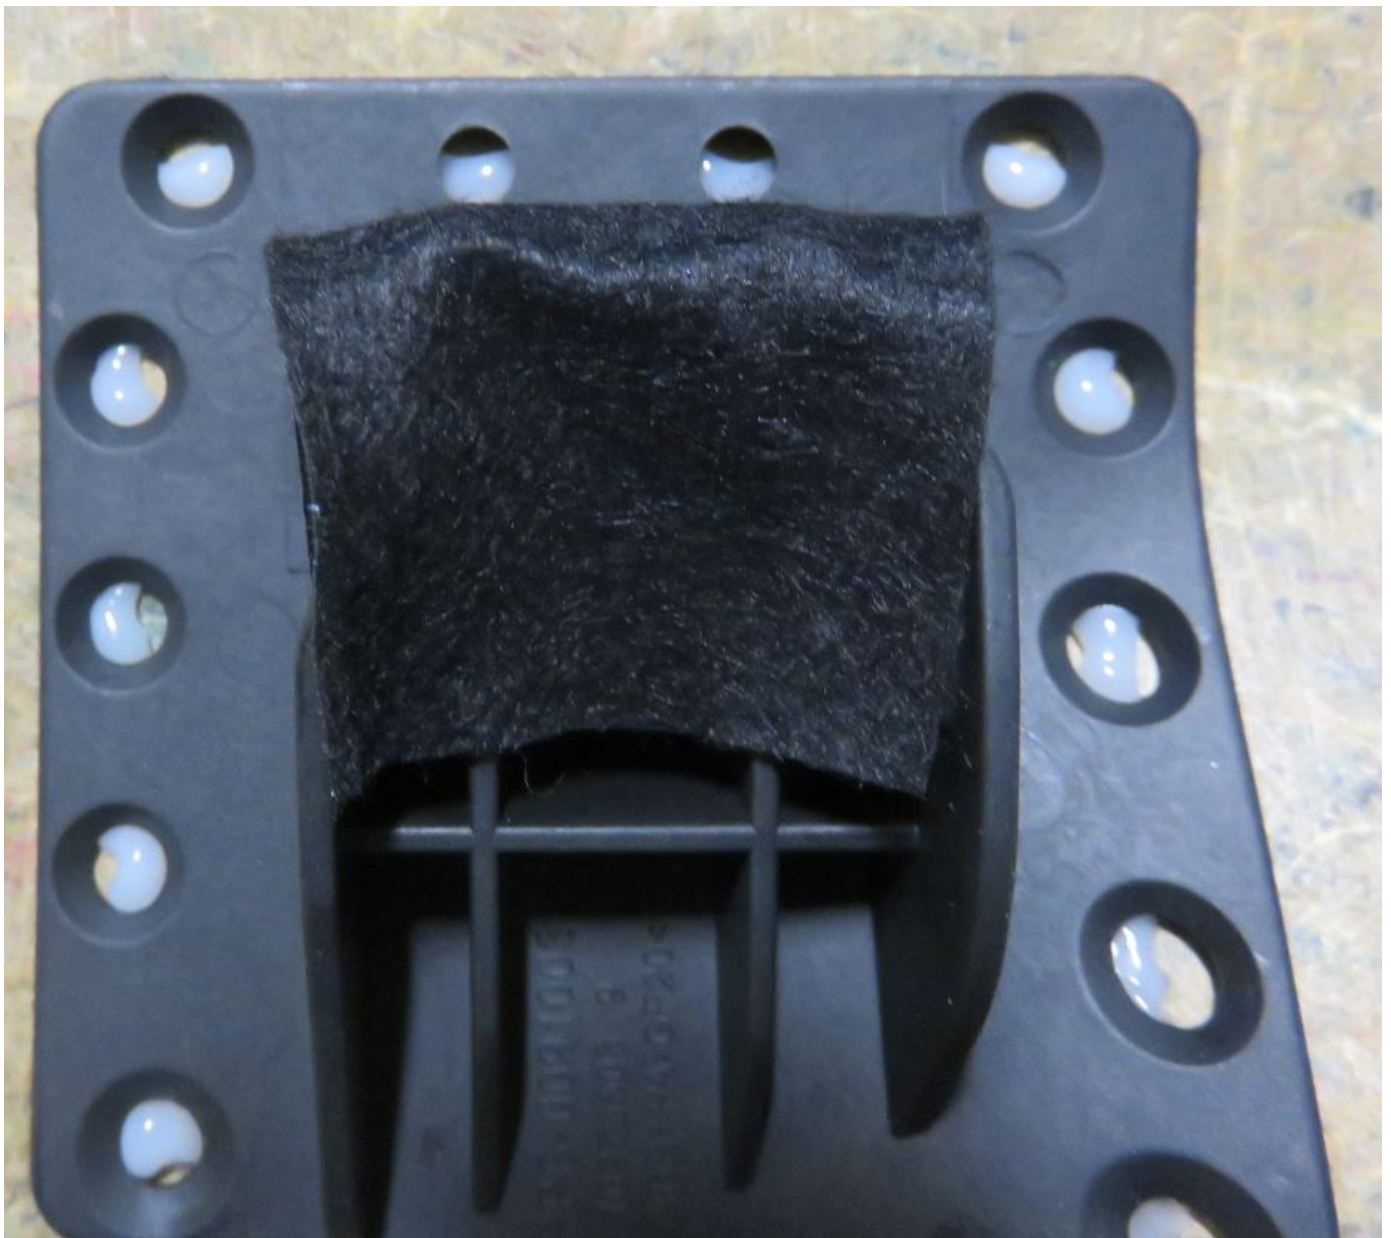
**Pic3.2**

Felt completely mounted onto fastening hooks of seat-back lining

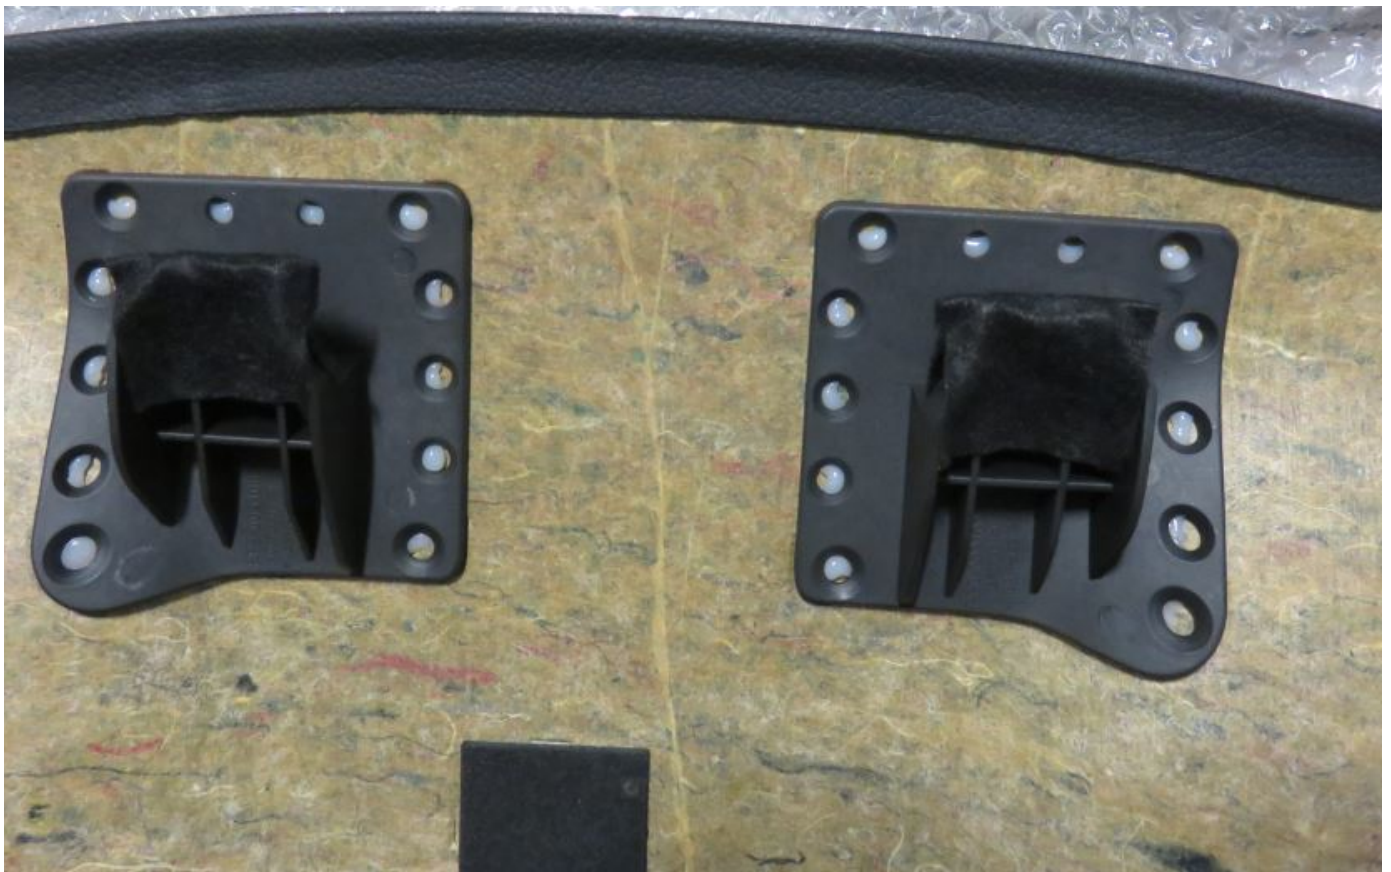
**Pic4**

Fastening hooks on seat-back lining with felt
