2018 Mercedes Benz E63S AMG 4MATIC Sed (213.089) V8-4.0L Turbo (177.980)

## CREAKING NOISES FROM SEAT CUSHION LENGTH ADJUSTMENT (SKTE) IN VEHICLES WITH MEMORY PACKAGE (CODE 275)

<b>Topic number</b>	LI91.10-P-067673
<b>Version</b>	1
<b>Function group</b>	91.10 Front seats
<b>Date</b>	02-02-2018
<b>Validity</b>	BR 213 with SA code 275 (Memory Package) up to manufacturing date 16.03.2017
<b>Reason for change</b>

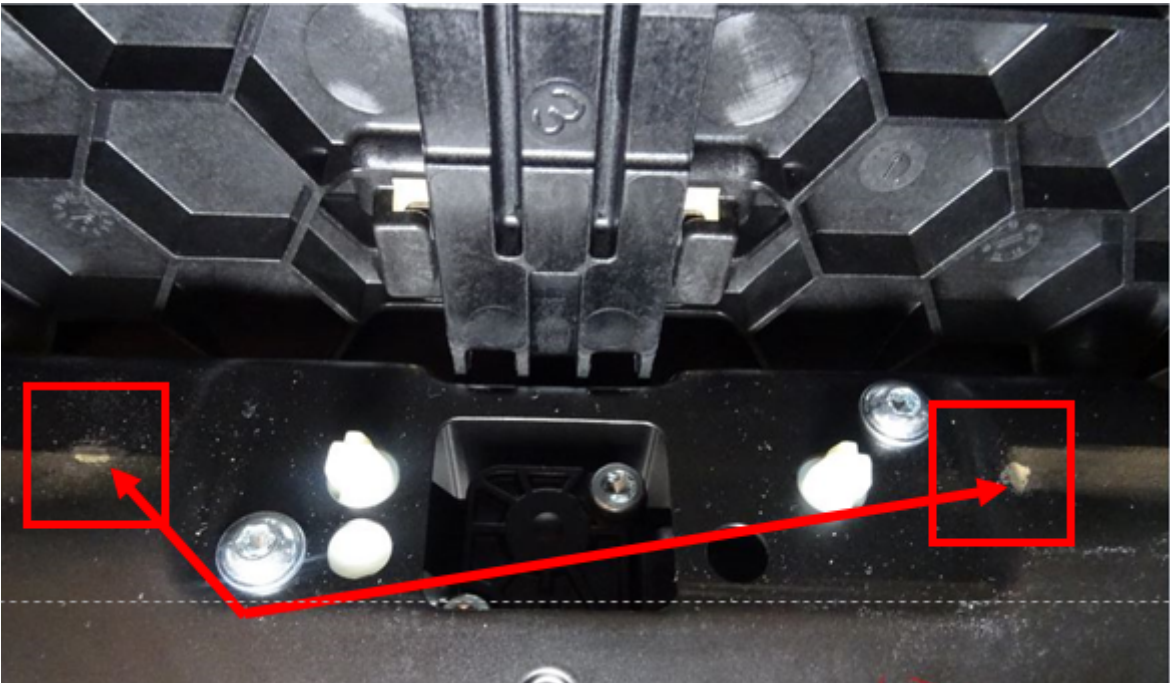
Pic.1

Contact between plastic lever of seat cushion and cushion shell (signs of abrasion visible on cushion shell).

Signs of abrasion on cushion shell. No felt attached.

- Remove seat cushion cover and seat cushion padding
- Stick felt strips (approx. 10x8 cm) onto cushion shell of seat (see pictures, illustrated without the SKTE lever). It is not necessary to remove the seat for this.

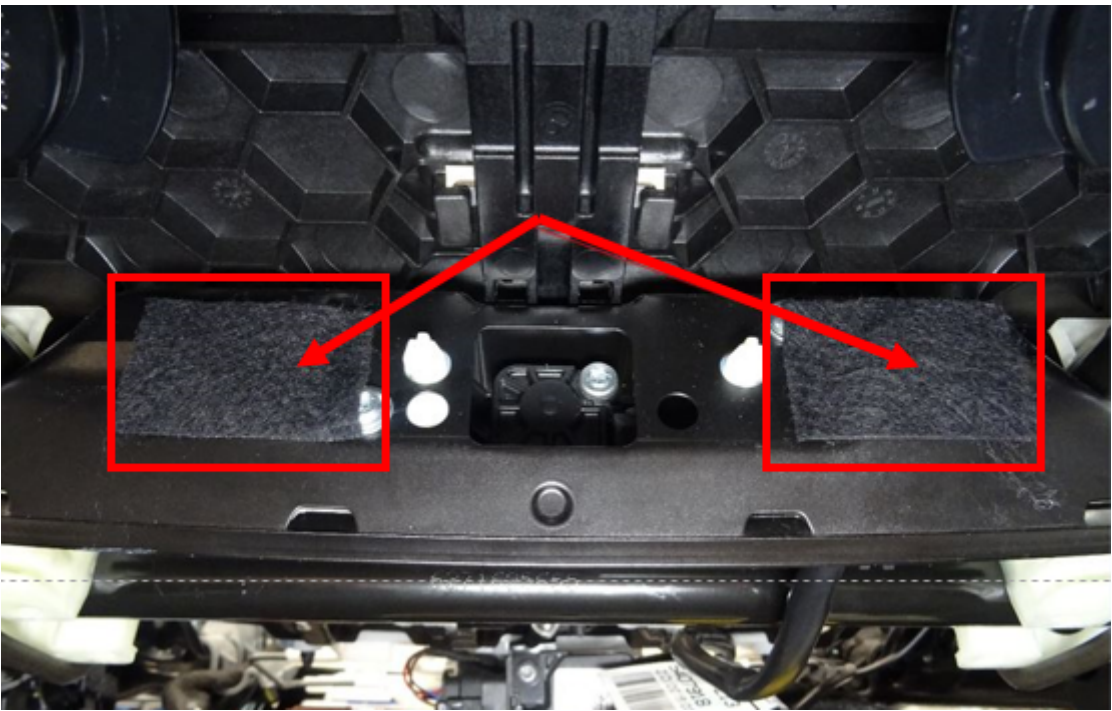
Pic.2

Felt strips attached to cushion shell.
