2018 Mercedes Benz E63S AMG 4MATIC Sed (213.089) V8-4.0L Turbo (177.980)

## FIREWALL GROMMET ON MAJOR ASSEMBLY PARTITION WALL LEAKY

<b>Topic number</b>	LI54.18-P-064682
<b>Version</b>	4
<b>Function group</b>	54.18 Cable harnesses
<b>Date</b>	05-23-2019
<b>Validity</b>	Model 213, 238 and 257
<b>Reason for change</b>	Cause and remedy added

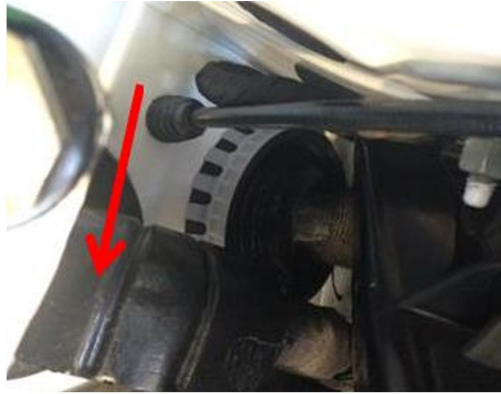
Op. no.	Operation text	Time	Damage code	Note
			5488204	Firewall grommet leaking
LI54.18-P-064682_1

1st cause: 2 of the 12 cavities in the foam-lined grommet (the cavities to be filled) may not be within the specified dimensions.

1st cause: Firewall grommet on driver's side

1st cause: Please stick on the foamed firewall grommet using adhesive sealant.

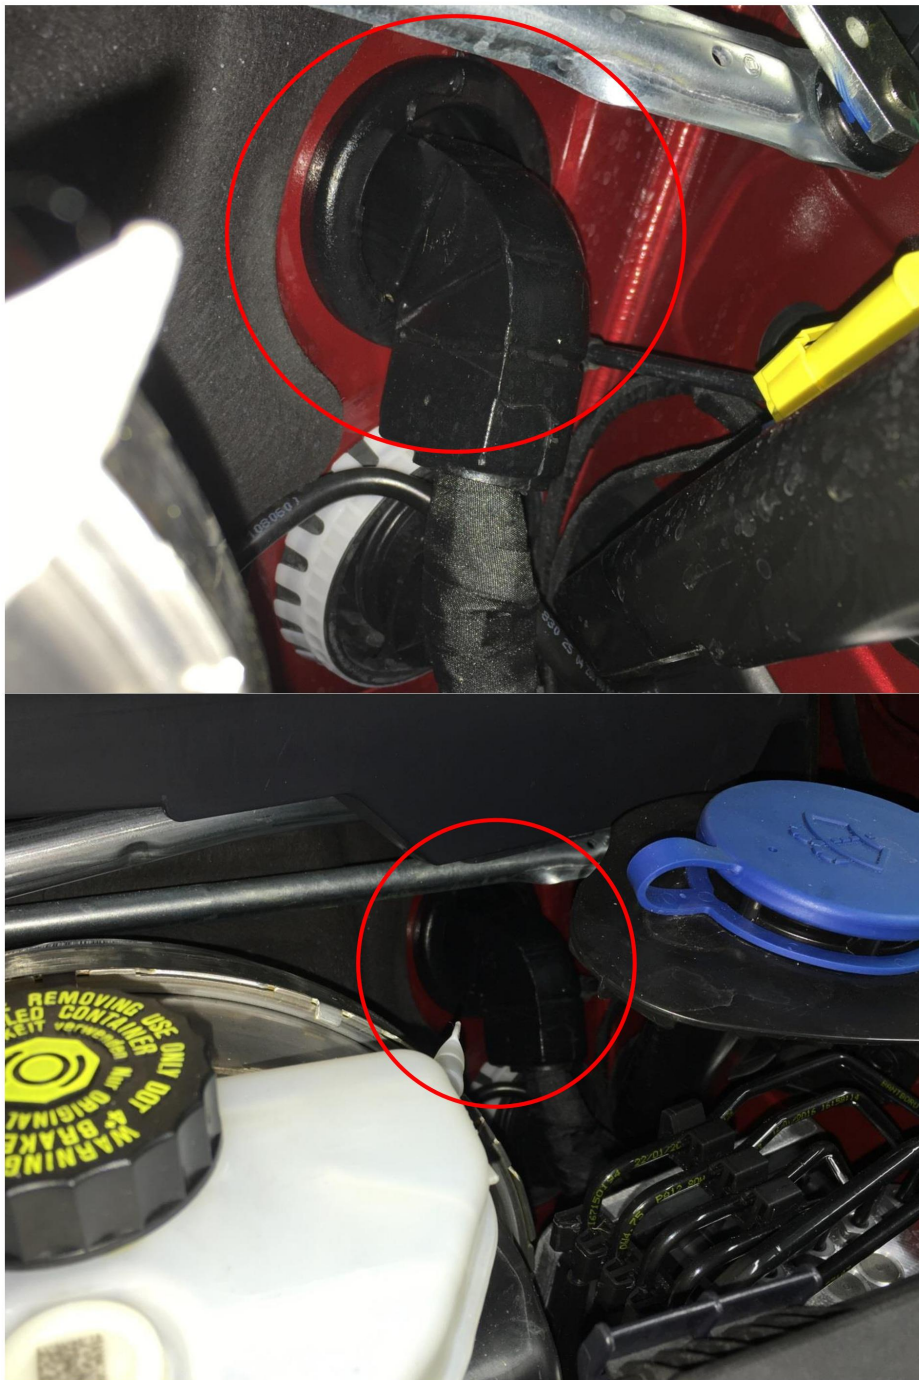
**LI54.18-P-064682\_2**

1st cause: Further photos for locating firewall grommet on driver's side
