2018 Mercedes Benz E63S AMG 4MATIC Sed (213.089) V8-4.0L Turbo (177.980)

## KEYLESS-GO INOPERATIVE DUE TO CORRODED PINS

Topic number	LI80.61-P-066149
Version	2
Function group	80.61 Keyless-Go/Keyless-Entry
Date	04-30-2018
Validity	Model series 213
Reason for change	Damage type revised

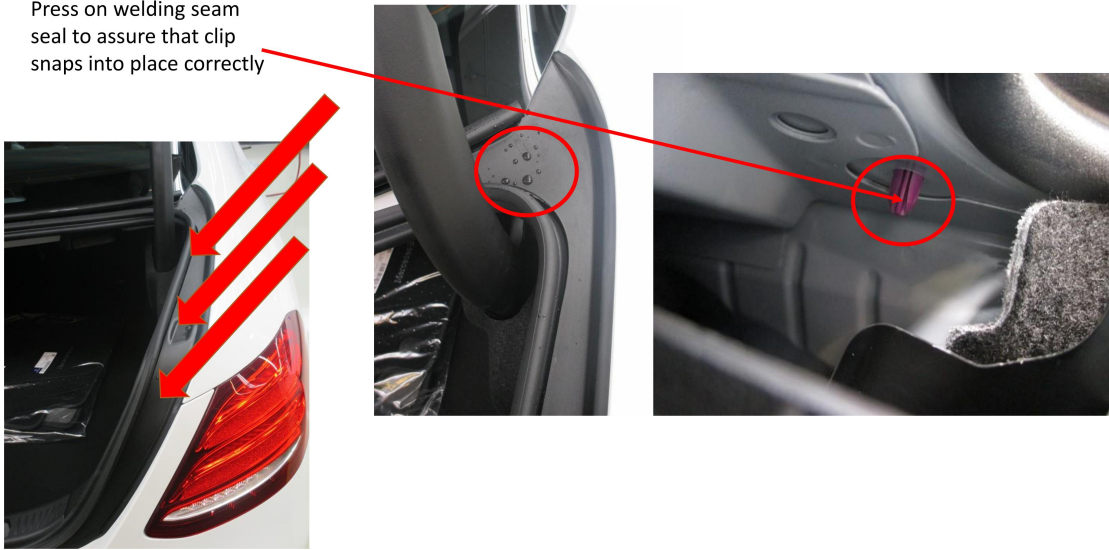
LI80.61-P-066149\_1

The pins on the Keyless-Go control unit and/or the contact sockets in the coupling housing are corroded, caused by an incorrectly engaged clip under the weld seam seal (see attachment).

Press on welding seam  
seal to assure that clip  
snaps into place correctly

1. Perform leak test
2. Replace the Keyless-Go control unit and, if necessary, the coupling.
