2018 Mercedes Benz E63S AMG 4MATIC Sed (213.089) V8-4.0L Turbo (177.980)

RETROFIT PROTECTIVE GRILLE FOR ADDITIONAL COOLER

Campaign No. 2019040010, May 2019

SUBJECT: **Model E-Class and GLC-Class (213, 253 platform)**
Model Year 2018-2019
Retrofit protective grille for additional cooler

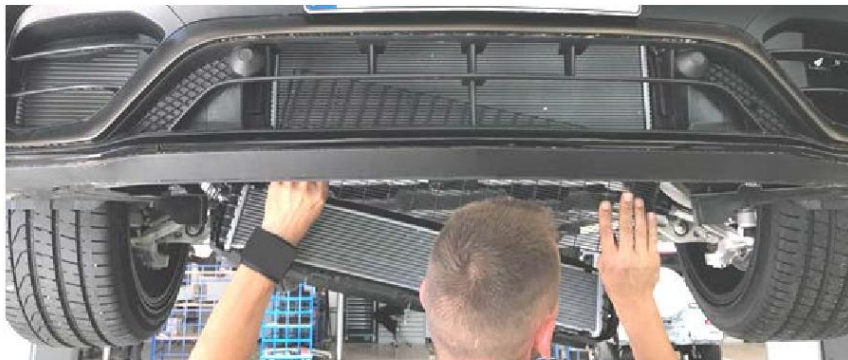
**Figure 1**

Daimler AG ("DAG"), the manufacturer of Mercedes-Benz vehicles, has determined that on certain Model Year ("MY") 2018-2019 E-Class and GLC-Class (213, 253 platform) vehicles, the installed stone chip guard does not correspond to current production specifications. As a result, this may allow stones to contact the radiator. An authorized Mercedes-Benz dealer will retrofit a protective grille on the affected vehicles.

For basic data of model 253, see **AR20.20-P-3867MNG**
3. Insert protective grille from underneath (**figure 1**) and attach on left and right at corners (**figure 2**) of additional cooler.
 -

Protective grille is mounted flush with the cooler edge.
