2018 Mercedes Benz E63S AMG 4MATIC Sed (213.089) V8-4.0L Turbo (177.980)

SQUEAKING NOISE FROM THE EXHAUST FLAP

Topic number	LI49.10-P-064655
Version	4
Function group	49.10 Exhaust pipes, mufflers
Date	07-10-2020
Validity	AMG vehicles with exhaust gas flaps
Reason for change	Validity supplemented to include vehicles with M176

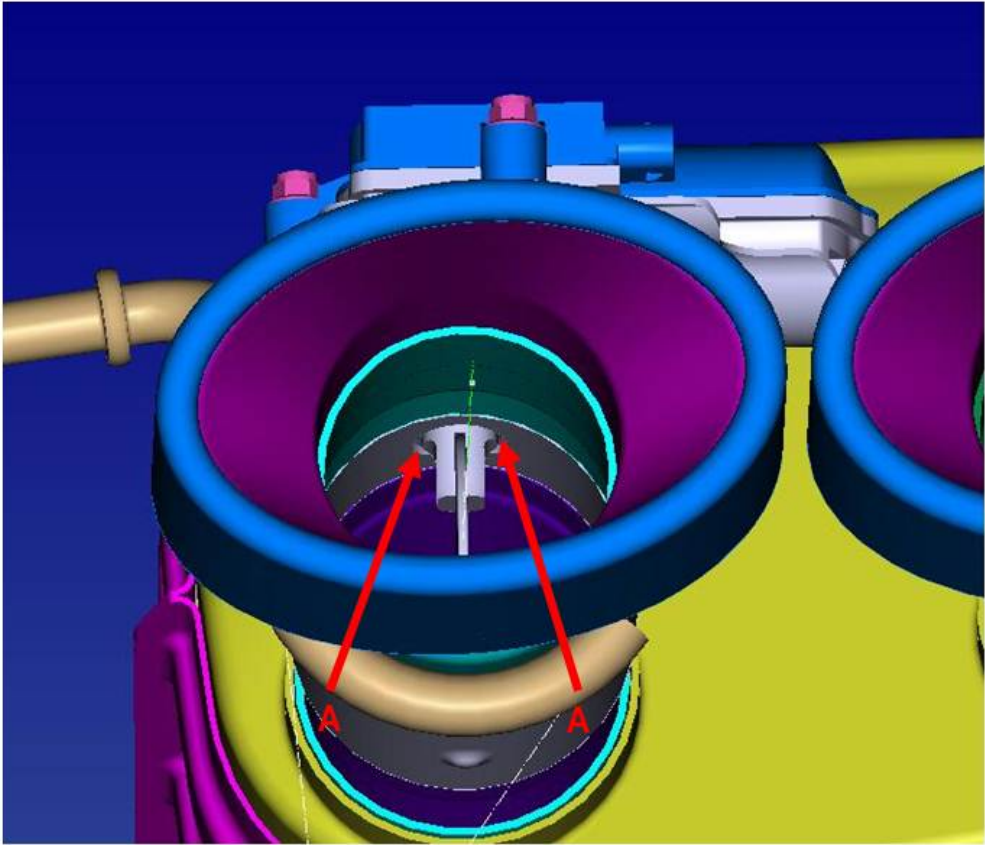
Bild 1

Squeaking noise from the exhaust gas flap and is audible at standstill with light abrupt acceleration and during normal driving

Insufficient lubrication on flap shaft

The arrows show the locations where the lubricant is to be applied.

1. Remove components of exhaust system, if necessary
2. Remove affected actuator
3. Spray shaft of exhaust gas flap with high-temperature grease (see picture 1 and picture 2)
4. Check, during a test drive, if the noise has been rectified
5. If necessary, repeat procedure
