2018 Mercedes Benz E63S AMG 4MATIC Sed (213.089) V8-4.0L Turbo (177.980)

## CREAKING NOISES AT SEAT WHEN CORNERING (LEFT SIDE OF SEAT)

Topic number	LI91.10-P-067712
Version	1
Function group	91.10 Front seats
Date	02-23-2018
Validity	BR 213: Up to 09.01.2018 (WDD2130421A409095) BR 205, 253: Up to 19.12.2017 (WDC2539891F394735) BR 257: Up to 08.01.2018 (WDD2573591A000497)
Reason for change

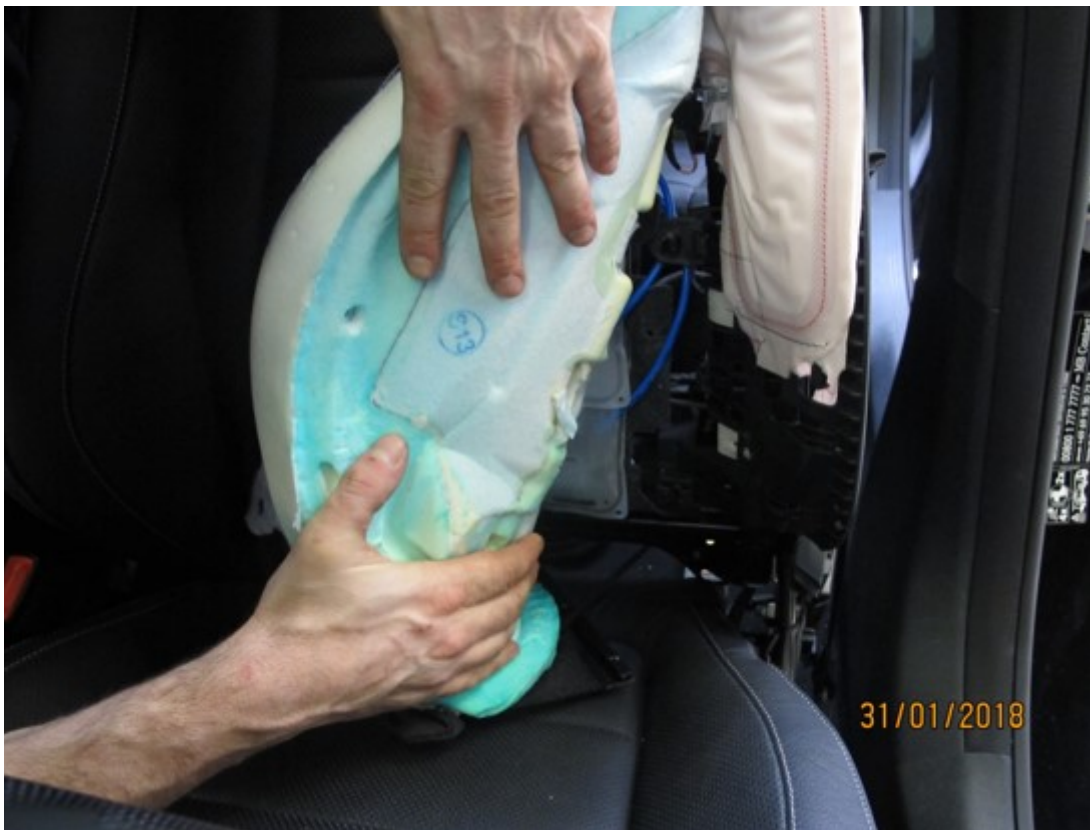
**Pic.3**

A burr at the bottom of the backrest member may cause contact with the lower crossmember. This produces a noise when the two components move.

- Raise the seat all the way up.
- Detach the seat-back lining (Pic.1).
- Detach the seat cover from the backrest frame on the left side of the seat (Pic.2).
- Push the detached seat cover and the seat cushion to the side in order to expose the affected area (Pic.3).
- Check the area between the backrest member and the lower crossmember using a feeler gauge of thickness .040mm (Pic.4, 5):

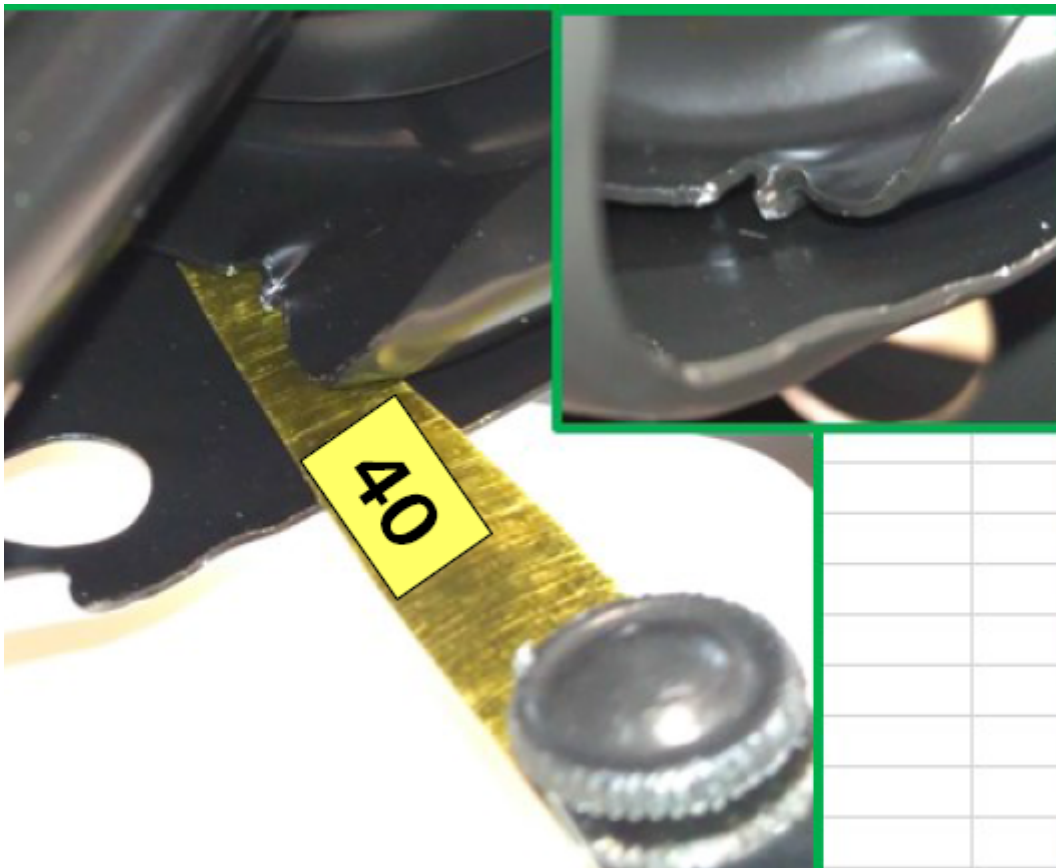
**Pic.6 i.O. Teil**

Result OK: The gauge passes through the area (Pic.6) - The cause of the noise complaint does not lie in the affected

area. End of test.

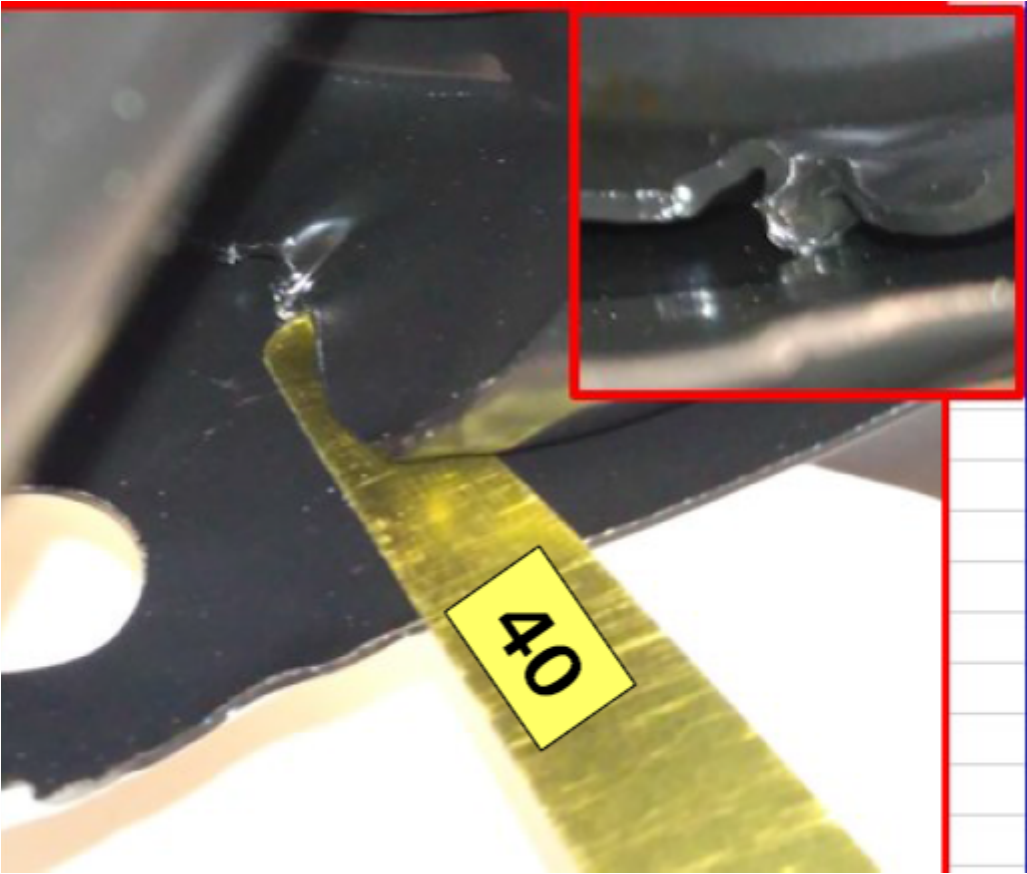
**Pic.7 n.i.O. Teil**

Result not OK: The gauge **does not** passes through the area (Pic.7) - Modify the seat backrest frame.
