2018 Mercedes Benz E63S AMG 4MATIC Sed (213.089) V8-4.0L Turbo (177.980)

NOISE FROM UPPER INSTRUMENT PANEL COVER (CENTERFILL GRILLE) MODEL SERIES 213, 238, OR 257

Topic number	LI68.10-P-064592
Version	11
Function group	68.10 Instrument panel
Date	04-15-2019
Validity	BR213, BR238, BR257 For vehicles as of manufacturing date July 1 2017, the attached analysis sheet must be attached to a PTSS case
Reason for change	A PTSS case must be created before starting work. BR257 added.

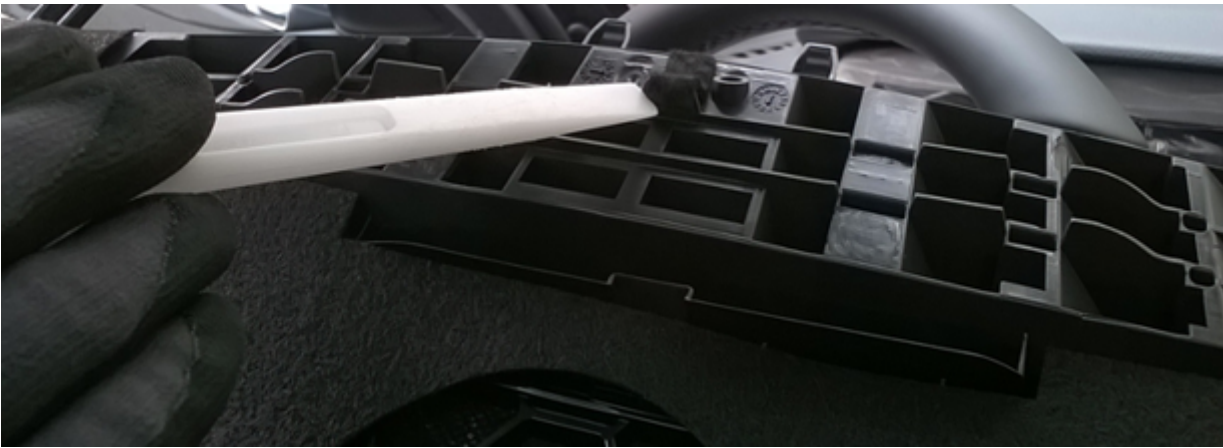
Abdeckung Instrumententafel oben Pic.1

Cover (centerfill grille) touches instrument panel

A rib is located at this point on the component. A 10x2x25 mm piece of felt must be fitted over this rib.

Cut felt to size 10X25 mm.

Apply felt to marked area (Pic. 1).
