2018 Mercedes Benz E63S AMG 4MATIC Sed (213.089) V8-4.0L Turbo (177.980)

CHROME SURFACE DETACHING FROM STOWAGE BOX/ASHTRAY

Topic number	LI68.20-P-068649
Version	3
Function group	68.20 Center console
Date	02-21-2019
Validity	Valid for vehicles of model series 205/253/213/238 with automatic transmission. Not valid for vehicles with world manufacturer code LE4.
Reason for change	Title clarification

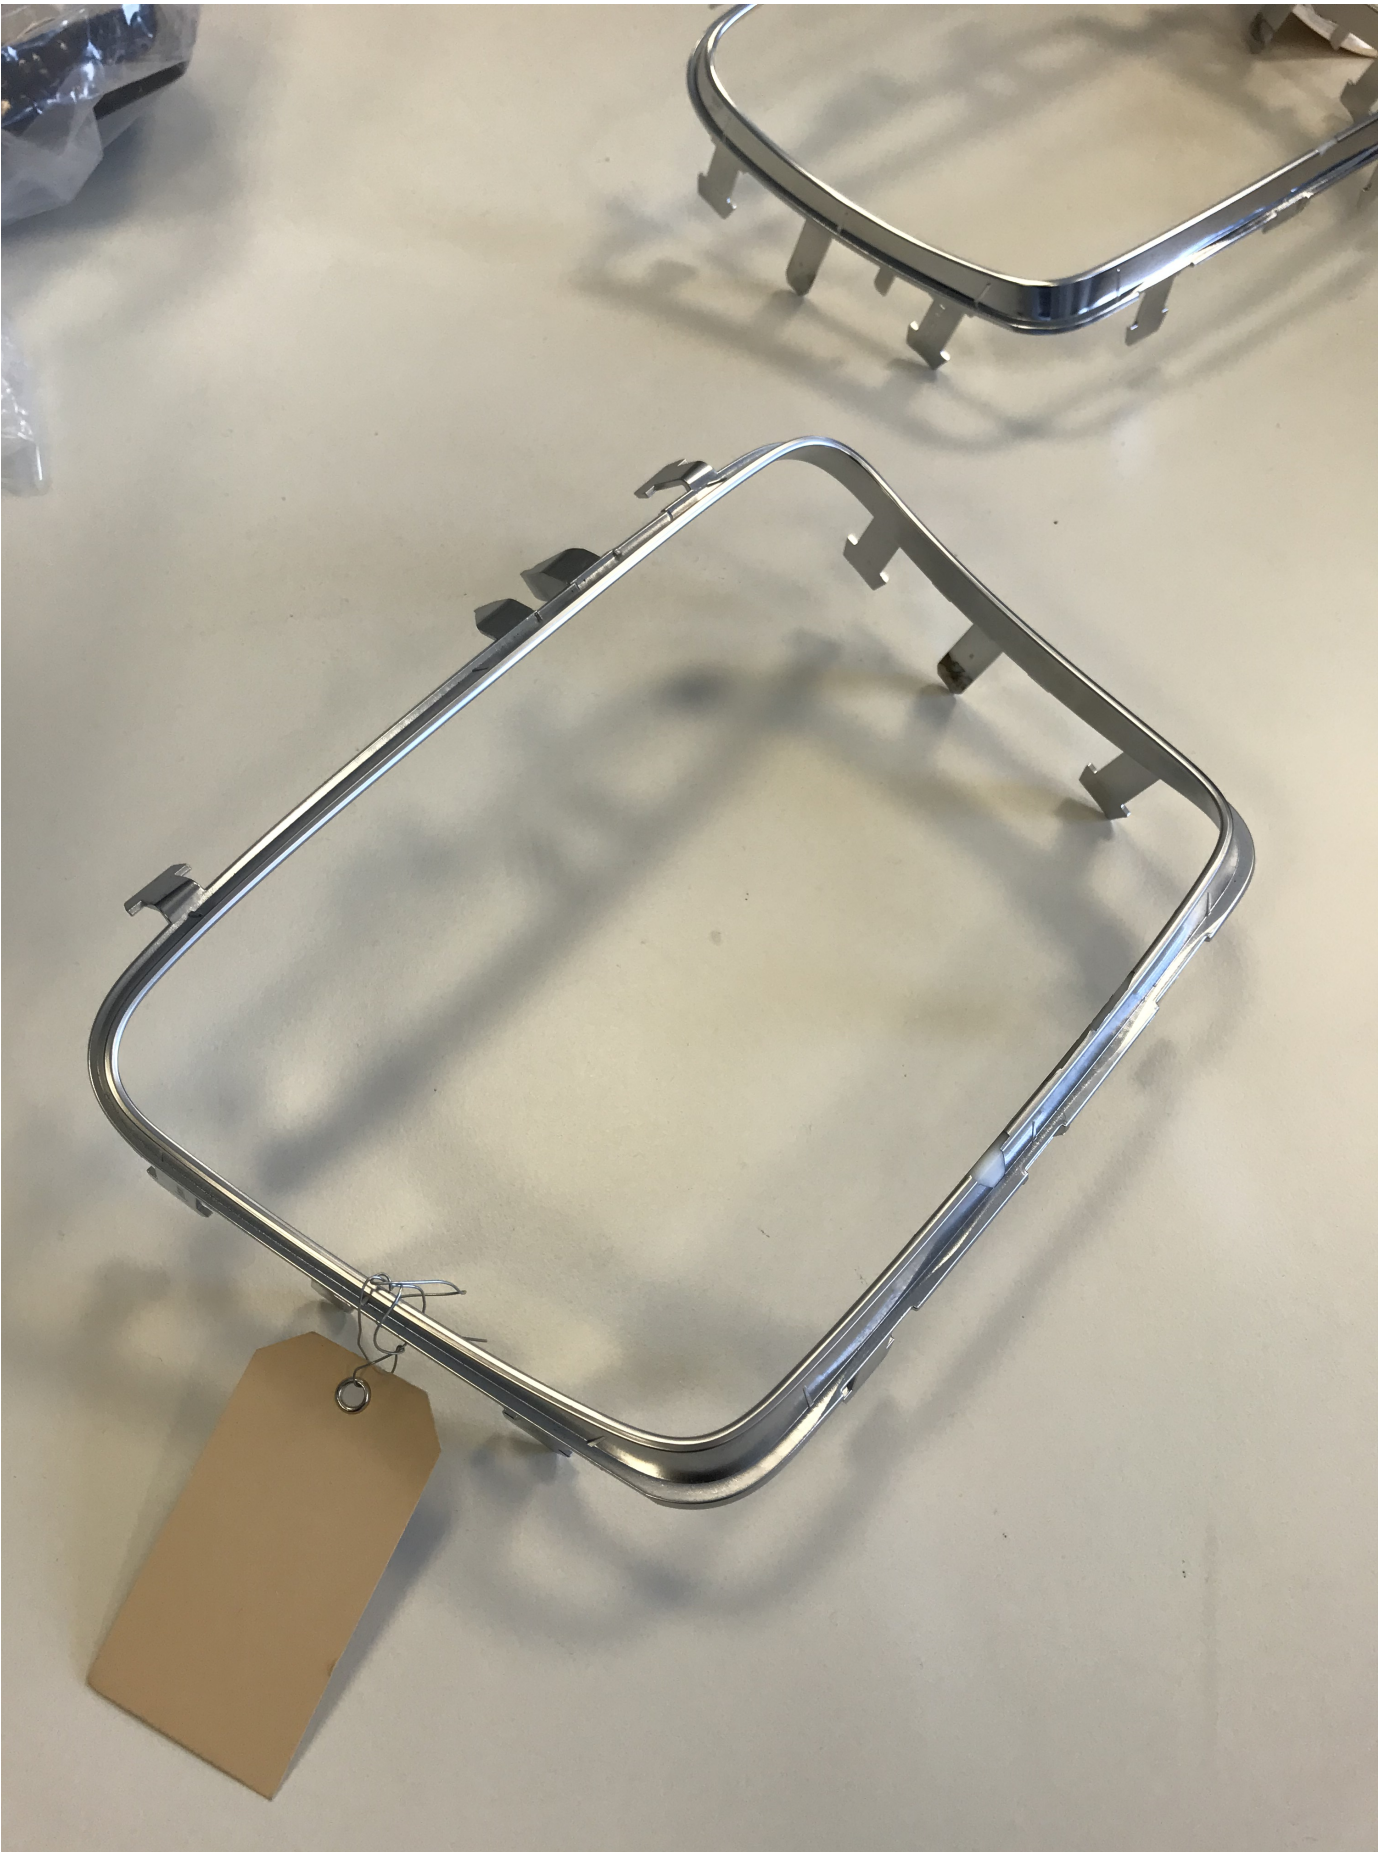
IMG_0102

Surface of border of stowage box is detaching

Frame of stowage box/ashtray

Damage to frame of stowage box/ashtray

Insufficient connection of base material to surface material.

Replacement of damaged frame with optimized component parts.

The replacement is done as per WIS document AR68.20-P-0002LWE.
