2018 Mercedes Benz E63S AMG 4MATIC Sed (213.089) V8-4.0L Turbo (177.980)

MESSAGE "SOS - SERVICE NOT ACTIVATED" IN INSTRUMENT CLUSTER

Topic number	LI82.85-P-067581
Version	2
Function group	82.85 Navigation and Communication systems
Date	10-20-2020
Validity	MODEL 117, 156, 166, 172, 176, 190, 205, 207, 213, 217, 218, 222, 231, 238, 242, 246, 253, 292 with SA code 362 (HERMES LTE communication module) AND mbrace (MY18 and prior) HERMES 1.0
Reason for change	Updated Validity

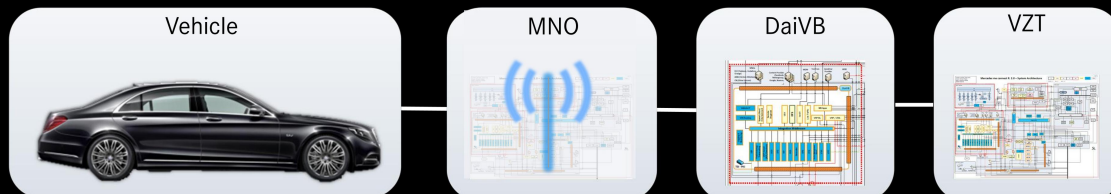
- There are several steps required for a successful OTAR
- The key players are the vehicle (Preconditions), the MNO (Mobile Network Operator - Verizon Wireless), DaiVB (Daimler Vehicle Backend) and VZT (Verizon Telematics)
- OTAR will start at VPC for new vehicles or after a change of HERMES
- OTAR attempts are always triggered by a key cycle (3 Retries within ~ 10 minutes)

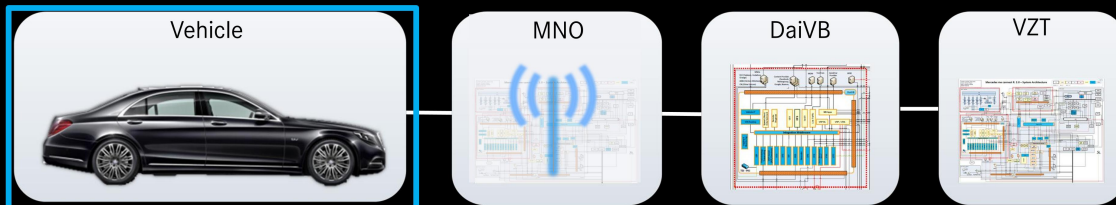
- HERMES control unit is in status "provisioning mode"
- Vehicle has proper GPS reception
- Vehicle has proper 3G/4G reception

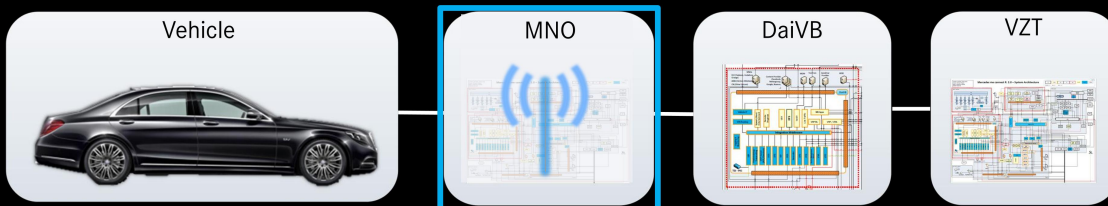
- Activate the internal SIM card
- Configure the right APN (Access Point Name)
- Assign and activate the MSISDN (telephone number)

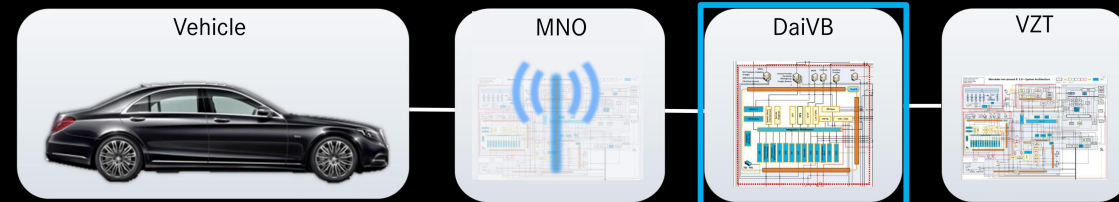
- Vehicle requests a valid certificate for communicating with the DaiVB
- DaiVB will check all necessary values in VeDoc (IMSI, ICCID, IMEI, Serial Number of Head-Unit)
- Only if the vehicle is known the vehicle will receive a valid authorization certificate

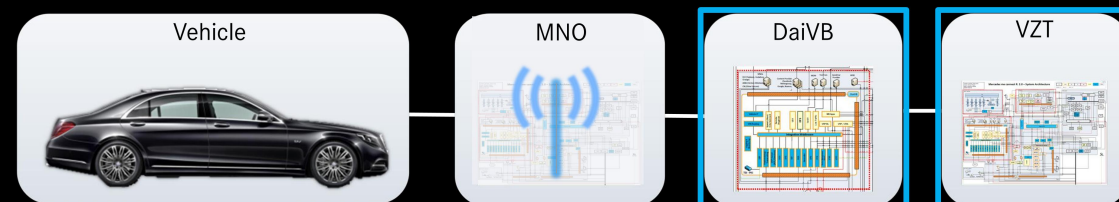
- Add vehicle data to Daimler backend systems
- Activate "In-Service mode" in HERMES control unit
- Configure (activate / deactivate) mbrace services
