2018 Mercedes Benz E63S AMG 4MATIC Sed (213.089) V8-4.0L Turbo (177.980)

REAR BUMPER CONTACTS BOTTOM OF TAILAMP

Topic number	LI88.20-P-071479
Version	1
Function group	88.20 Bumpers
Date	07-20-2020
Validity	W and V 213 with series (Not AMG) production bumper
Reason for change

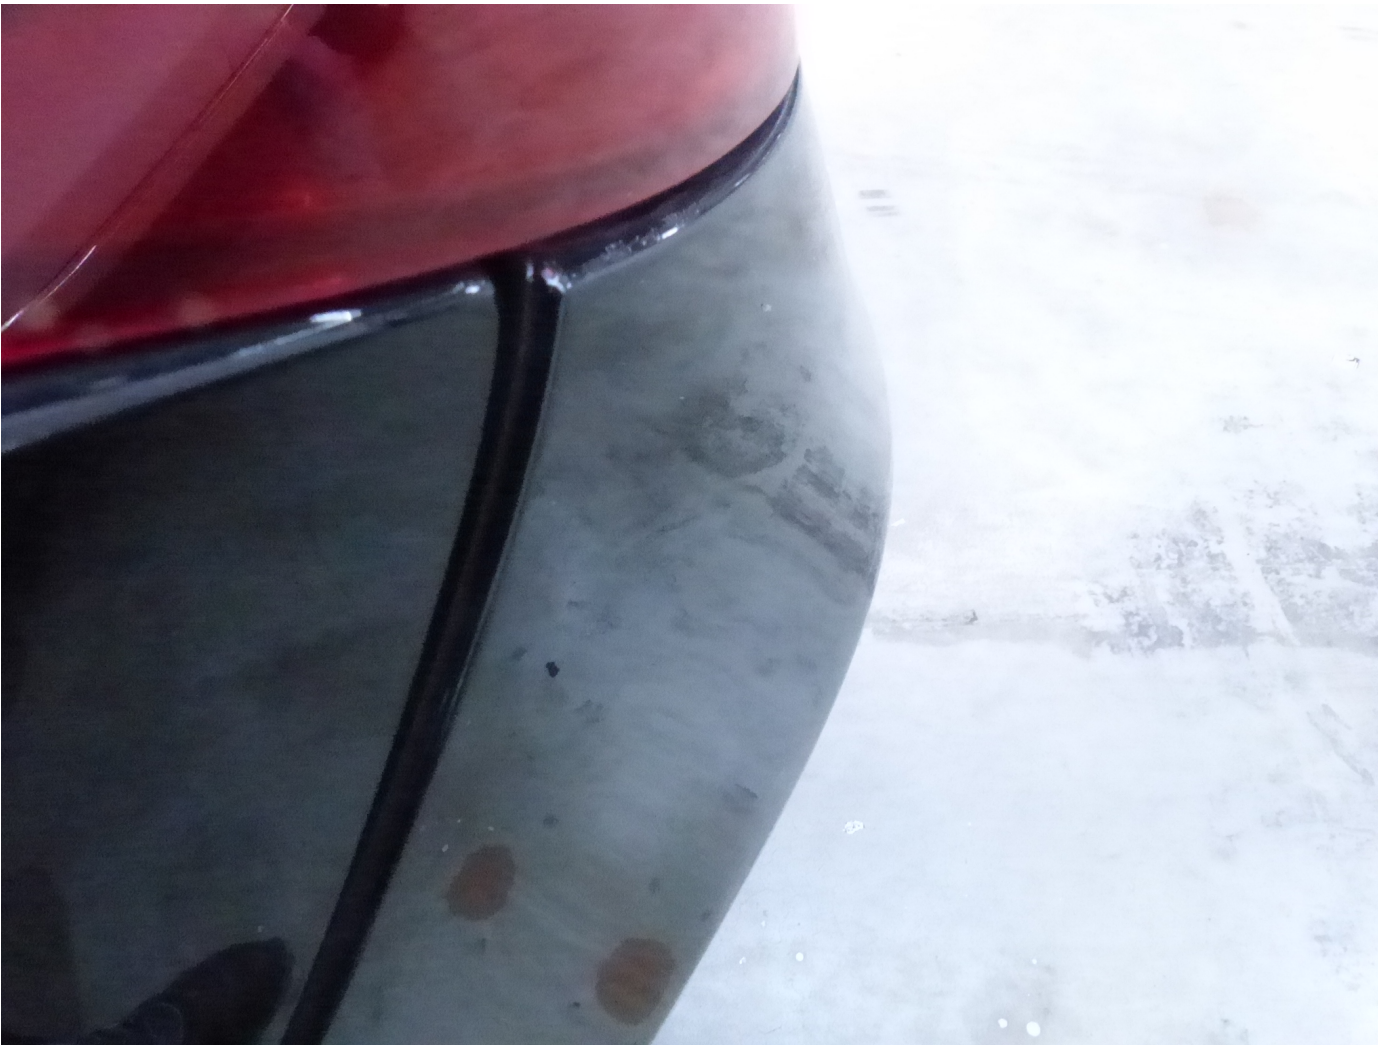
Bild 1

Rear bumper contacts bottom of tail lamp (see figure 1).

Bumper protrudes in area of rear lamp.

Bumper may not be fully engaged in left and/or right lateral support rail.

1. Remove the rear bumper and the left and right rear lamps.
2. Adjust the gap between the lateral support and the basic carrier of the rear lamp to 6 mm (see picture 2, measure 1). To do so, loosen the screw at the side, adjust the gap and tighten the screw again.
