2018 Mercedes Benz E63S AMG 4MATIC Sed (213.089) V8-4.0L Turbo (177.980)

SEAT CUSHION FORE/AFT ADJUSTER SEAT CUSHION COVER BECOMES DETACHED

Topic number	LI91.18-P-049463
Version	3
Function group	91.18 Seat covers
Date	07-31-2018
Validity	BR204 and 207 with SA code 409 (Multicontour seat) and BR212 with SA code 409/432 (Multicontour seat/active multicontour seat) BR 205 and 213 with SA code P65 (Seat cushion fore/aft adjustment) and with 275 (Electrically adjustable driver seat with memory function) or 241 (Electrically adjustable front seats) or 242 (Electrically adjustable front passenger seat with memory function)
Reason for change	BR213 added

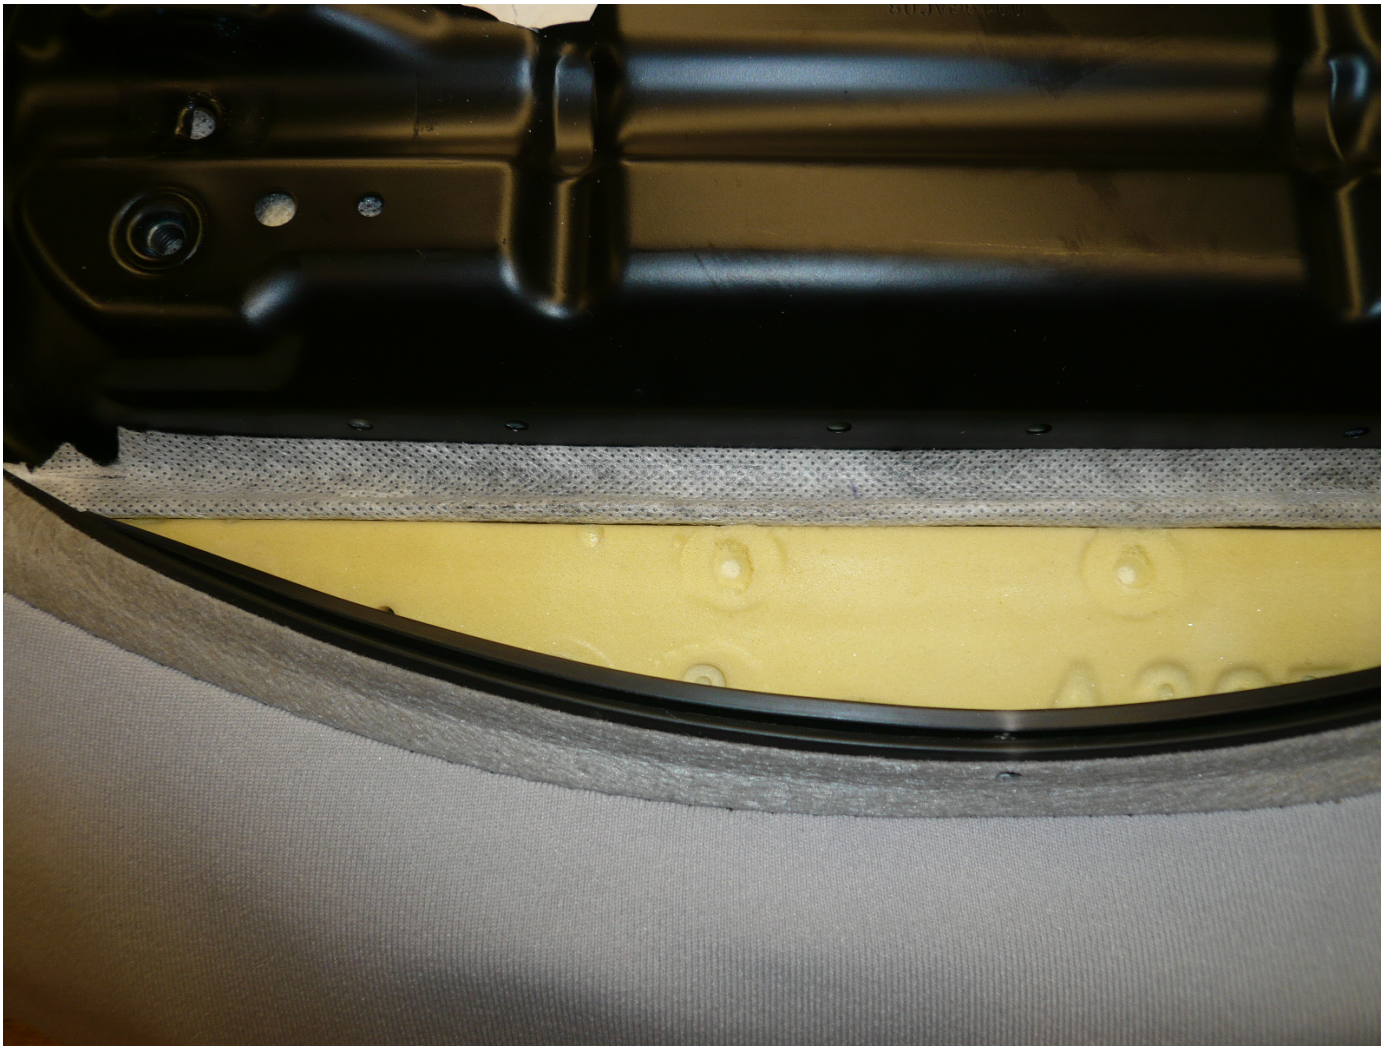
P1040937

- Model series 204 and 212: Insufficient holding ability of the fastening strip
- Model series 207: Matting incorrectly positioned. (See picture P1040937)
- Model series 205 and 213: Insufficient holding ability of the fastening strip

Designation
Matting trapped in profile

- Model series 207:
- Remove cushion as per AR91.10-P-3310CW

! Remove the folded matting from the fold, reattach the cover accurately and make sure that the fastener clicks firmly into place !

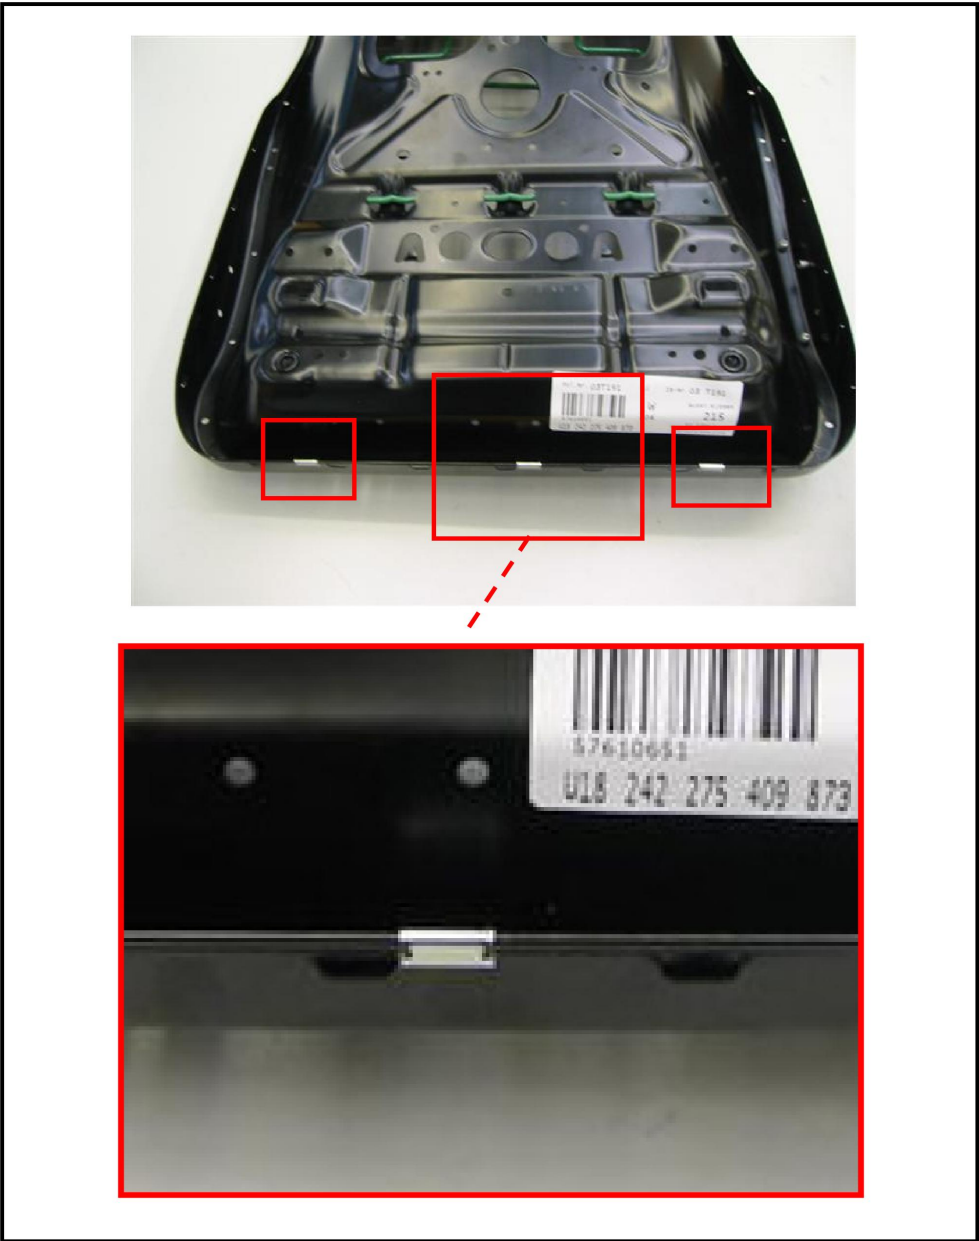
LI91.18-P-049463_2

The fastening strip for the seat cushion cover becomes detached from the front of the seat cushion shell.

- Model series 204 and 212:
- Remove cushion as per AR91.10-P-3310CW
- Fit clips as described in the attachment
- Reattach cover accurately

! It is important that the metal protrusions in the edge of the cushion shell still protrude noticeably and that the fastener clicks firmly and audibly into place !
