7G-TRONIC /7G-TRONIC PLUS (722.9) in the Workshop

Tips and Tricks

**7G-TRONIC/7G-TRONIC PLUS (722.9)
in the Workshop
Tips and Tricks**

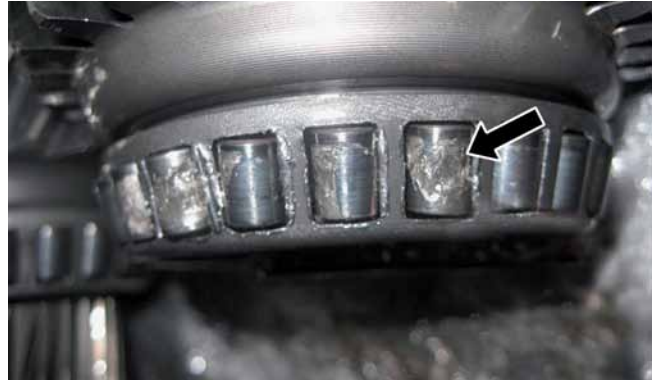
P27.00-2393-00

At the moment, the entire transmission must be replaced in the event of this type of damage, repair is not possible.

Pitting damage

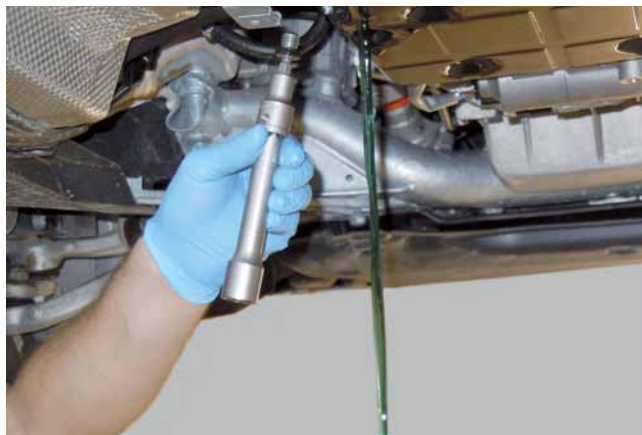
P27.10-2492-00

Transmission oil level is OK with this flow rate.

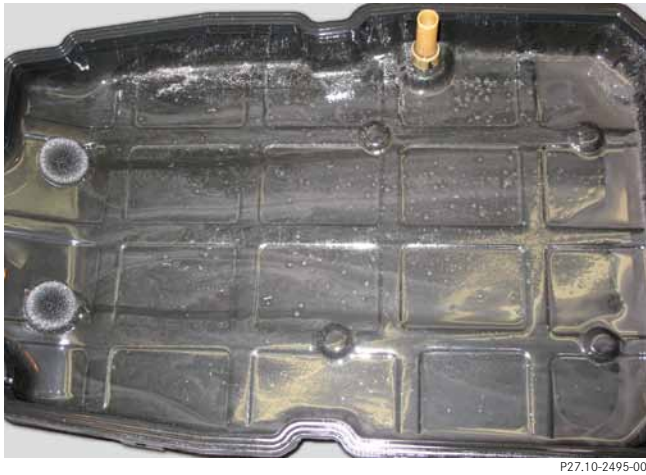
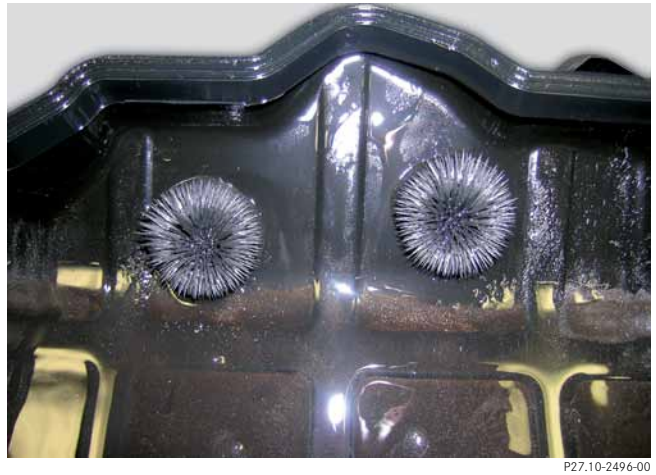
Transmissions with obvious mechanical damage

We currently recommend replacing the transmission if the following damage is present: Oil pump has corroded in housing Rear planetary gear set is defective Torque converter lockup clutch or other components in converter worn (very large amount of shavings in the transmission oil pan without visible defects in transmission) If there is a very large amount of contamination, it is also recommended to replace the cooler. Flushing the cooler is not possible because the thermostat only opens at an oil temperature of approx. 80°C. The following pictures give examples of transmissions where there is obvious mechanical damage and of transmissions whereby the pictures do not allow a conclusion to be drawn about damage. Naturally, the transmission can also be damaged even if no wear debris has been produced

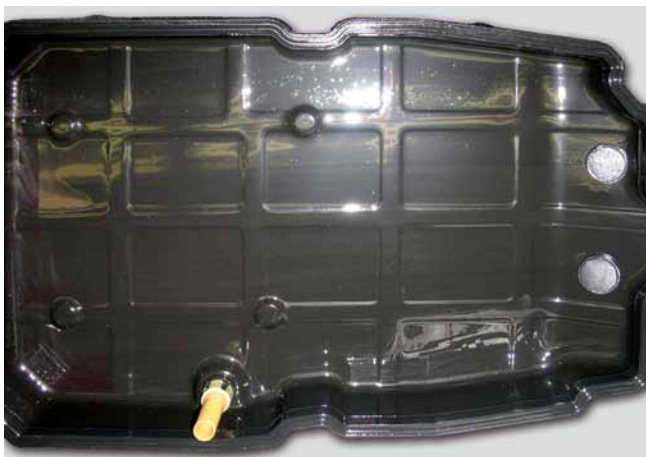
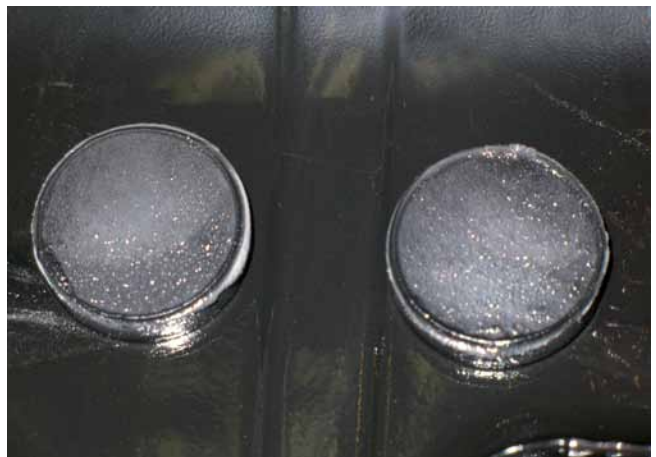
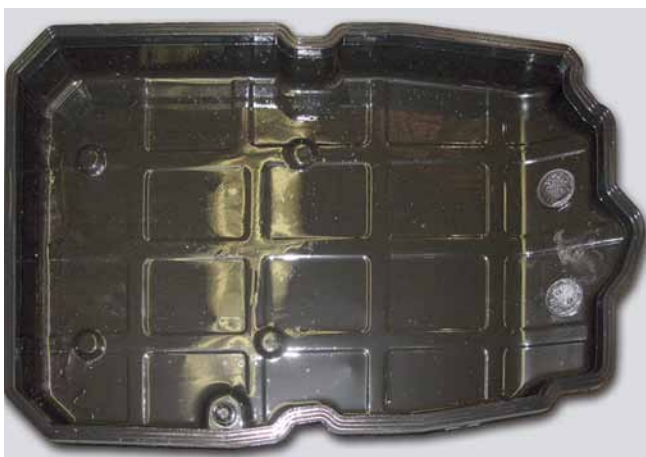
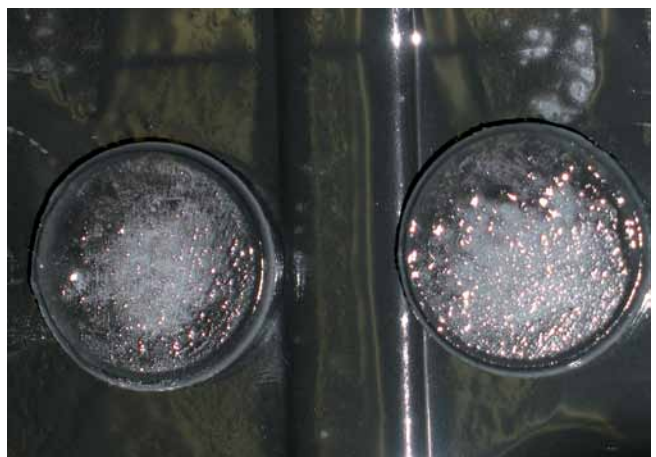
Mechanical damage not identifiable based on pictures

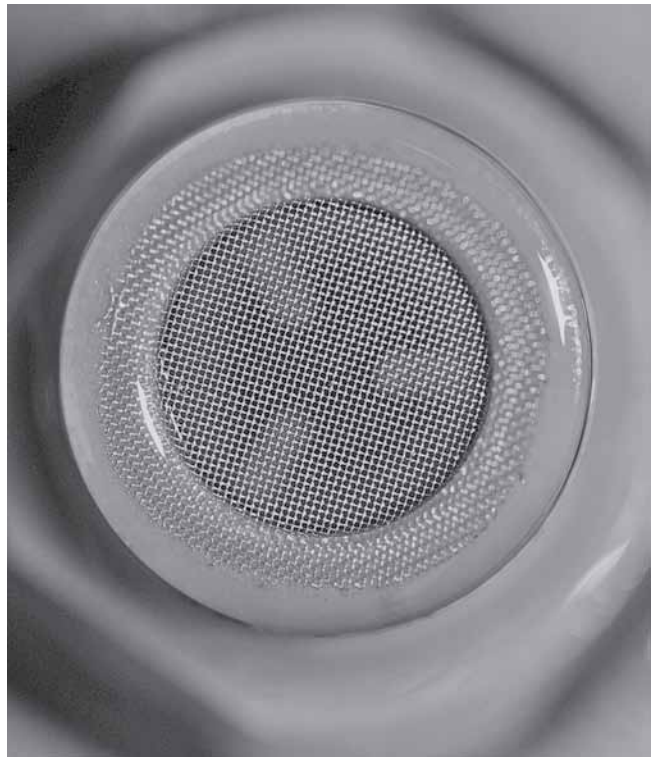
P27.60-3689-00

Control solenoid valve OK, can be reinstalled.

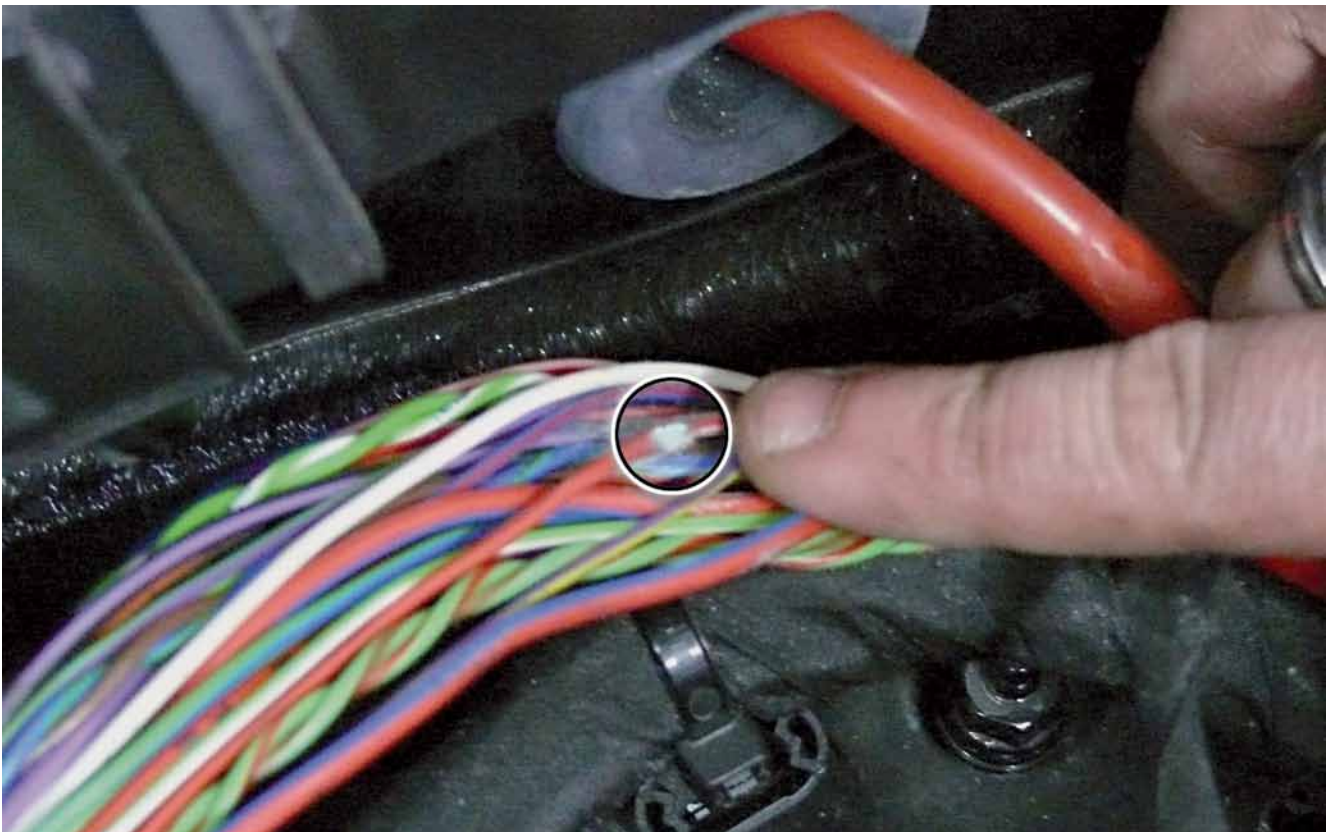
P27.19-2643-00

A typical indication of a damaged wiring harness is sporadic occurrence of the complaint e.g. caused by a loose contact or short circuit. The damage is often very difficult to detect, so it is recommended to expose the lines in question and carefully check them for chafe marks. In addition, all contacts and connectors should be carefully checked for water entry, corrosion and widened pins. The following pictures show a number of defective wiring harnesses.

Chafe mark
