**Model** 172, 204, 205, 207, 211, 212, 213, 216, 217, 218, 219, 221, 222, 230, 231, 253, 293

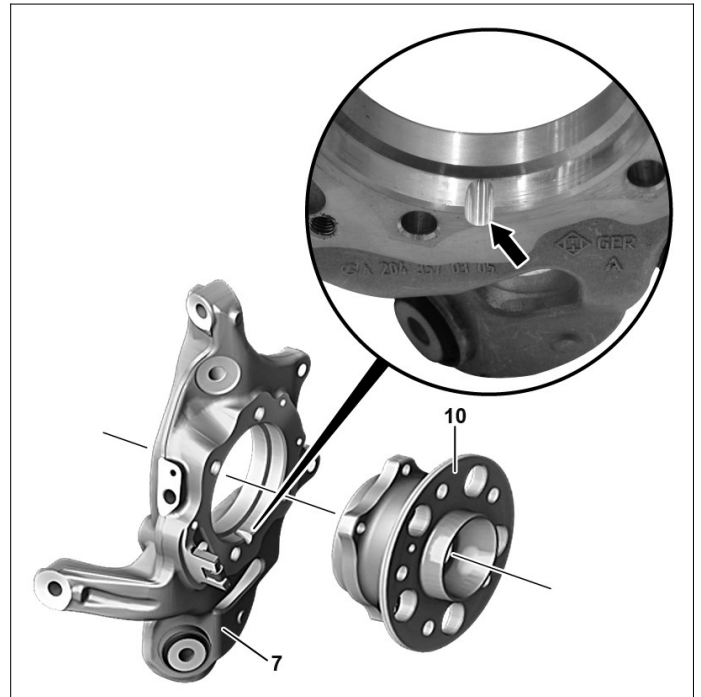
P35.20-2248-12

⚠ Due to dirt deposits in the groove (arrow), water that has penetrated between the steering knuckle and wheel bearing cannot flow away.

As a result damage to the wheel bearing can occur.

- 1 Clean groove (arrow) in steering knuckle (7) after removing wheel bearing with rear axle shaft flange (10).
