Written by krazzdav

Virginizing ME9.7

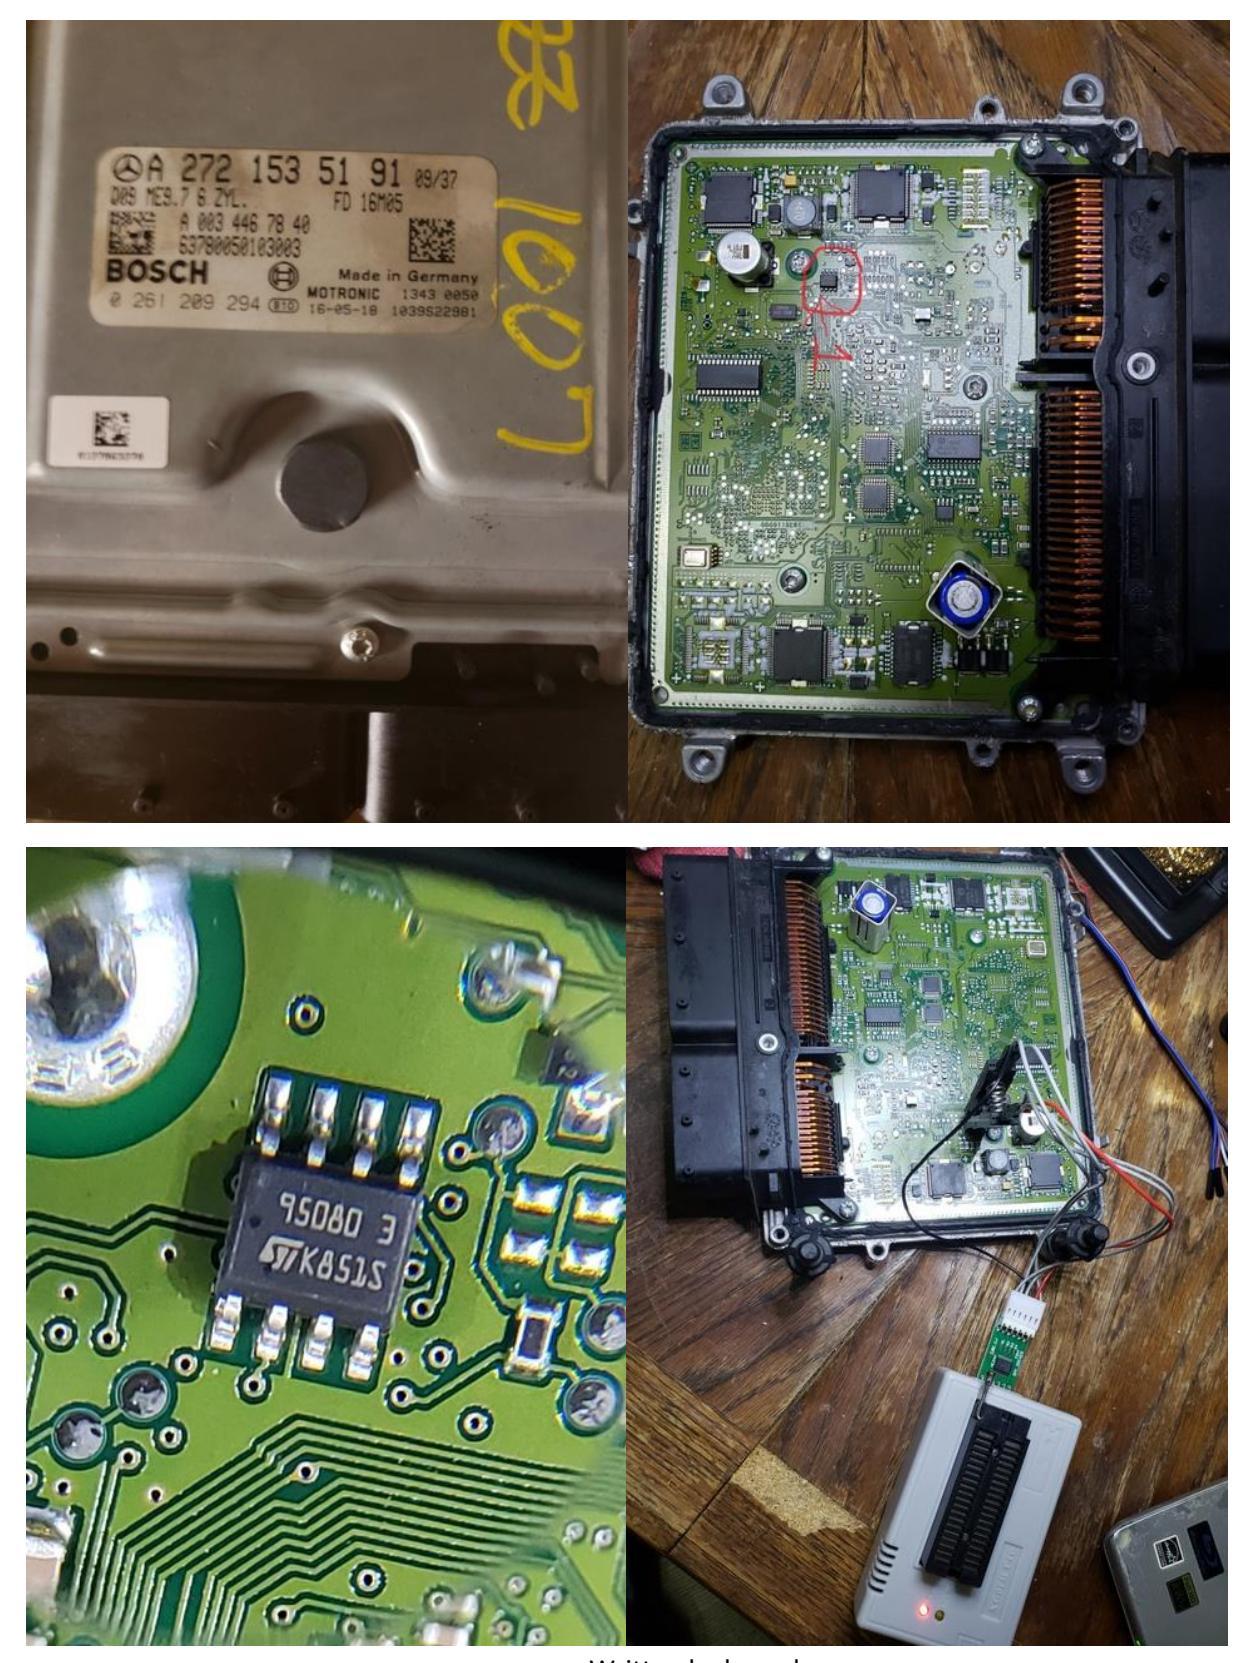
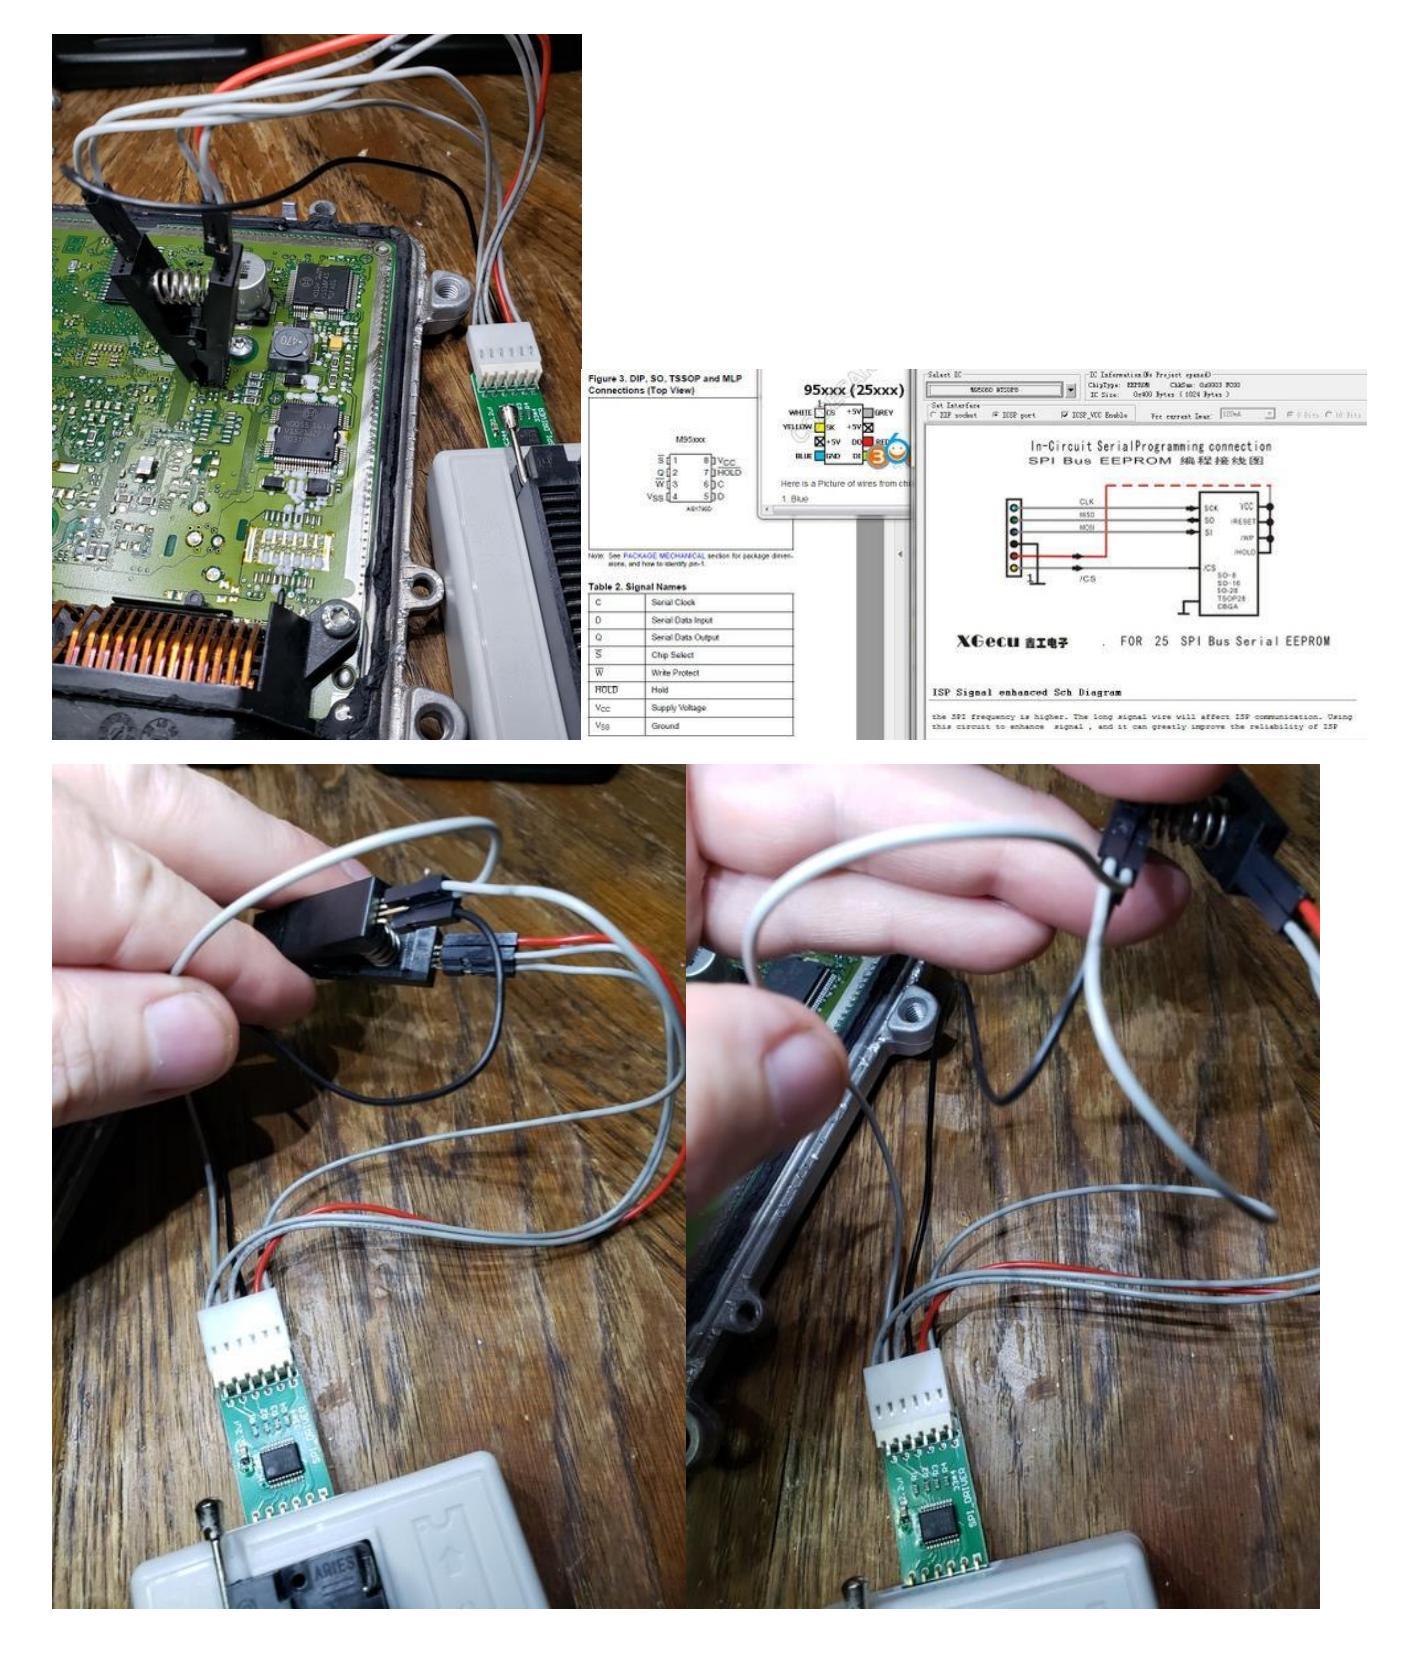
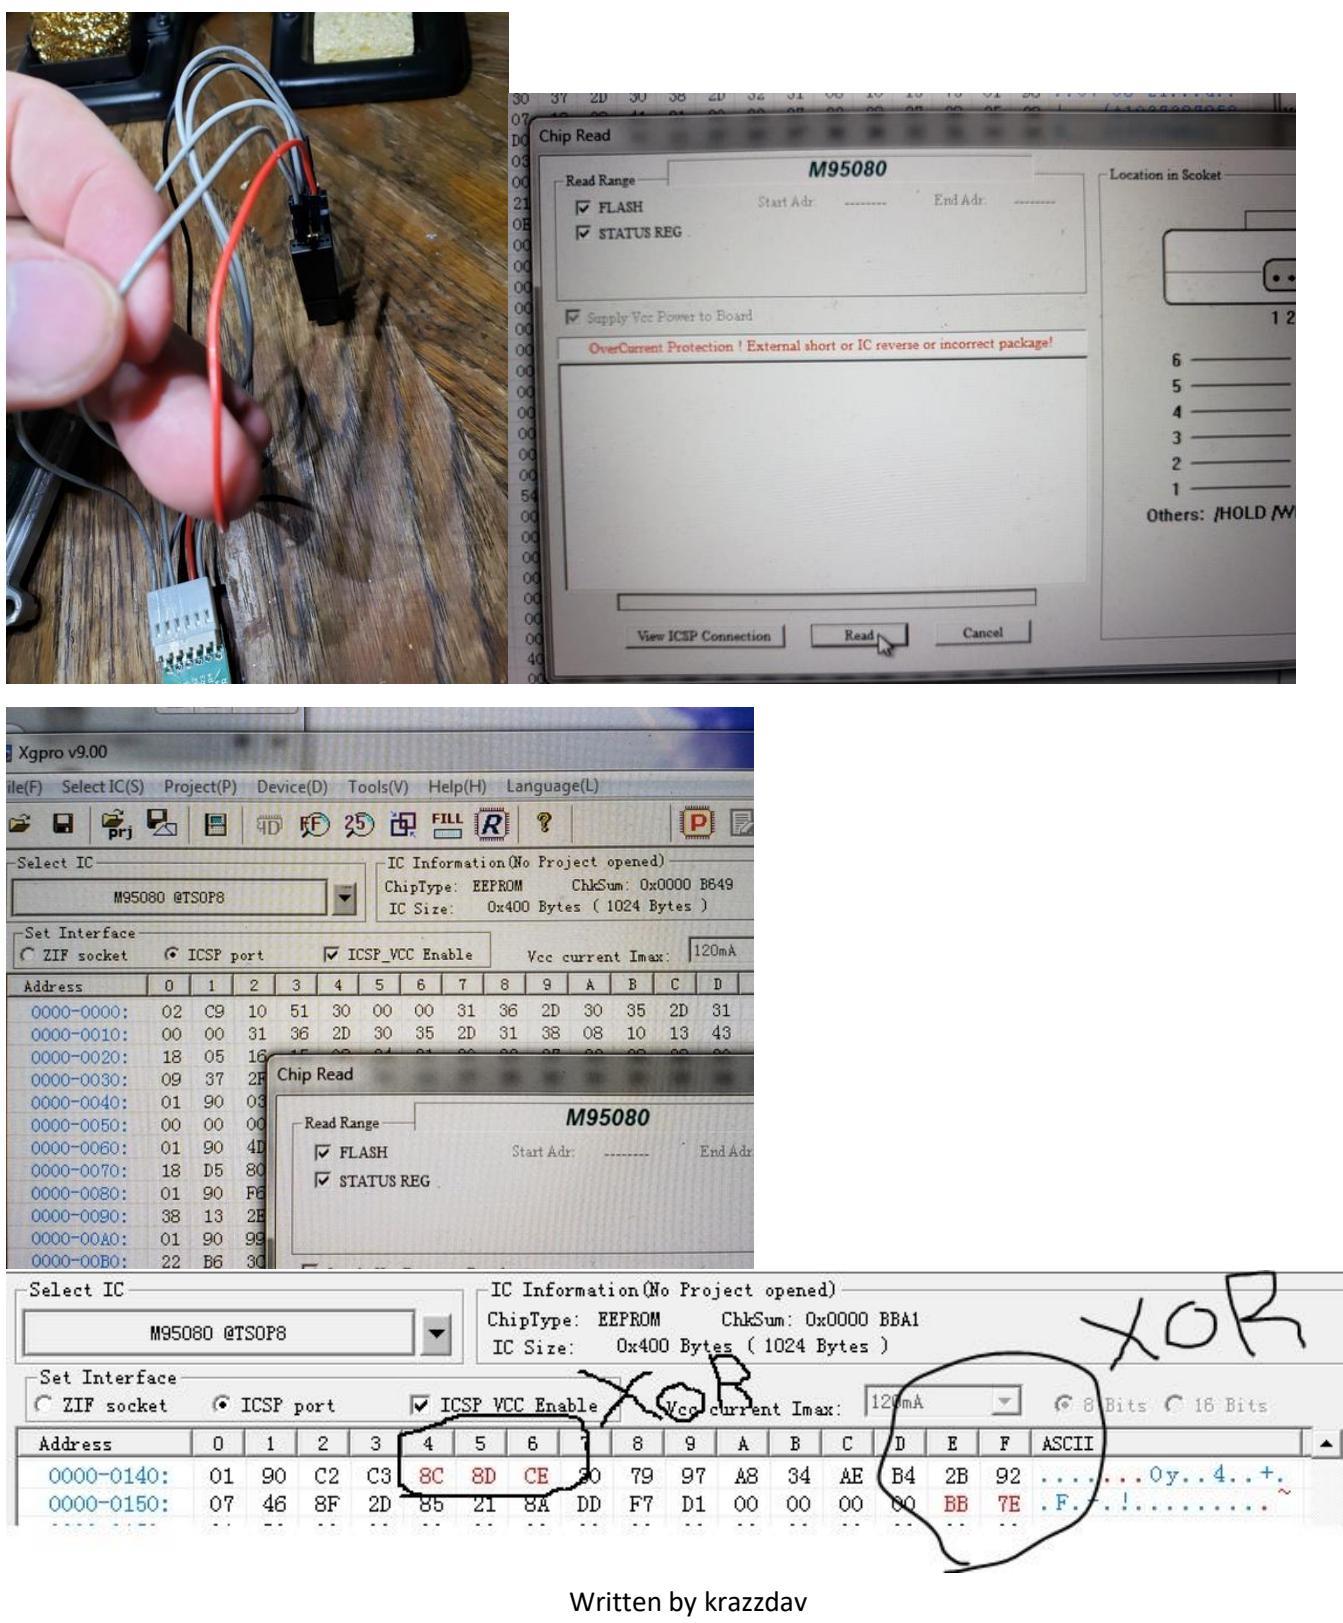
Attached some reference pics as well --- I didn't see any around.
