7G-TRONIC /7G-TRONIC PLUS (722.9) in the Workshop

Tips and Tricks

**7G-TRONIC/7G-TRONIC PLUS (722.9)
in the Workshop
Tips and Tricks**

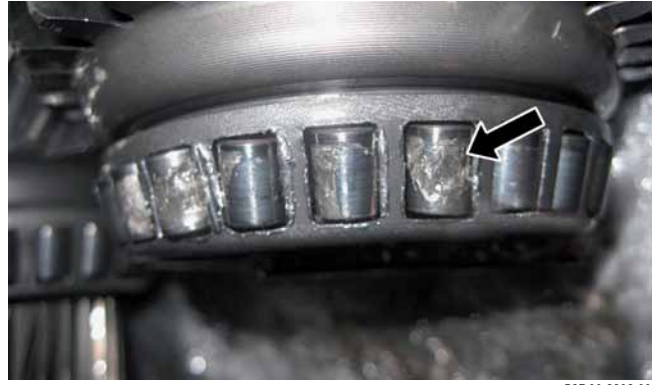
P27.00-2393-00

Pitting damage

At the moment, the entire transmission must be replaced in the event of this type of damage, repair is not possible.

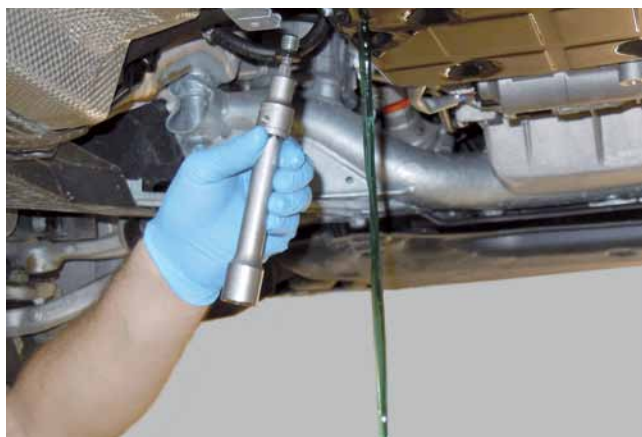
P27.10-2492-00

Transmission oil level is OK with this flow rate.

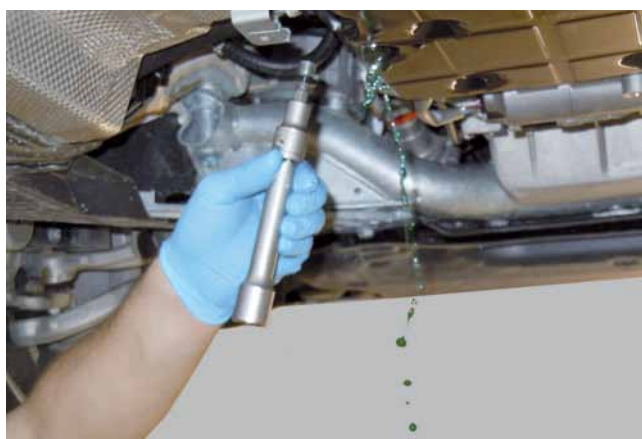
P27.10-2493-00

Transmission oil level is OK with this flow rate.

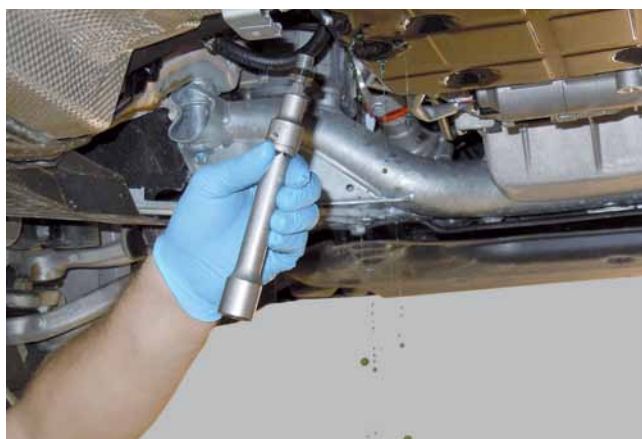
P27.10-2494-00

Transmission oil level must be corrected and rechecked with this flow rate.

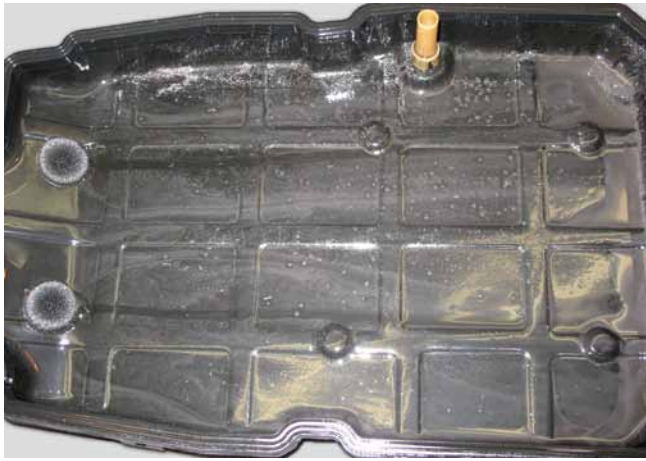
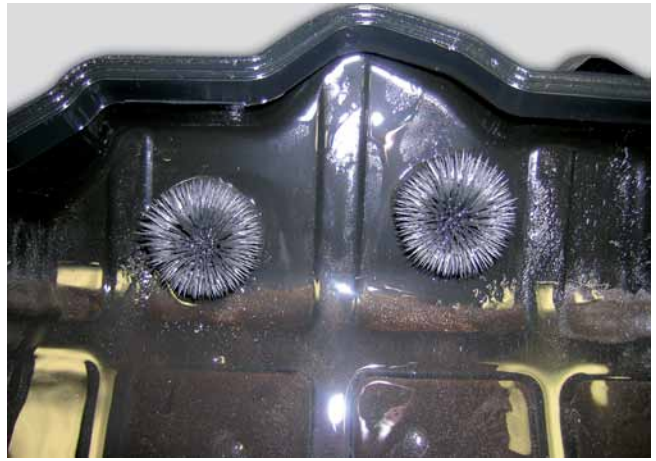
Transmissions with obvious mechanical damage

We currently recommend replacing the transmission if the following damage is present: Oil pump has corroded in housing Rear planetary gear set is defective Torque converter lockup clutch or other components in converter worn (very large amount of shavings in the transmission oil pan without visible defects in transmission) If there is a very large amount of contamination, it is also recommended to replace the cooler. Flushing the cooler is not possible because the thermostat only opens at an oil temperature of approx. 80°C. The following pictures give examples of transmissions where there is obvious mechanical damage and of transmissions whereby the pictures do not allow a conclusion to be drawn about damage. Naturally, the transmission can also be damaged even if no wear debris has been produced

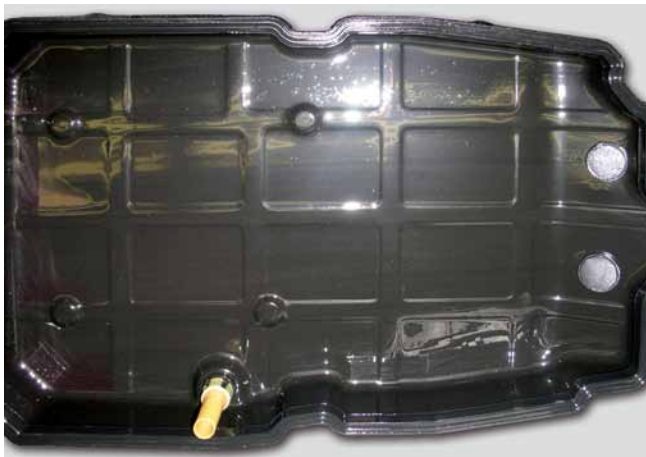
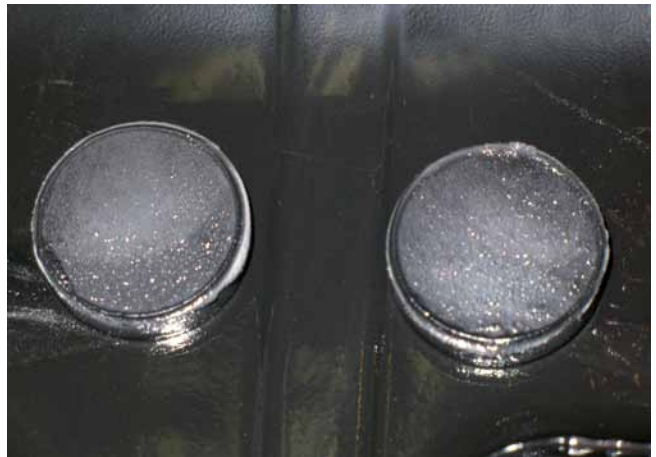
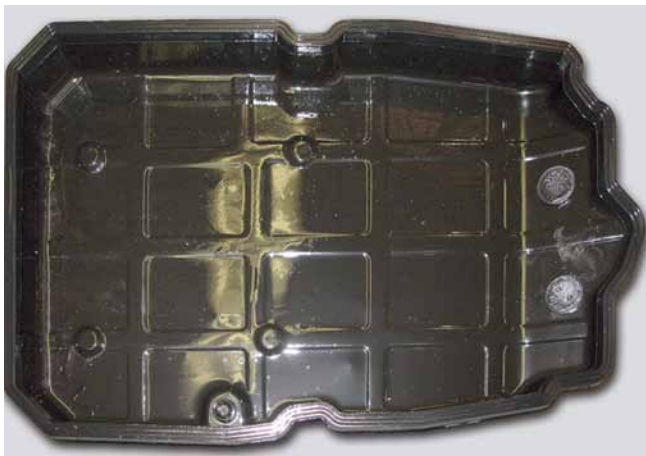
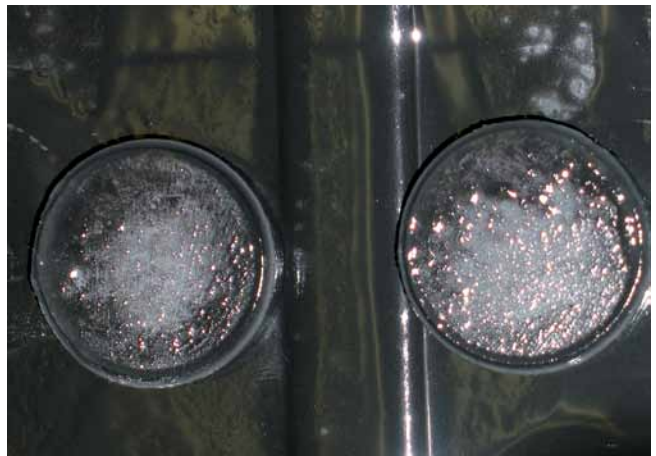
Mechanical damage not identifiable based on pictures

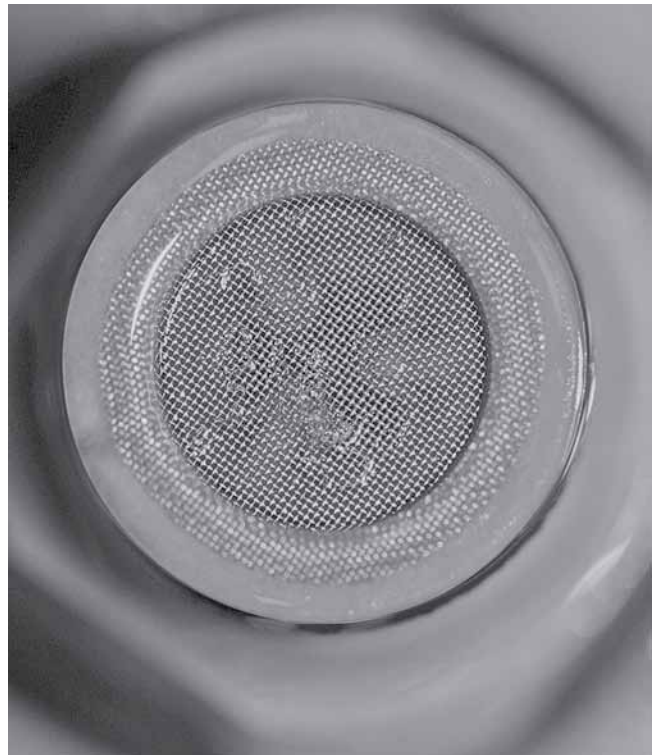
P27.60-3687-00

If the control solenoid valve looks like this after cleaning, it must be replaced.

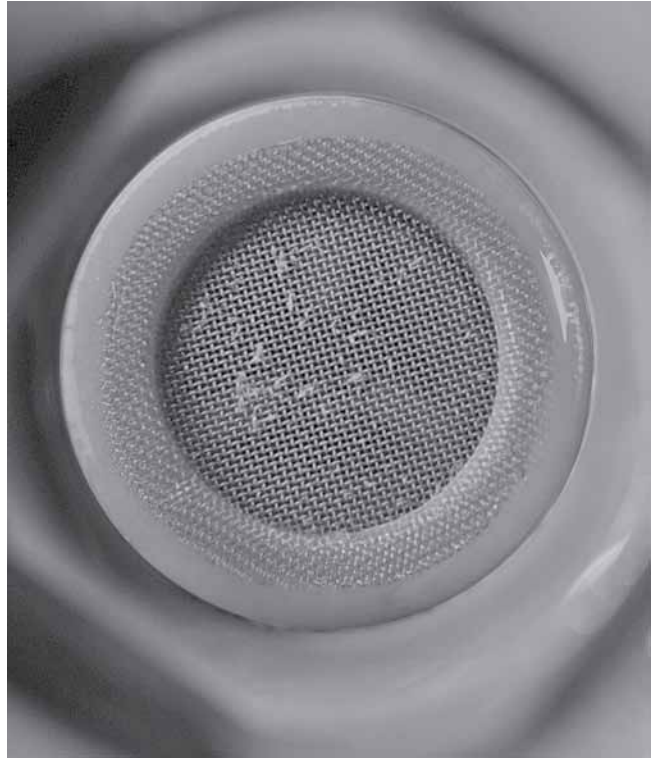
P27.60-3688-00

Clean control solenoid valve, if it looks like this after cleaning, it can be reinstalled.

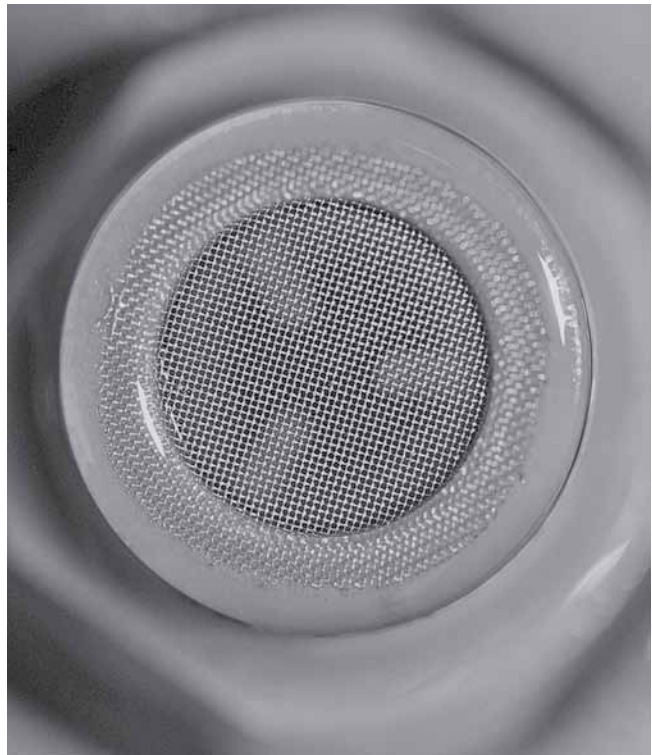
P27.60-3689-00

Control solenoid valve OK, can be reinstalled.

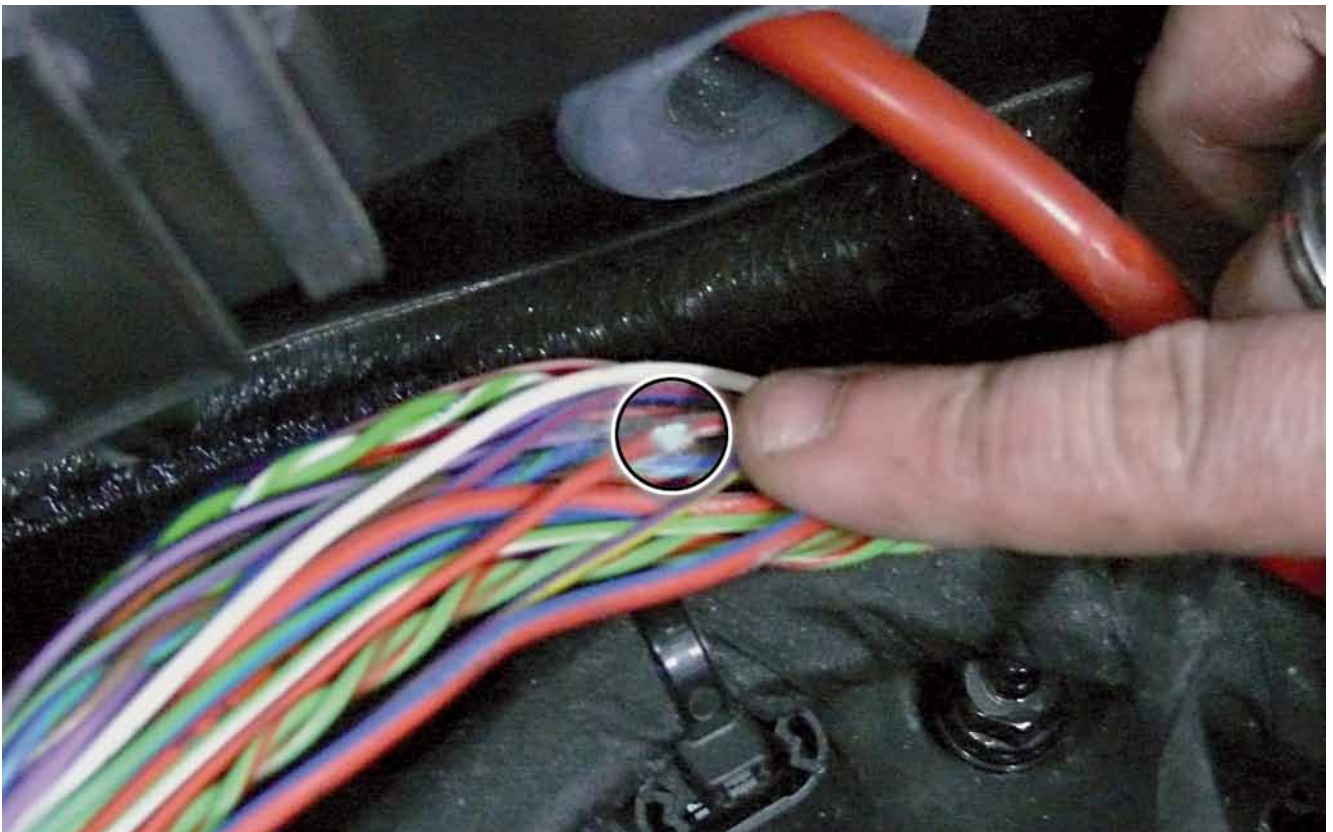
P27.19-2643-00

A typical indication of a damaged wiring harness is sporadic occurrence of the complaint e.g. caused by a loose contact or short circuit. The damage is often very difficult to detect, so it is recommended to expose the lines in question and carefully check them for chafe marks. In addition, all contacts and connectors should be carefully checked for water entry, corrosion and widened pins. The following pictures show a number of defective wiring harnesses.

Chafe mark

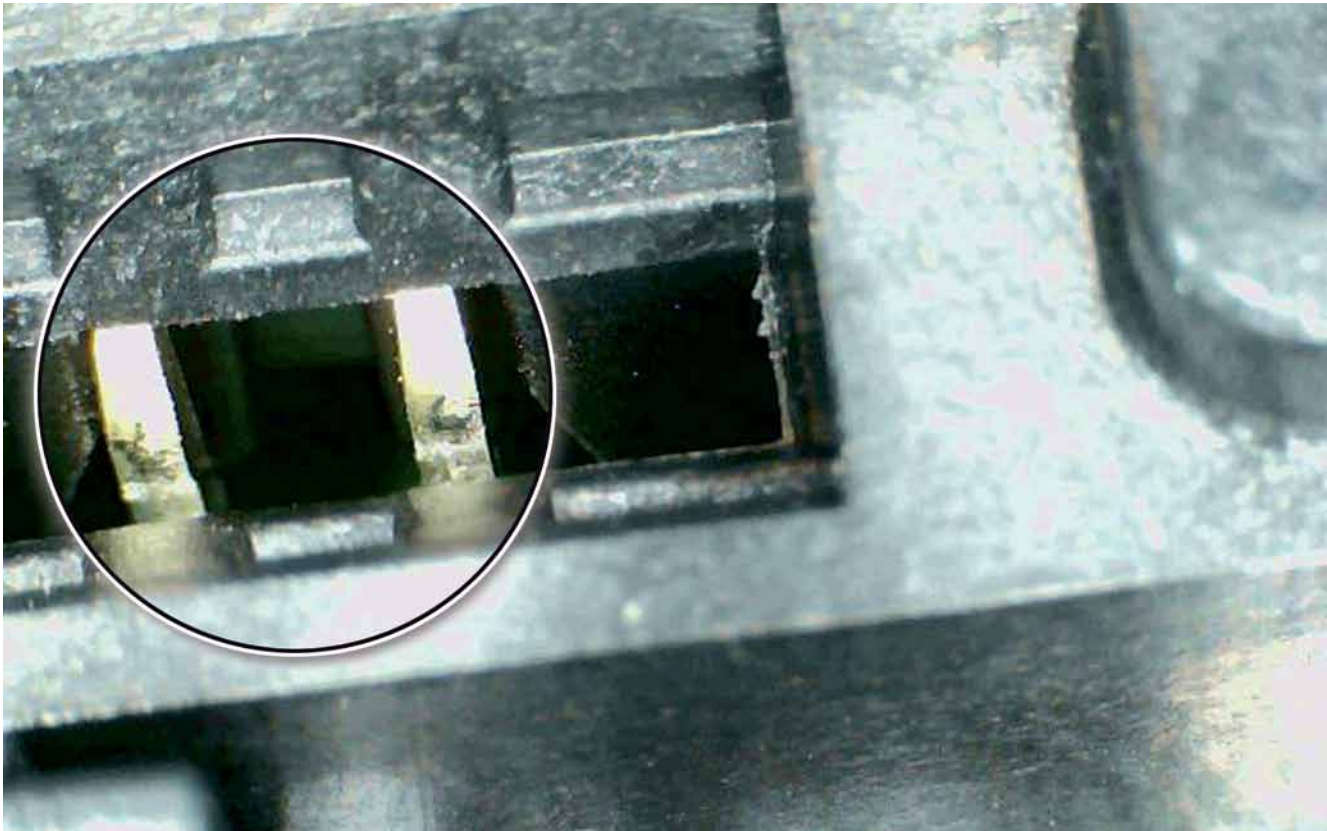
P27.19-2644-00

Burned contact

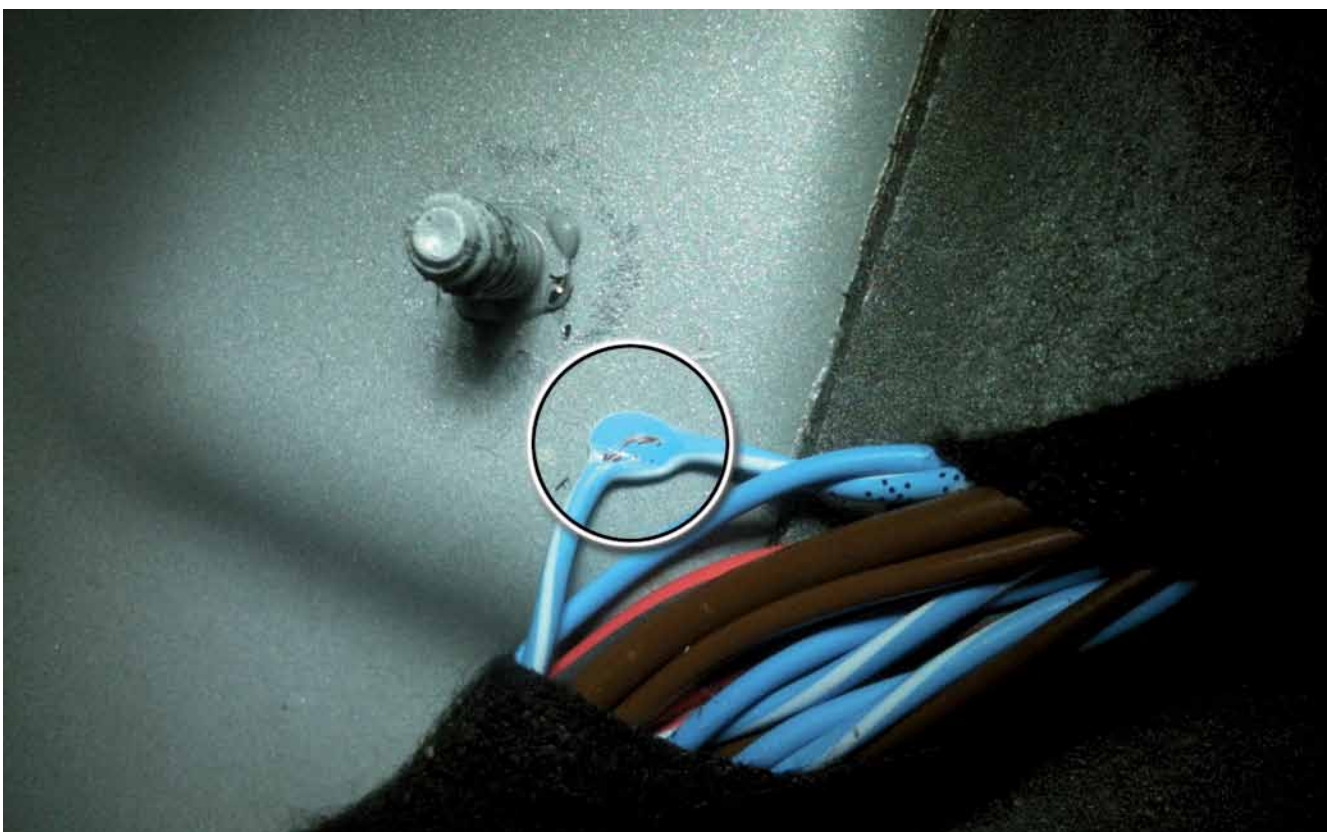
P27.19-2645-00

Pinched line

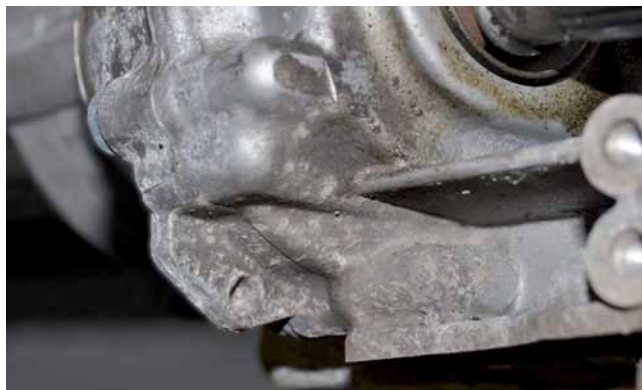
P28.00-2070-00

As with all oil-filled systems, a transfer case may "sweat" due to its design. This is normal and there is no action required. The following pictures provide an example of the difference between sweating and leakage.

Transfer case sweating

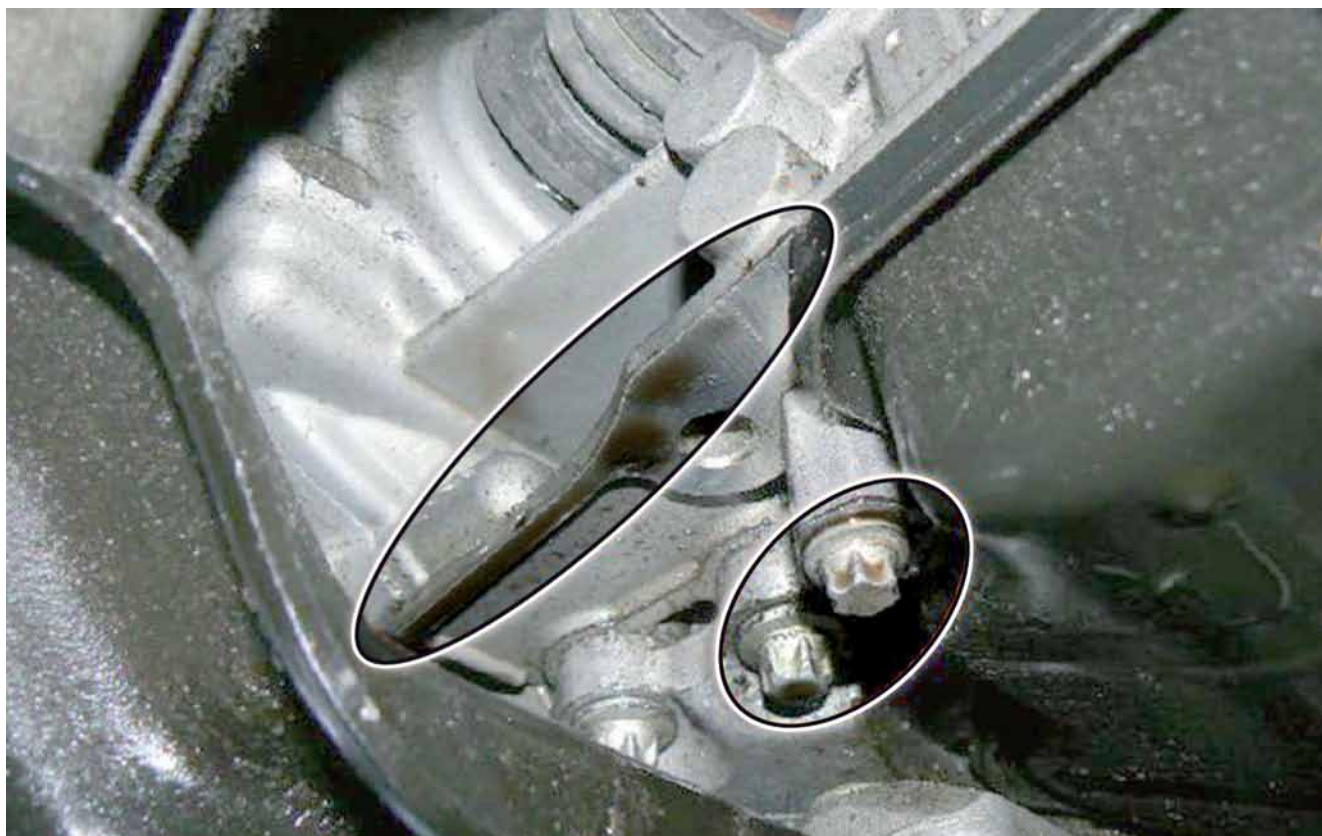
P28.00-2071-00

Transfer case leaky
