Document title General information on inspecting cylinder walls

Document number ah0100p030001a

General information on engines with cast iron cylinder barrels

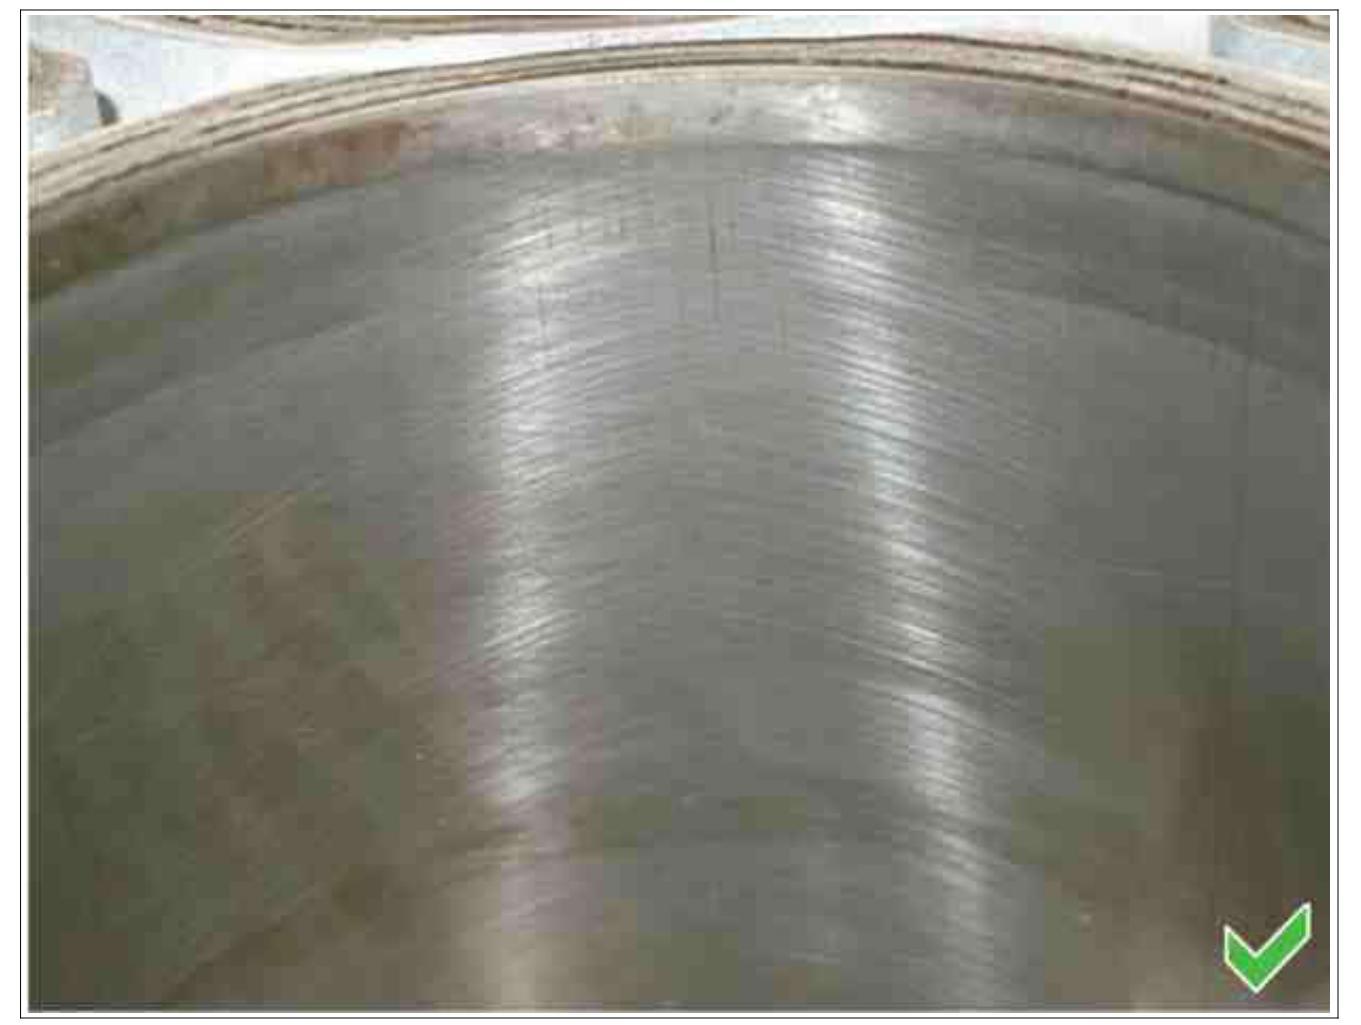
P01.00-3667-76

Ideal condition (not for engine 622/626) Cross-grinding marks from honing clearly visible on cylinder wall.

i Reuse crankcase.

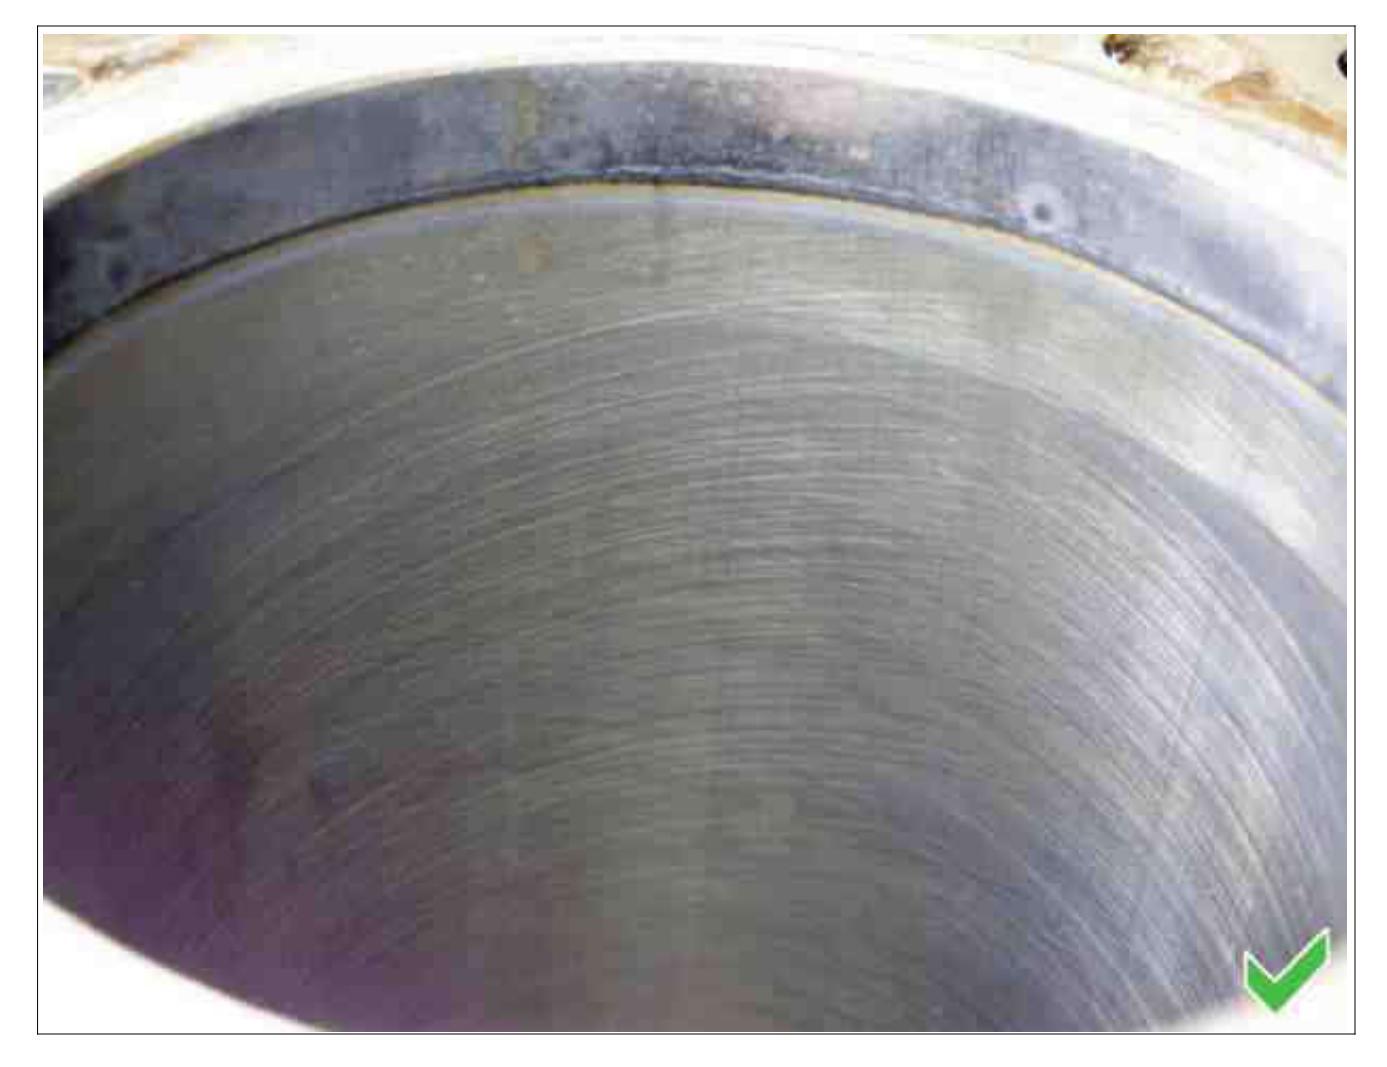
P01.00-A007-76

Ideal condition (for engine 622/626) Parabolic cut marks from honing clearly visible on cylinder wall. i Reuse crankcase.

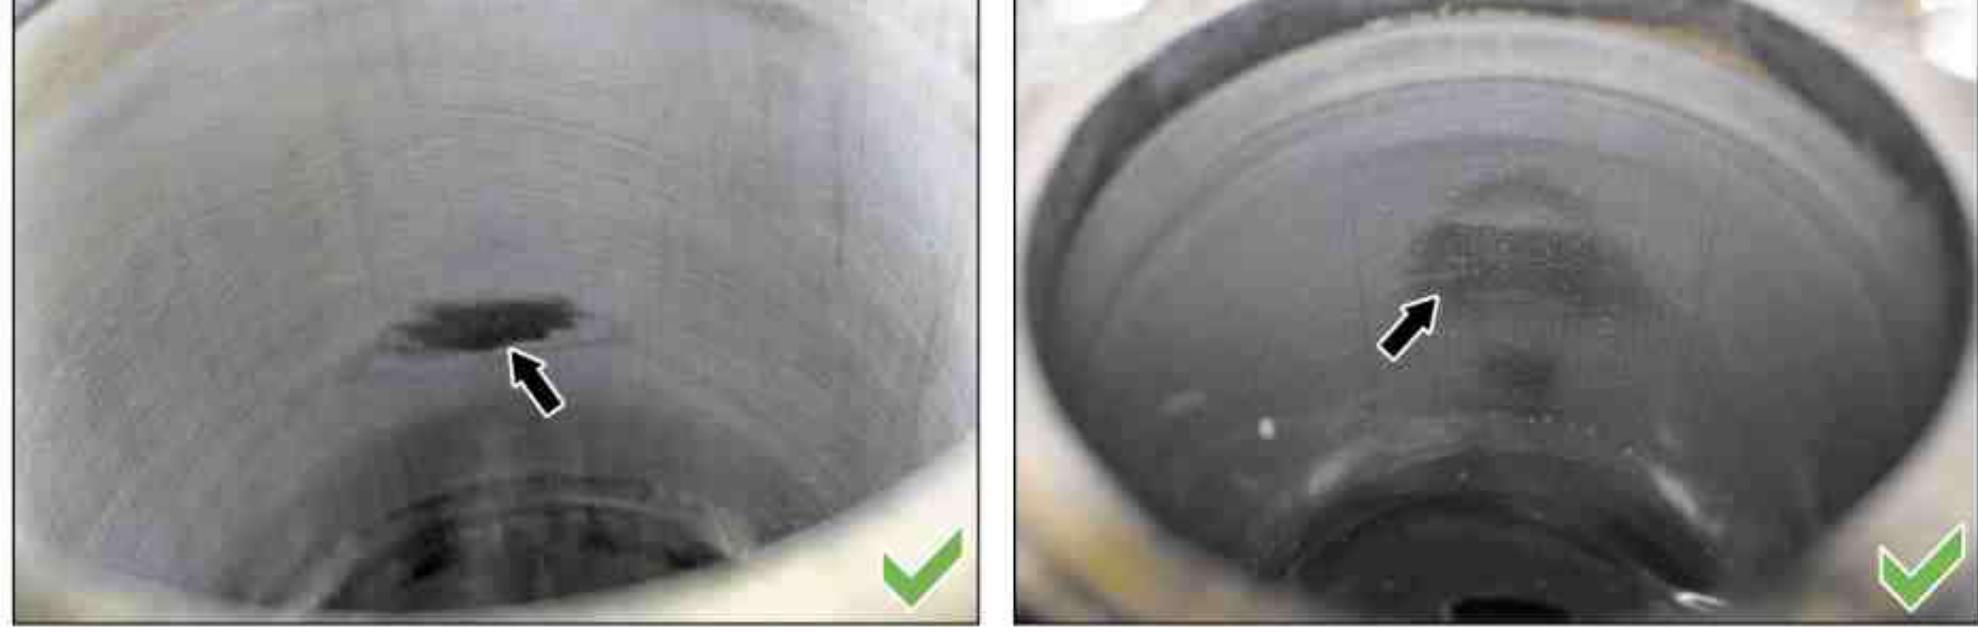
Glazing, smooth spots

Individual blank points, e.g. in the middle of the cylinder barrel or around the cylinder head bolts.

i Reuse crankcase.

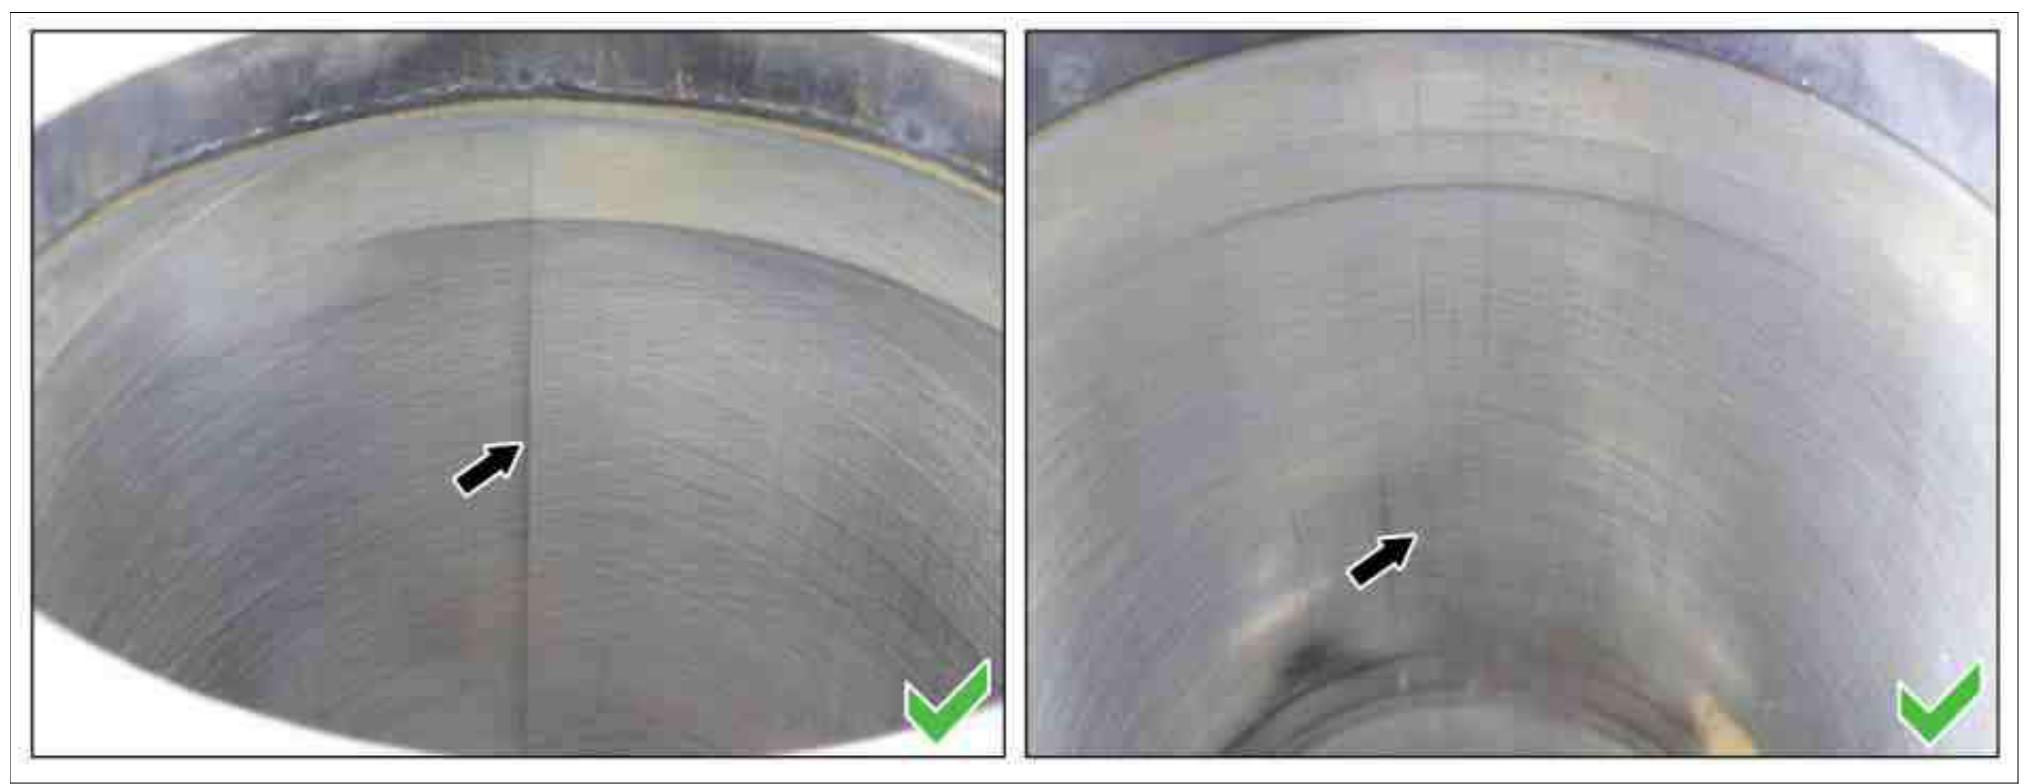
P01.00-A010-78

Continuous individual traces of scratch

Oil carbon marks caused by soiling, for example through back-pulsation of soot particles from the exhaust system. They are imperceptible to the touch.

i Reuse crankcase.

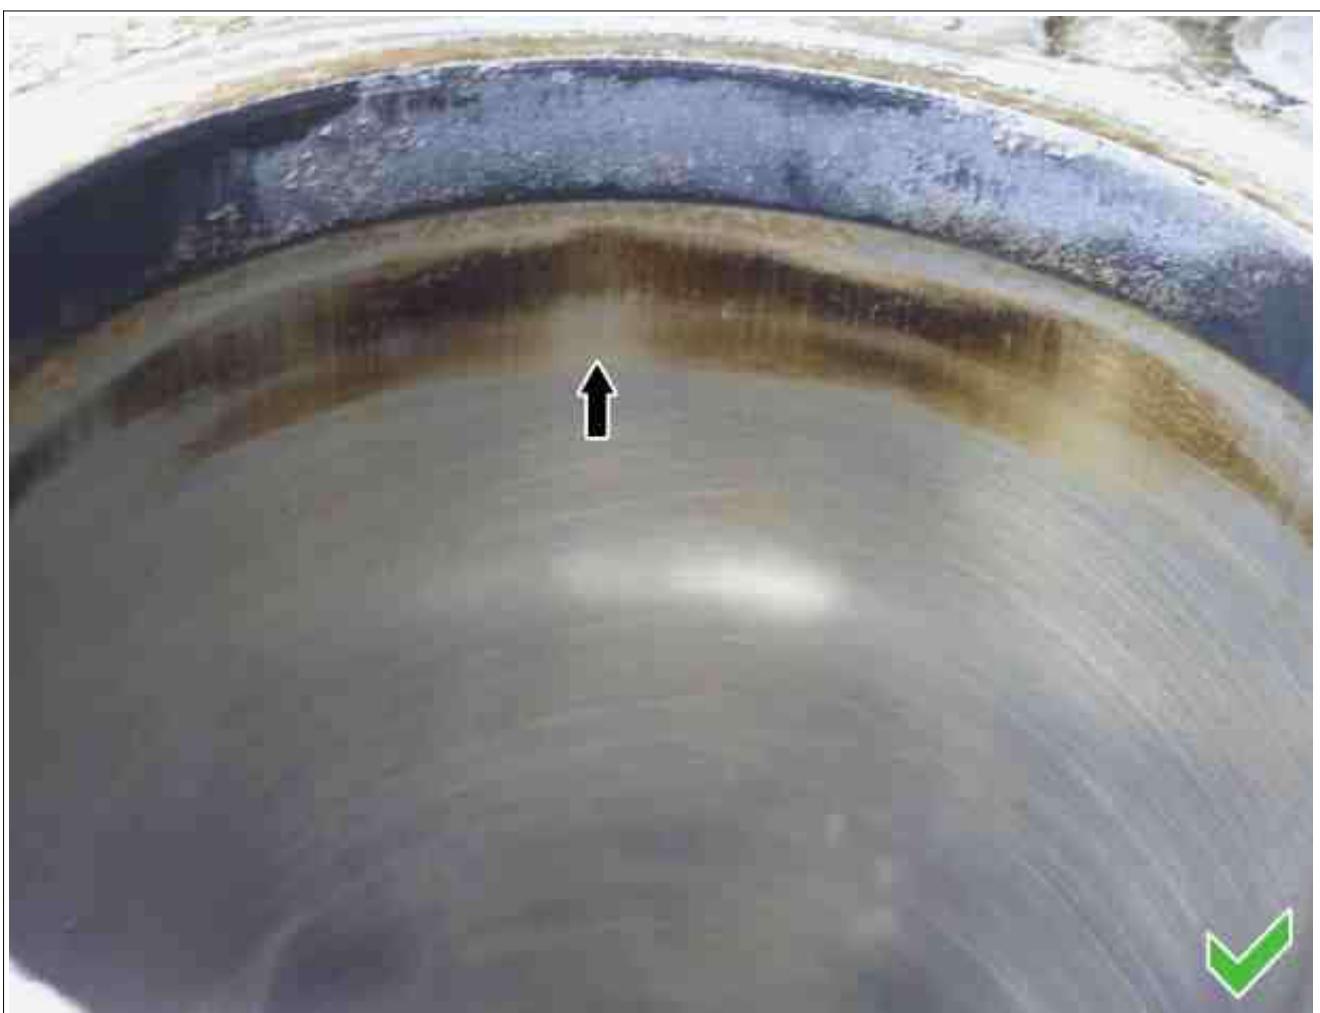
Brown coloration of cylinder barrel A brown coloration over large areas of the cylinder barrel arises from oil varnish and indicates that the engine has been driven at a high temperature level. Oil varnish above piston ring zone is normal and is not a reason for complaint.

i Reuse crankcase.

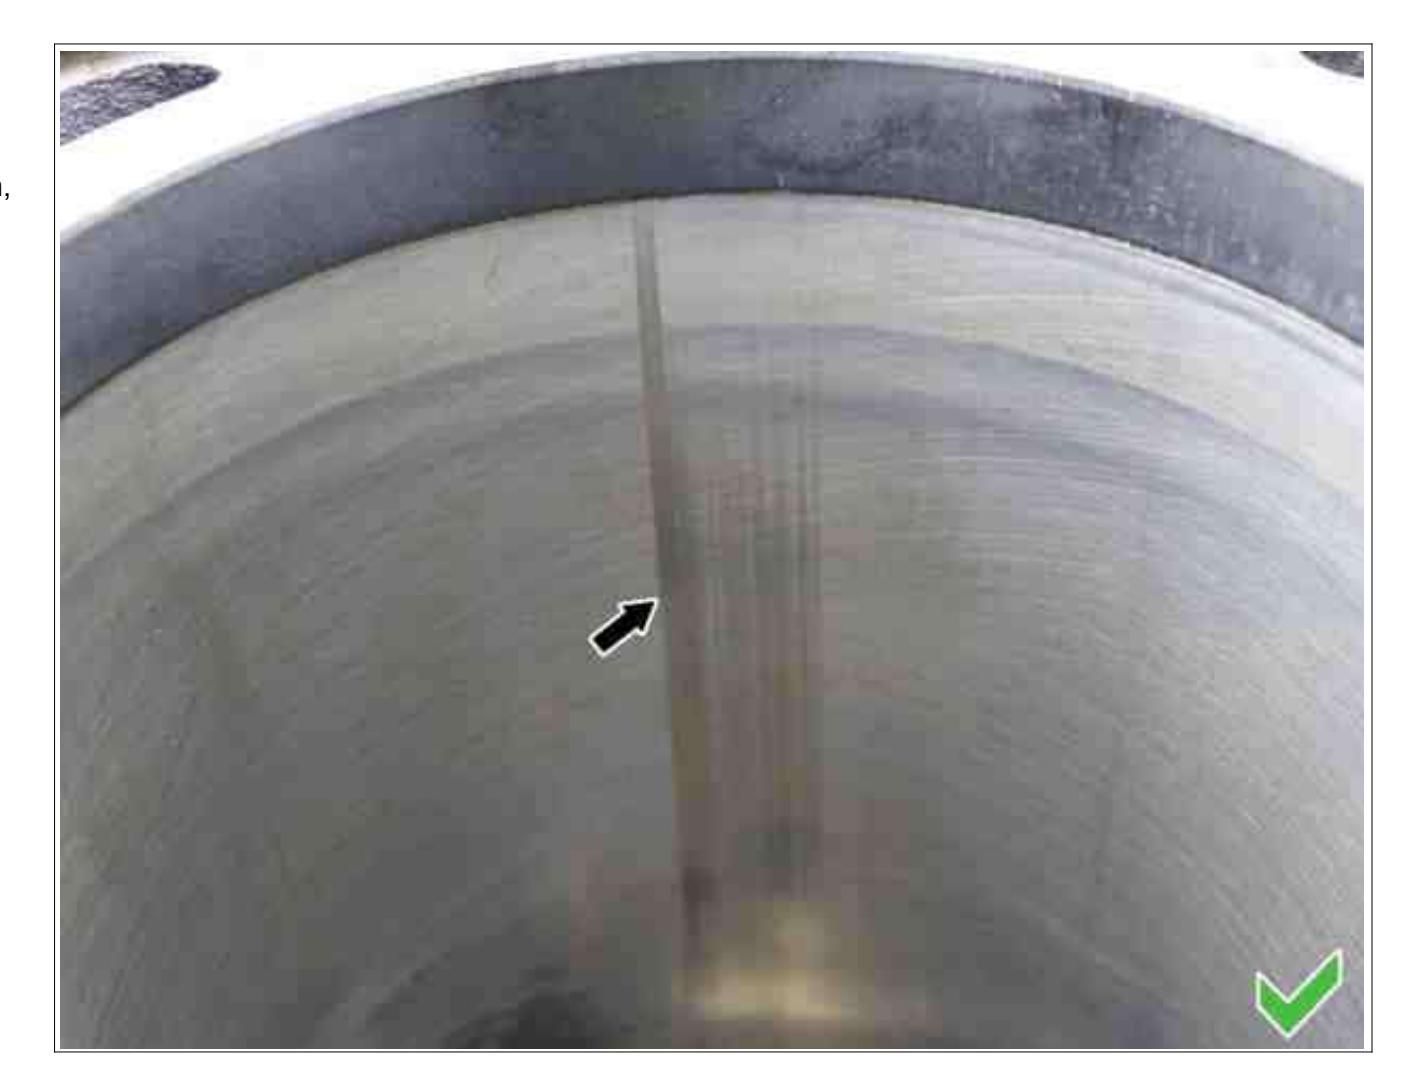
P01.00-A011-76

Visible stripes, friction marks Starting from reverse area of the upper piston ring tapering downwards. Friction marks that are imperceptible to the touch, caused by oil film being washed off by fuel, the piston rings are not damaged. i Reuse crankcase.

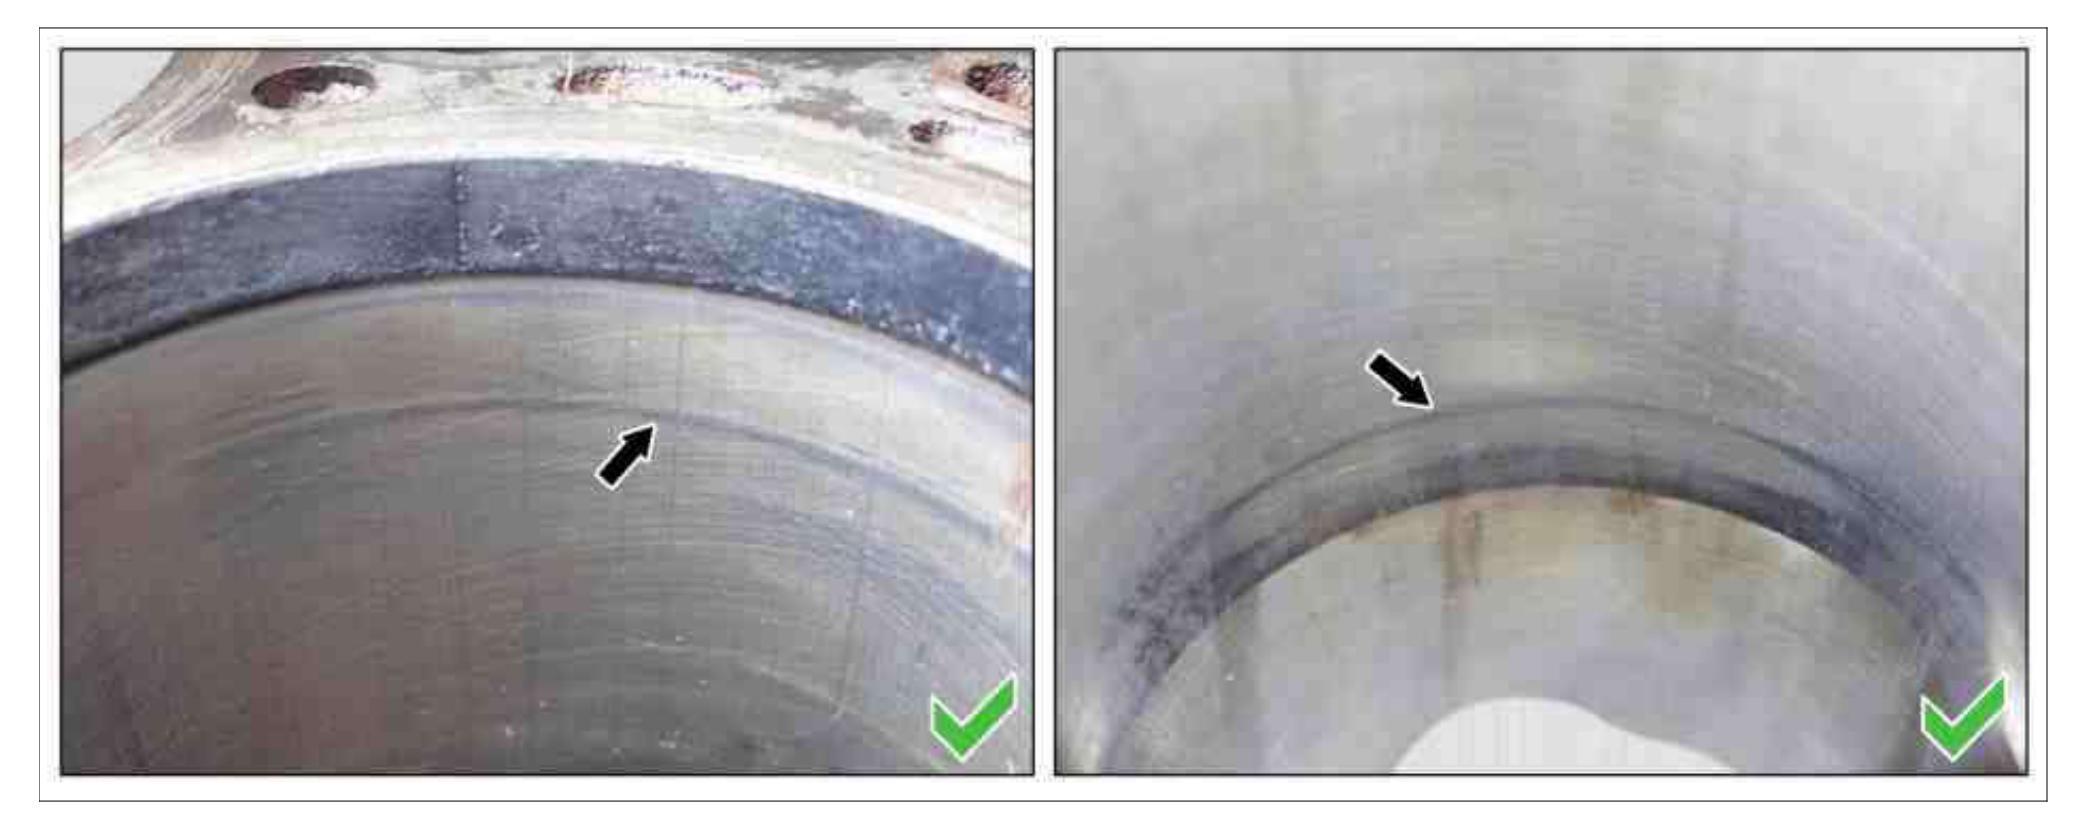
P01.00-A012-78

Ring shaped imprints

Visible imprints on cylinder barrel in the upper and lower reverse area of piston rings are not a cause for complaint.

i Reuse crankcase.

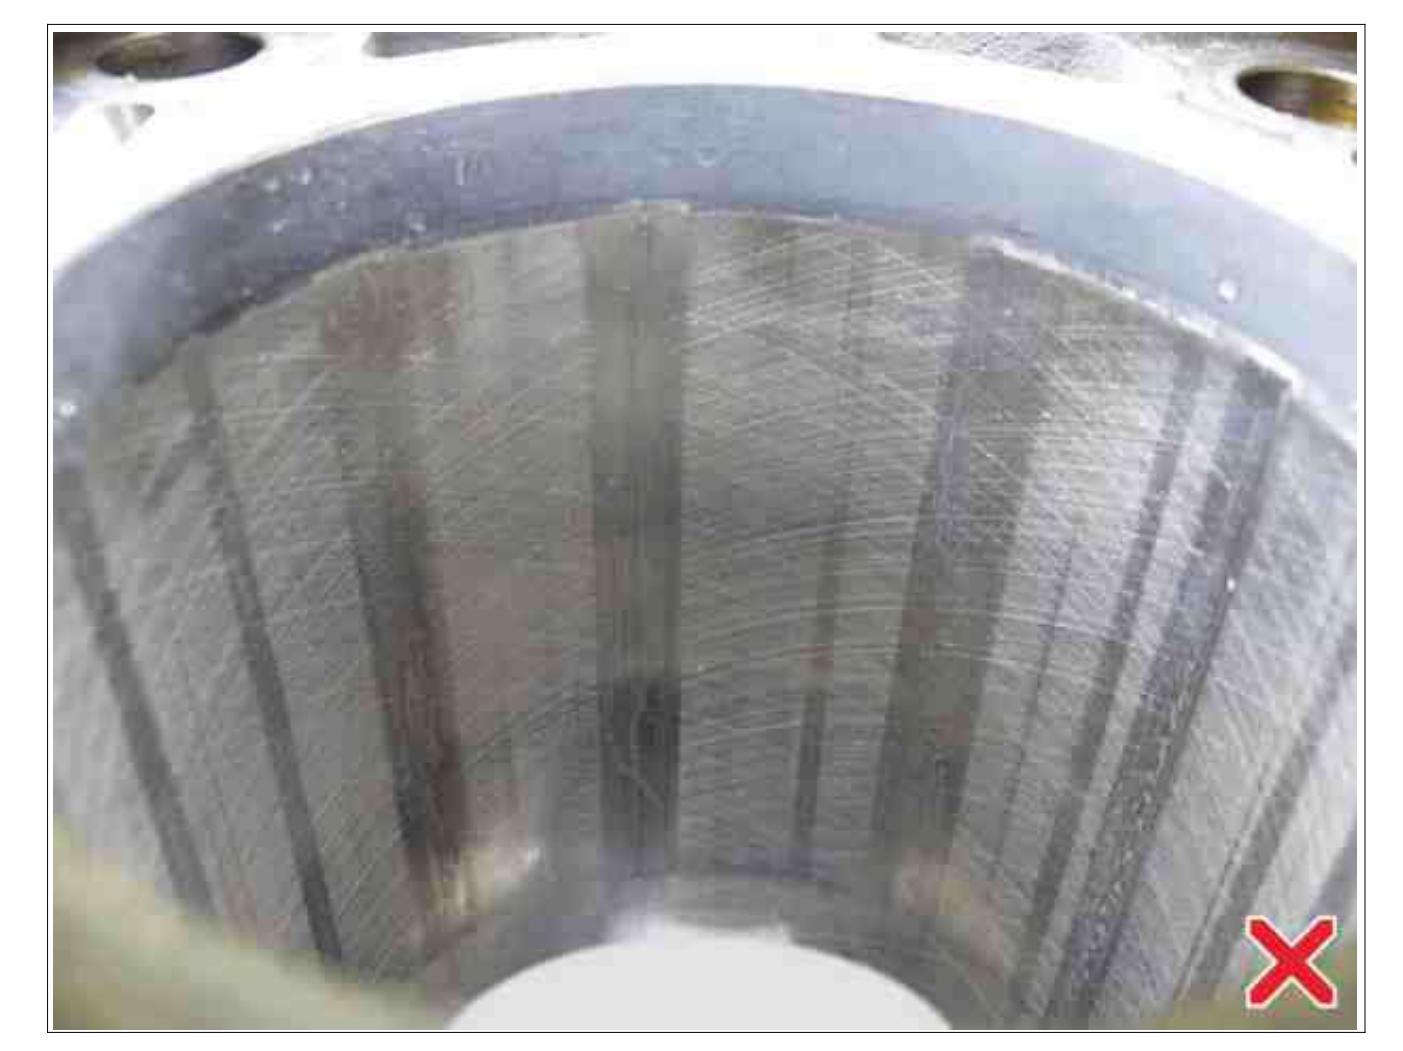
P01.00-A013-76

Rough streaks, friction scoring Starting from first and second piston ring, tapering to an end only in bottom part of cylinder. Progressive signs of friction lead to friction score marks.

Where these signs of friction are perceptible, the cylinder barrel is unusable. The piston rings may be damaged. i Do not use crankcase again.

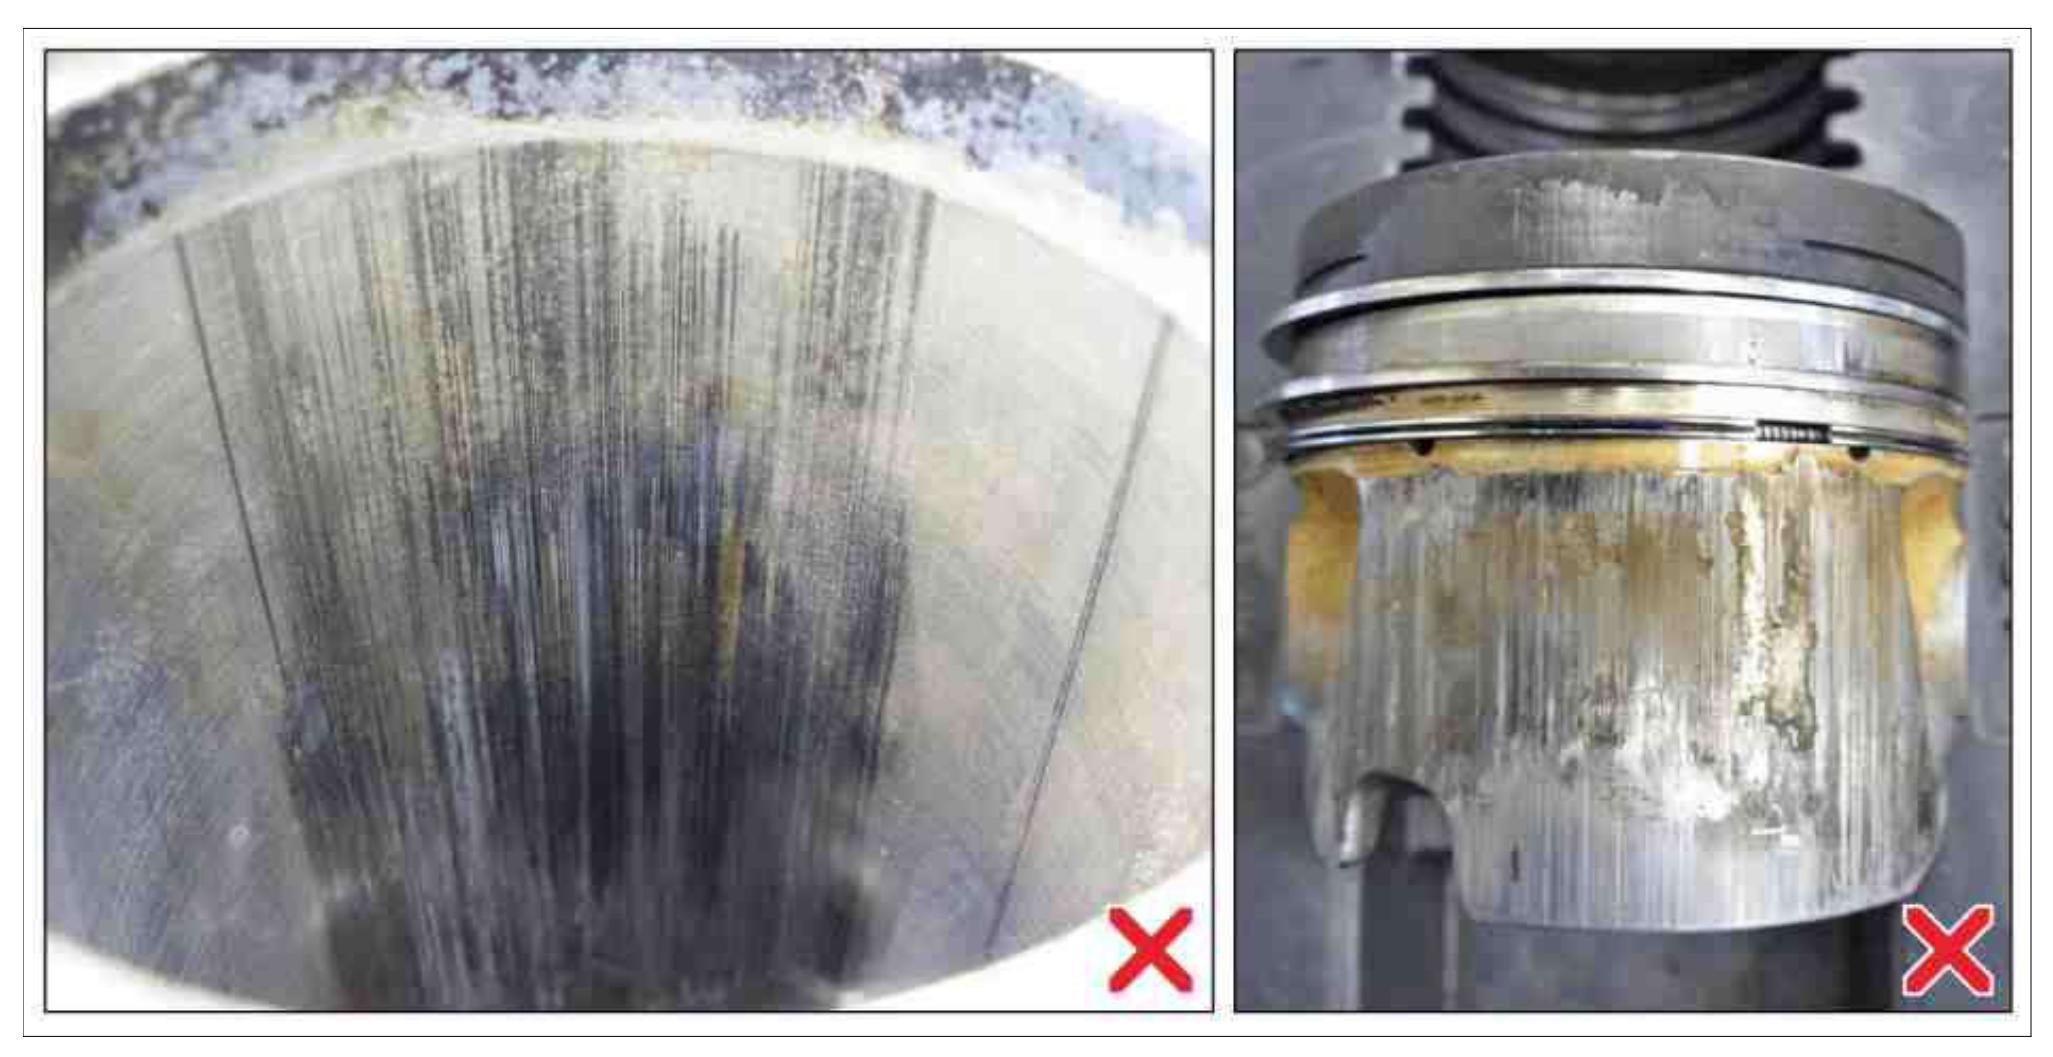
P01.00-A014-79

Piston seizure

Most of cylinder wall perceptibly roughened over the entire length.

Material deposits and perceptible scoring marks on cylinder wall and at piston skirt.

i Do not use crankcase again.
