## 7G-TRONIC (722.9) in the Workshop Tips and Tricks

Service Information Brochure

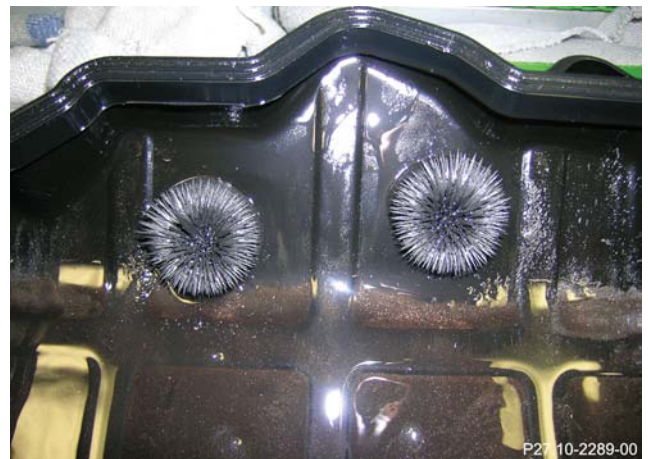
If there is a significant amount of wear debris in the transmission oil pan (see picture), it must be assumed that the torque converter lockup clutch is already seriously damaged.

*Oil pan with significant wear debris*

In this case, it is recommended that the entire transmission including torque converter be replaced because the shavings will have spread out within the transmission. In addition, the oil cooler must be flushed. If an additional oil cooler with thermostat is installed, this must also be replaced because it cannot be flushed (thermostat does not open until temperature of approx. 85 °C is reached).
