Mercedes-Benz

star bulletin

DTB			Date:	April 23, 2009
			Order No.:	S-B-03.30/08i
			Supersedes:	S-B-03.30/08h dated October 24, 2008
			Croups	03
Revision	History		Group.	
Revision	Date	Purpose		
i	4/23/09	Applicable Model	s Updated / Tech	nical Content Revised
h	10/24/08	Damage Code (S	Scenario 2 and 3)	Revised
g	10/20/08	Applicable Model	s (164.172/886) a	and Warranty Information Updated
f	6/26/08	Model 204 & Sce	nario 3 Added, Er	ngine Nos. Added (Scen.2), Model 251.156
		Added, Warra	anty Info. Updated	Ł
е	4/24/08	Op Code (05-721	1 – Scenario 1) R	Removed
d	4/16/08	Damage Code (S	Scenario 2) Revise	ed
С	4/3/08	Parts Information	Corrected	
b	3/28/08	Warranty Informa	tion Corrected	
а	3/26/08	Content Revised	and Warranty Info	ormation Revised
_	8/23/07	Initial issue

SUBJECT	F: Mode Mode Mode Mode Mode Mode Mode Mode	 164.156/172/186 171.454/456 203.052/054/056 204.054/056/081 209.356/372/456 211.056/072/087 216.371/386 219.372 221.171/186 230.471 251.156/165 2ped with M272 of k Engine Light Or 	/871/886 /087/092 /987 /472 /090/256/287 r M273 Engine n / Fault Codes C	Current and/or Stored in ME-SFI Control
SUBJECT	F: Mode Mode Mode Mode Mode Mode Mode Mode	 164.156/172/186 17

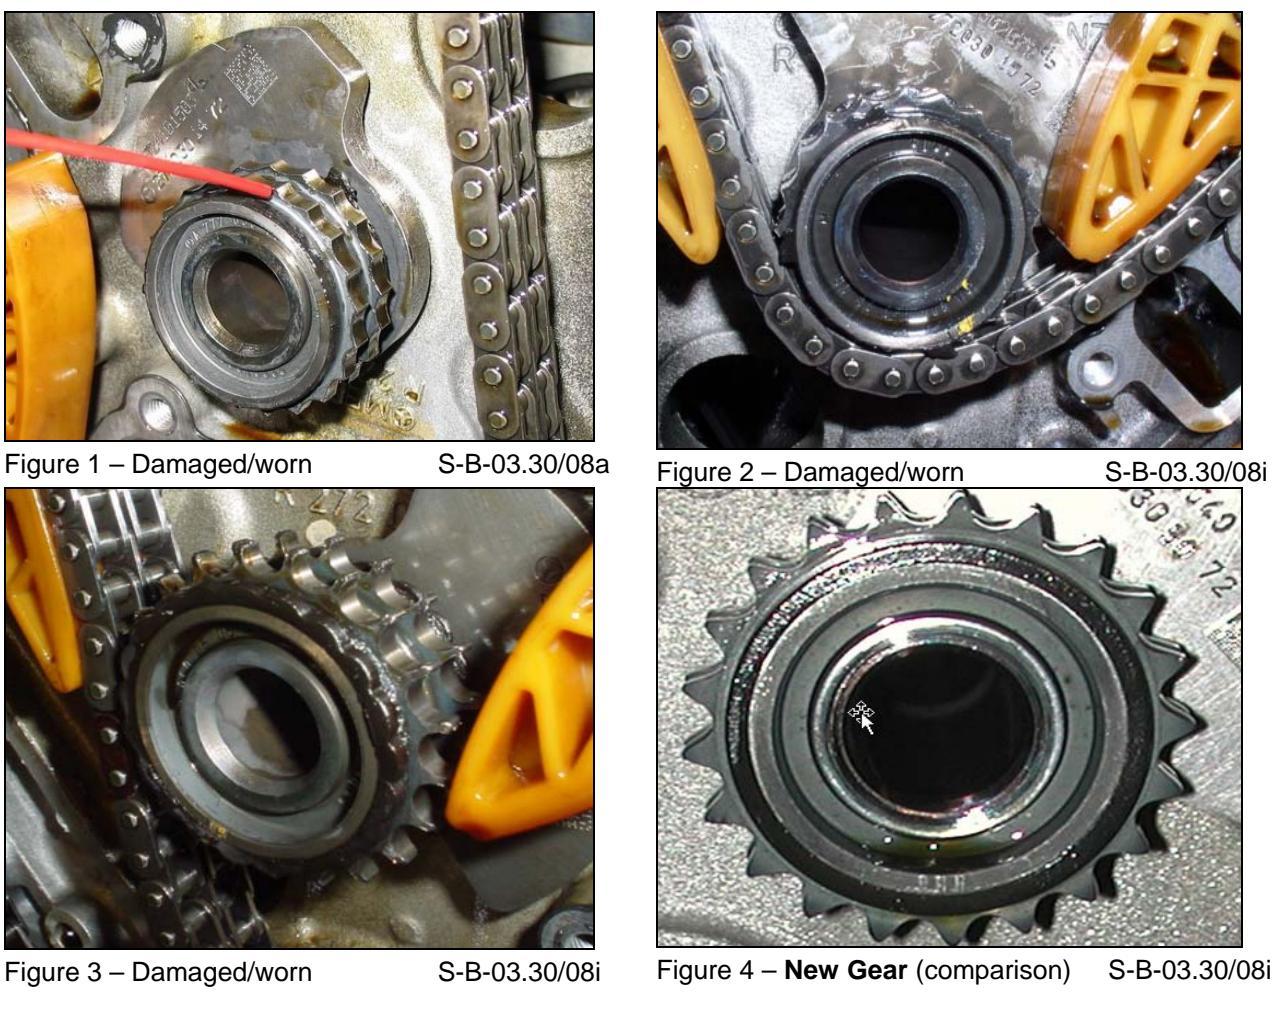
Fault Code Scenario 1: DTC 1200 and/or 1208 is/are present in ME-SFI control module. The fault codes are recorded as current and/or stored in the fault memory. When the fault memory is erased and the engine is restarted, the fault codes reoccur immediately. This is due to the positioning of the timing chain driven camshafts relative to the crankshaft and can be caused by a worn sprocket on the balance shaft on engine M272 or by a worn guide (idler) gear for the timing chain on engine M273. Figure 1, 2 and 3 show extremely worn sprocket gears. Figure 4, for comparison, shows a new sprocket gear.

I Note: Refer to Figure 1 through 3 for examples of damaged / worn sprocket profile. Refer to Figure 4 for example of a new gear (for comparison).

a) Perform a visual inspection for any wear of the teeth (damage profile) on the sprocket of the balance shaft (M272) or of the guide (idler) gear for timing chain (M273) by removing the timing case cover on the engine. Refer to WIS instructions AR01.40-P-8000* (* - applies to a specific model designation e.g. AR01.40-P-8000SX – models 221, 216). Ensure the use of the Special Tool W001 589 81 09 00 when removing / installing timing case cover.

b) Only if worn (sprocket teeth profile damaged), replace the balance shaft on engine M272 or replace the guide (idler) gear of the chain drive on engine M273 as per WIS instructions AR03.20-P-1000* (* - applies to a specific model designation e.g. AR03.20-P-1000VA – model 171).

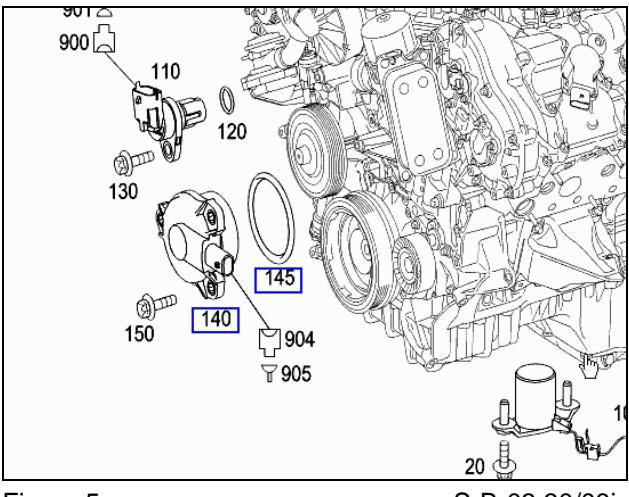
Figure 5

Fault Scenario 3: Camshaft adjustment solenoid is leaking oil, and no Fault Codes are current or stored in the ME Control Module. Determine the cause of the leak. The solenoid can be leaking from under the sealing ring or through the harness connector.

a) If the leak appears to be between the solenoid and the cylinder head replace solenoid sealing ring (Figure 5, 145).

b) If the leak is from the electrical connector, replace the solenoid (Figure 5, 140).
