## **A-Pillar Seal Replacement**

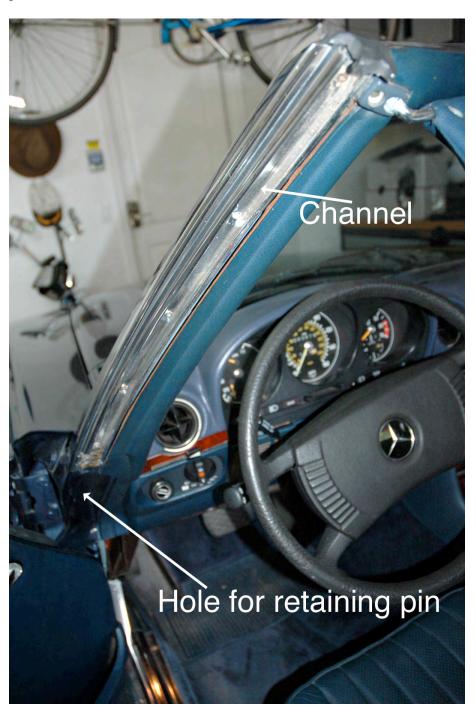
The rearward portion of the "A" pillar seal, against which the window closes, is held in place by grooves in the rubber molding that fit into a channel in the aluminum trim. One simply pulls the old piece out; there may be a "T" shaped nylon retainer at the lower end of the weatherstrip, below the channel. It simply pulls out. There is no need to remove the aluminum channel. Although the weatherstrip is one piece, my old one had long since separated at the top of the pillar.

Finally, push one side of the weatherstrip on the rearward side of the pillar into the aluminum channel shown in the first photo in this document. I found that a screen spline tool was useful for seating the remaining groove in place (it is also invaluable to seating the weatherstrip on the soft top rear bow, when you replace that). Then, push the nylon "T" retainer into the hole below the rear channel, and you're done.

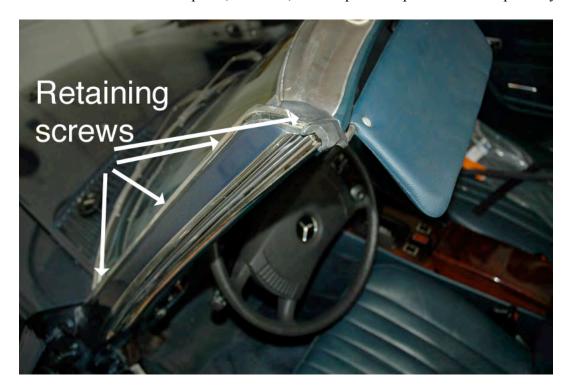
On the forward side of the pillar, a curved, "L" shaped trim piece is held in place by four screws.

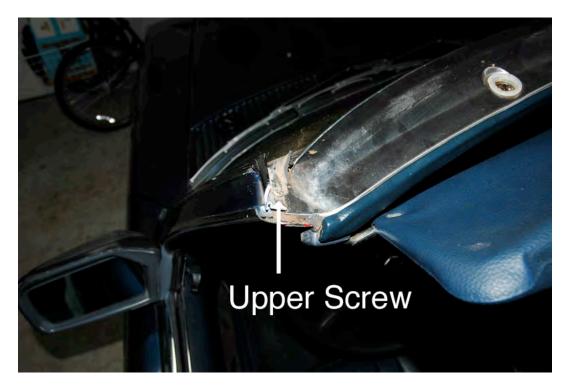
I forcibly tore the uppermost piece of weatherstrip off to reveal the uppermost screw. Once that screw is removed, one may be able to loosen the remaining screws and tilt the trim piece so that it comes off (if you can, this is not necessarily a good thing).

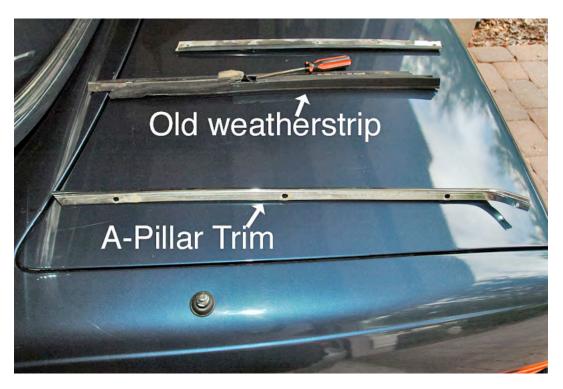
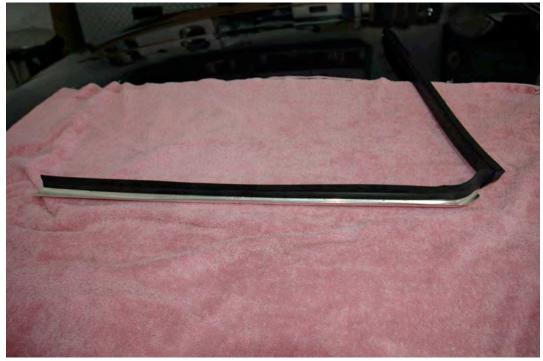
Silly me, I thought that by leaving the screws in place I would be able to slip the front part of the weatherstrip over the trim piece, line up the holes in the rubber and aluminum, and slide the trim back into place, and retighten the screws. Attempting this resulted in 2-1/2 hours of sheer frustration and a very sore back, from bending over the pillar for that time. Below is the aluminum trim piece, followed by the trim positioned in the rubber "pocket" in the front part of the weatherstrip.

The error in this approach is that 1) Despite having OE Mercedes weatherstripping (P/Ns A 107 690 07 97 and A 107 690 08 97), the holes in the rubber did not line up with the holes in the aluminum. 2) The screws were corroded, and the heads were smaller than the holes in the aluminum trim – so that when they were tightened, after much wrestling to keep the rubber slipped over the trim, they pulled through and the trim popped free. I quickly came to realize why folks hate this task.
