Project: Installation of the Dension Gateway 500 for Mercedes Benz C320 2001 with D2B systems (without COMAND).

Summary

5/18/2007

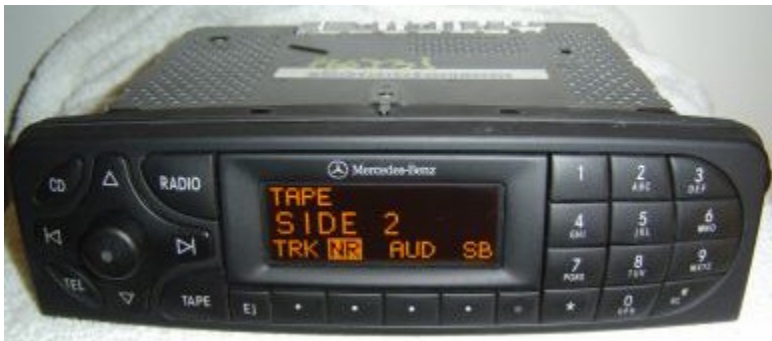
Front of Radio **CM 1010** showing the CD button (upper left) that will be used to access the GW500:

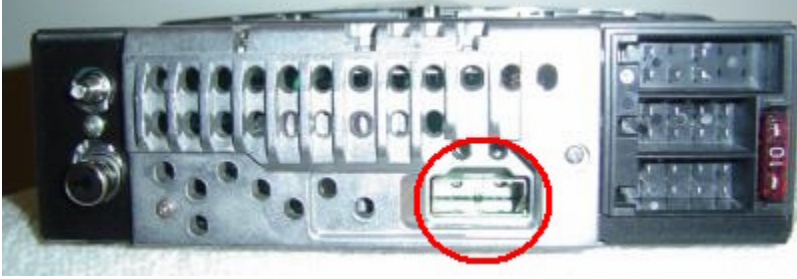
Back of radio **CM 1010** showing the Mercedes Benz Female Optical Connector:

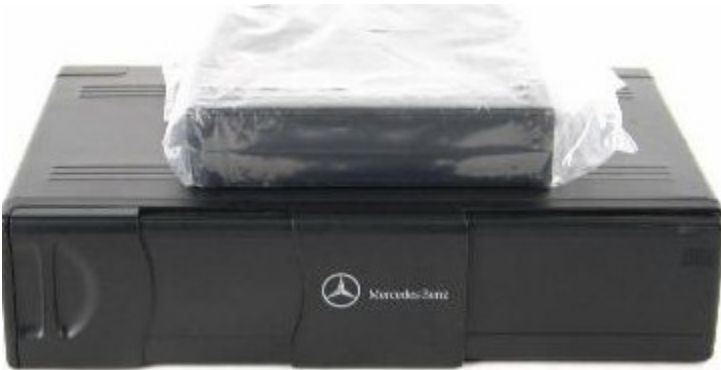
Front of CD Changer MC3010:

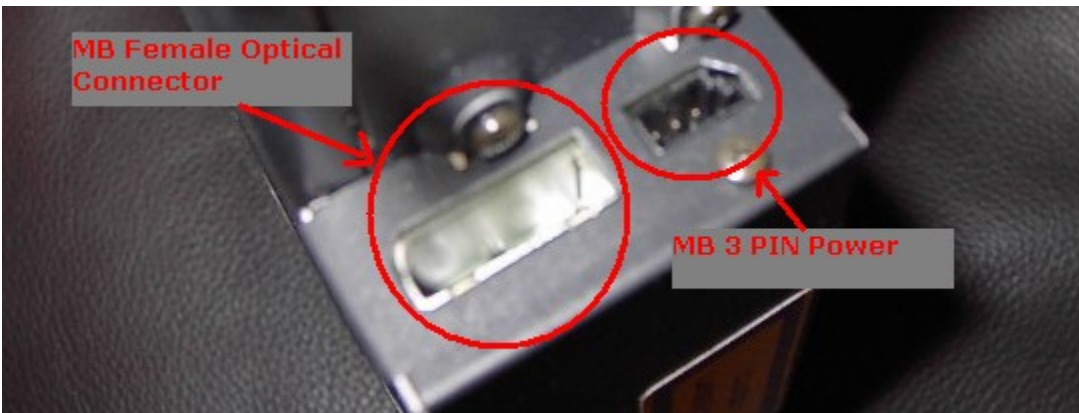
Back of CD Changer MC3010 showing the MB Female Optical Connector and the 3PIN power supply:

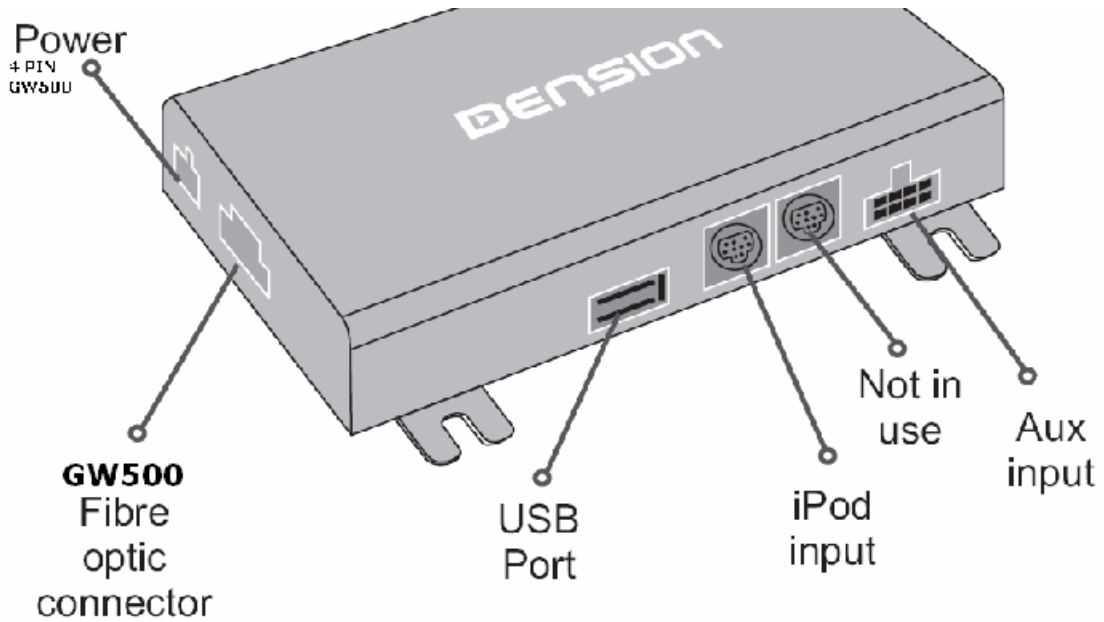
Dension Gateway 500:

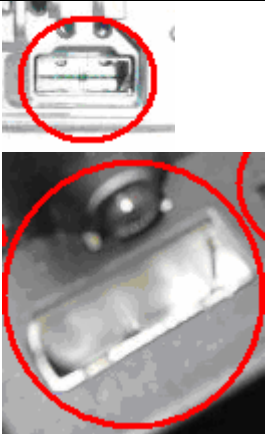
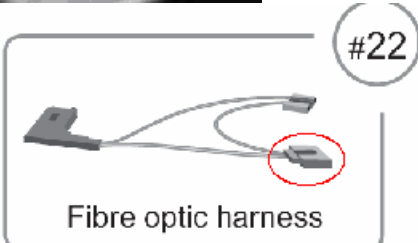
| | Picture | Description |
|--|--|--|
| Mercedes Benz Female Optical Connector | <p>Fibre optic harness</p> | <p>Found on the back of the Radio and back of CD Changer.</p> <p>Also, part of GW500 Harness #22.</p> |

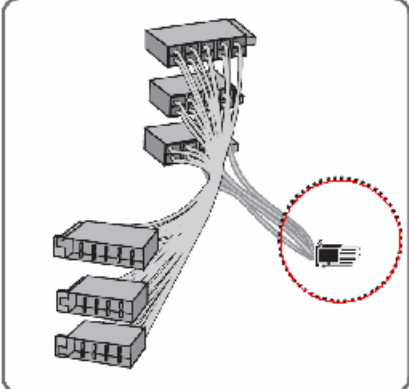
| <p>Gateway 500 Power connector Male / Female</p> | <p>Power</p> <p>1 PIN GW500</p> | <p>Used to supply power to GW500. Has 4 pins: Red: +12V, Black: GND, Blue: +12 V ignition, Purple: wakeup.</p> |

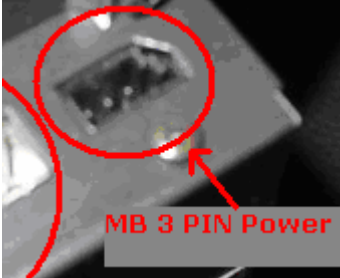
| <p>CD Changer Power Connector Male (not Pictured) and Female.</p> | | <p>Used to supply power to OEM CD Changer. Has 3 pins: Red: +12V, Black: GND, Purple: wakeup</p> |
