COMAND 2.0 Retrofit into a 2002 W203 Coupe: An overview of my installation and my reference material.

This document is my experiences and some of the reference material I used for retrofitting the COMAND 2.0 into my 2002 C-Class Coupe. It should be generally the same for other similar models up through the 2004 ½ model year when Mercedes did the facelift. Just for reference, my 2002 C-Class had the telephone integration, voice control, TeleAid and Bose System.

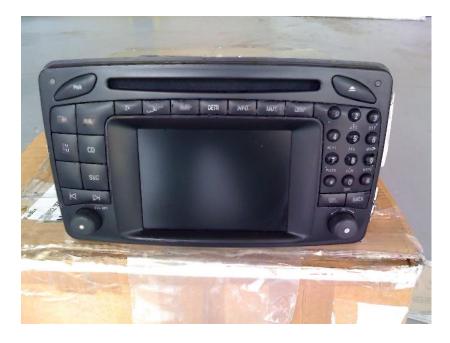
After determining what I wanted to do, I obtained a U.S. Spec COMAND unit. The specific unit I found was from a 2003 vehicle, and had previously had the blank

button enabled for TV and Video In Motion (which might become a future project to enable iPod video).

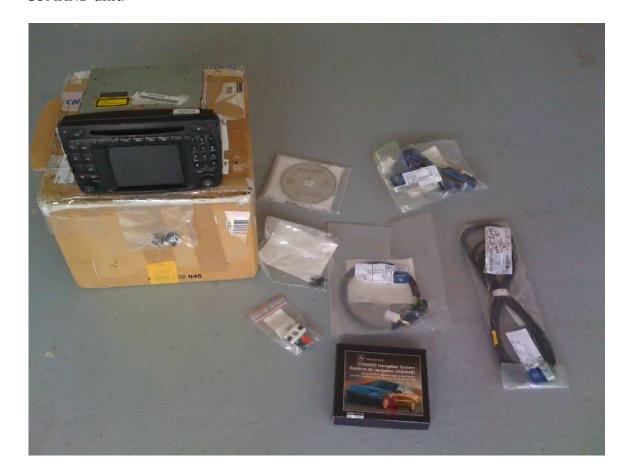
I gathered all my toys for a quick picture. In the picture below, you can see the COMAND (with the original Mercedes box), the replacement knobs just below it, then update CD, the four screws used to hold the COMAND in (yes I bought those too – the factory radio only uses two, and they were cheap). You can also see the red and black ends on the GPS splitter, the factory cabin radio harness, the auxiliary connector cable, the GPS coaxial cable and the Navigation CDs that I got with the COMAND unit.

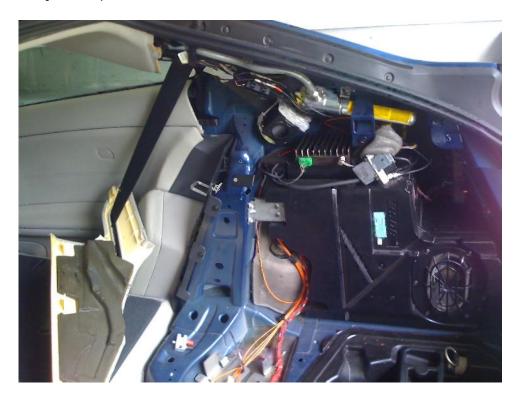
The GPS antenna was on the right rear C-pillar, just below the headliner. Very near where it apparently is on the sedans. You can see it with the red end on the cable in this picture, just above the seatbelt reel.

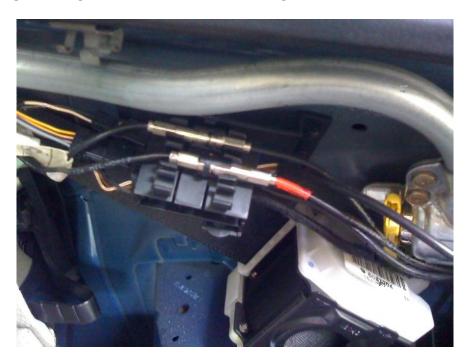
Below you can see a close up of the connector. The cable with the red continues to the TeleAid unit. The GPS splitter will fit in this connection and clip under the black plastic clip. There are holes for it to snap into.

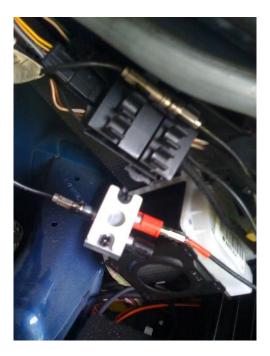
Here you can see the GPS splitter in place with the TeleAid lead attached and lead to the existing antenna attached. In the next picture you can see it with the TeleAid lead attached and with the coaxial cable that goes to the dash attached.

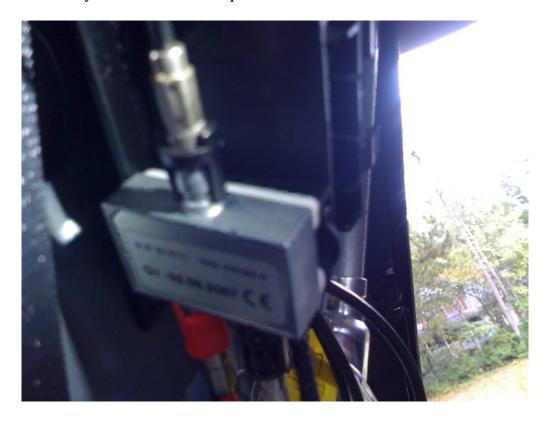
And here you can see the GPS splitter attached to the bracket.

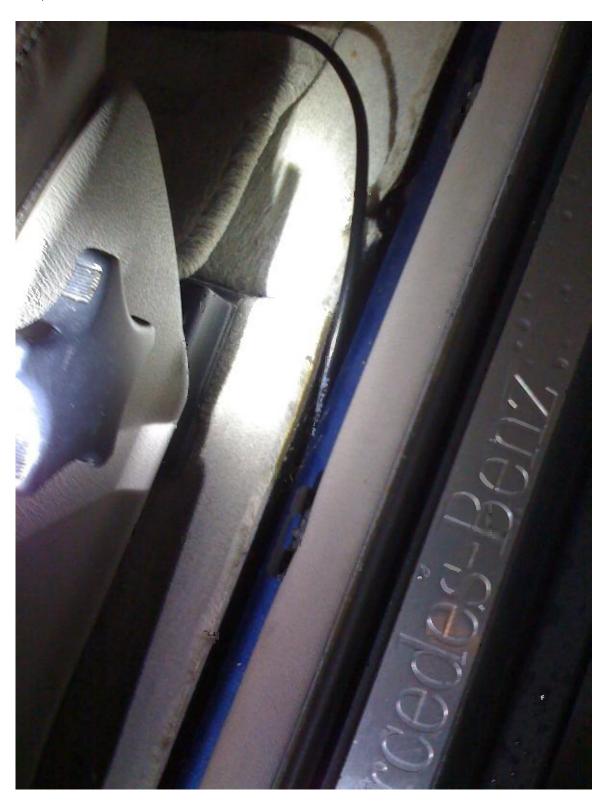
Then you need to feed the coaxial cable to the front, along the passenger side door-sill. Feed it into the wiring channel that already exists and up the passenger side foot well, and across to the dash.

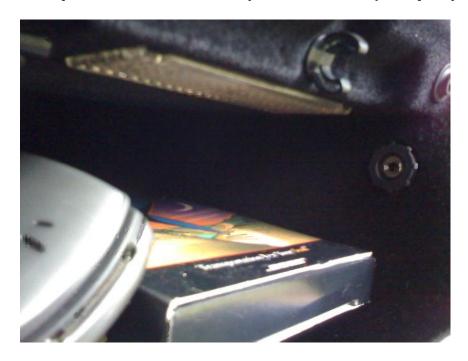
While I was at this point, I installed the Auxiliary input jack in the glove compartment. There is a punch out on the right side of the glove compartment that will accept the plug.

Pop out the circle, slide the plug in (there is a front piece that snaps back around the plug to hold it in place, it makes sense when you look close at it); it is pretty simple.

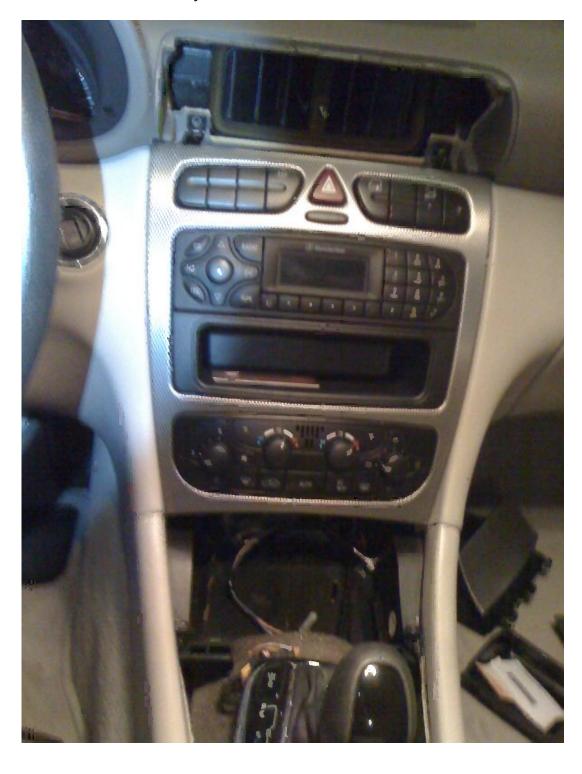
Once the dash vent is removed, you still have to remove the console trim around the gear shifter and the ashtray before you can get the trim around the radio loose. This is when it starts to look scary.

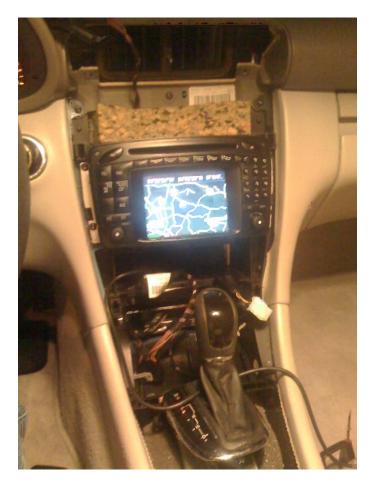
Plugging in the C1 and C2 Connectors, along with the bottom connector (which does not require an adapter), the DB2 (fiber optic) connector, the antenna connections and the auxiliary input cable and I was ready to power it up for the first time in the car. Still looking pretty scary here....

Unfortunately, this is where I ran into a problem. With the COMAND unit not mounted in the dash, just partway out, it would recognize the CD changer and Voice Control. Pushed back in the dash it would not recognize either one. I also learned that it was not getting the speed or direction (gear) signal. My car got driven like this for a day or so.

After a day of fiddling, I was sure that the COMAND was not getting the CAN signal, but checking my connections on the adapter harness just showed everything was working fine. I almost gave up and decided that the COMAND unit was bad, but after sleeping on it for another night (and driving it like this for another day) I plugged the C-2 Connector in without the outer shell attached. I didn't take pictures of this,

but essentially what I did was connect each pin connector without the connector at all, and everything worked, so then I put the connector back together part at a time. I finally figured out that the C2 connector was not seated well when it clicked in place, so after making sure it was seated well, I tried it again and everything worked find. Moral of the story: Make sure the connections are good. ©

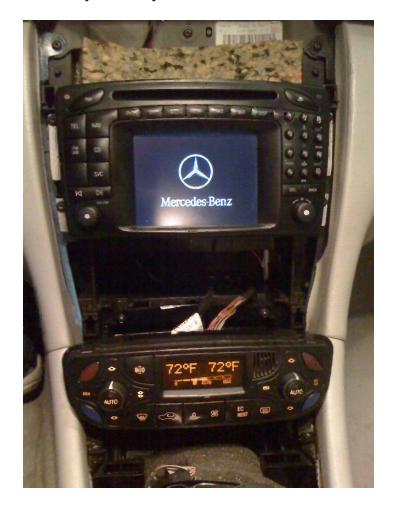
I added the digital climate controls and was ready for the first road check. Not quite as scary, but still not how you want your car to look.

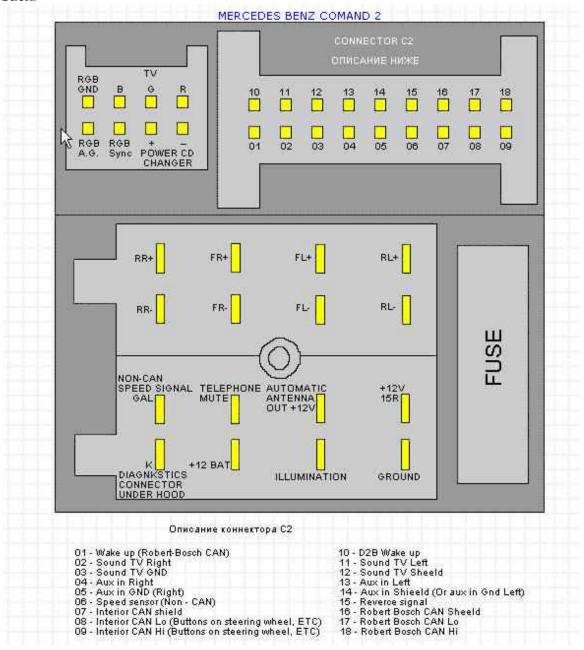
Below is a nice picture of the pin-outs for the W203 COMAND 2.0 units. I am pretty sure that some of the others are different, so check with someone like www.Audiocomp.de to make sure of the pin-outs for units for other cars. I am not sure who originally did this nice drawing, but someone emailed to me quite a while back.
