Date: March 24, 2006
 Order No.: P-B-27.55/50f
 Supersedes: P-B-27.55/50e dated March 6, 2006
 Group: 27

SUBJECT: Model 203.040/061/064/065/081/084/261/264/281/284/740/747/764
Model 209.365/375/376/465/475
Model 211.065/070/076/083/265/283
Up to Production Date 09/2003
Harsh Engagement Possibly Followed by Droning/Buzzing Noises During Light
Acceleration Between Engine Speed of 1200 – 2500 RPM

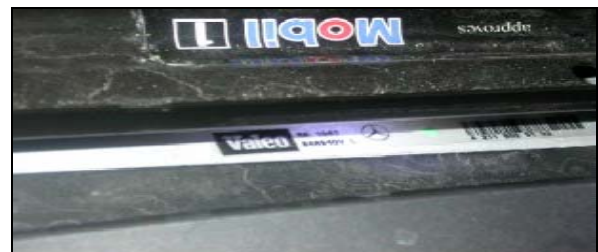
- a. the vehicle was produced before 09/2003,
- b. the radiator is manufactured by “Valeo”, refer to Figure 1 for identification,
- c. old crimping method used to assemble the radiator end tanks resembles Figure 2.
