**DTB**

Date: June 4, 2009  
 Order No.: S-B-83.30/74p  
 Supersedes: S-B-83.30/74o dated April 29, 2009  
 Group: 83

**SUBJECT: All Model 164, 171, 203, 204, 209, 211, 215, 216, 219, 220, 221, 230 and 251 Vehicles  
 Air Conditioning Musty/Moldy Odor Complaints**

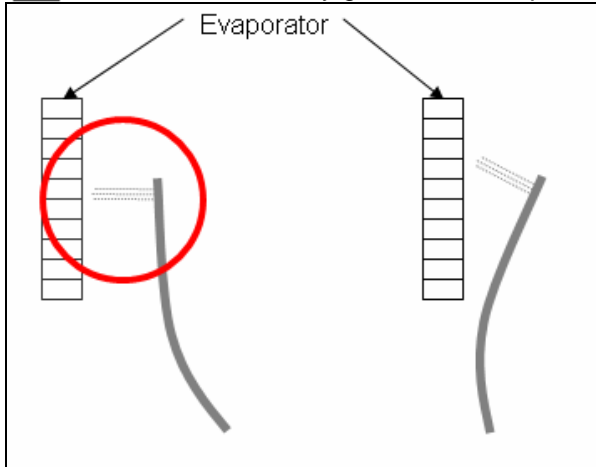
- Spray the evaporator in a 90° angle.
- Move up and down, left and right to reach all areas of the evaporator
- Do not rotate the probe to reach other areas of the evaporator. This will change the spraying angle and the cleaning effect will diminish.

1. Remove all filters installed in the air conditioning system. The following filter may be fitted: Pollen filter, dust filter, combination filter or active charcoal filter.
2. Clean evaporator with Mercedes-Benz Contra Sept as per WIS document AR83.30-P-5555T. Contra Sept is applied using a spray gun attached to a long probe. It is imperative to have as much of the evaporator sprayed with the cleaner by moving the probe in / out and up / down inside the case. It may be necessary to bend the probe in order to gain access. The cleaner is applied and allowed to dry. Refer to Figure 1a for spraying angle recommendation.

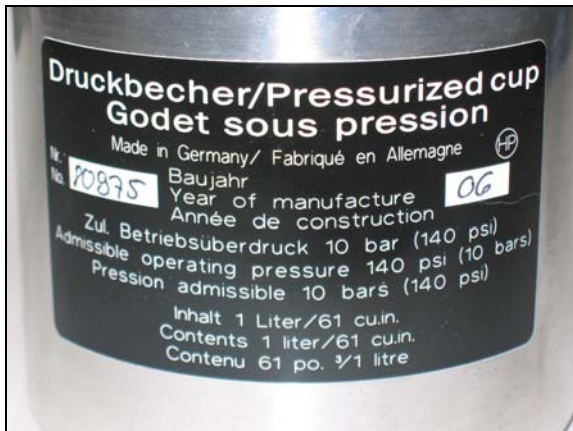
Figure 1b

**Warning!** Do not exceed the manufacturer's recommended maximum air pressure as stated on the label affixed to the pressure cup (Figure 1b). Excessive air pressure could cause the canister to explode and potentially cause personal injury. The recommended pressure to clean the evaporator effectively is 120psi.

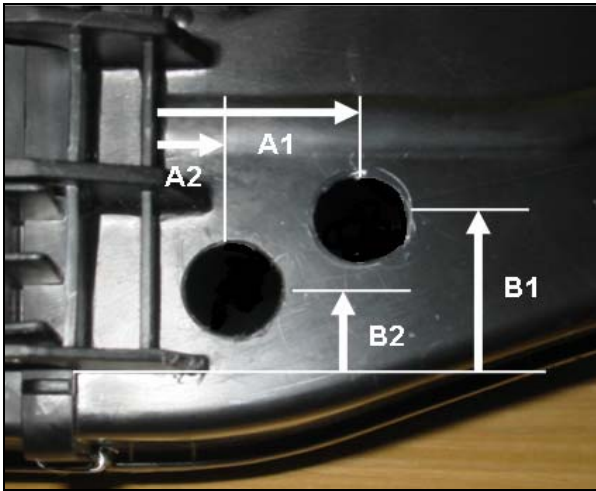
Figure 1 P-B-83.30/74h  
Without foam block as in WIS AR83.30-P-5555-01A  
Dimension A1 = 30 mm  
Dimension B1 = 25 mm  
With foam block  
Dimension A2 = 10 mm  
Dimension B2 = 15 mm

1. Equipped with ACC climate system Option Code 580 - It is necessary to drill a 15mm hole in the

climate housing to access the evaporator with the spray probe. The location for drilling the hole is described in WIS document AR83.30-P-5555-01A and Figure 1, A1 and B1.

2. A white foam block may be mounted to the housing between the blower motor and the main section of the case, see (Figure 2). On these housings, there is an alternate location of the hole as shown in Figure 1, A2 and B2.

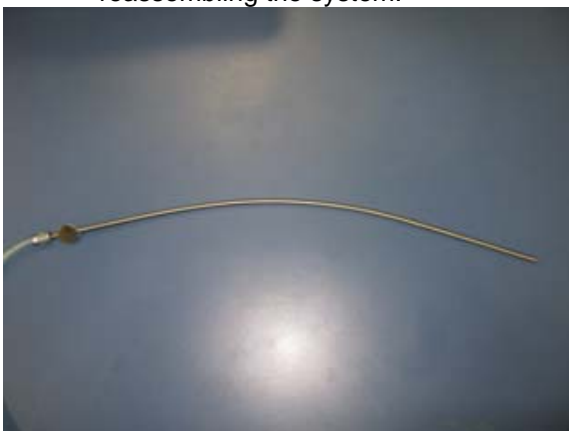
3. Bend the shorter of the two probes (Figure 3). Move the probe up and down as well as side to side to ensure the entire evaporator is sprayed with the cleaner. Plug hole after cleaning with seal plug A110 987 10 44 64.

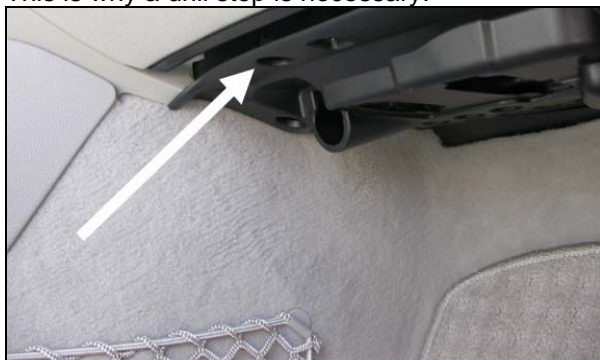
Figure 4

5. Location of hole is shown in Figures 4 and 5. The hole should be centered in the triangular shaped section of the climate housing as shown in Figure 5.

6. Drill a 15mm hole in small increments using a mechanical drill stop to limit how far the drill bit penetrates the climate housing. A collar type drill stop, a piece of rubber hose or tape can be used as the drill stop.

**!** **Warning!** The drill bit cannot be allowed to penetrate the housing more than 13mm or damage to the evaporator could occur. When the drill bit breaks through the housing it has a tendency to pull inward. This is why a drill stop is necessary.
