Remove and replace trunk/boot soft-close motor - Mercedes-Benz W205 (2014-2021)

This guide is for the W205, but many other models use this same motor
(<https://www.autohausaz.com/pn/MB-2047500060>)

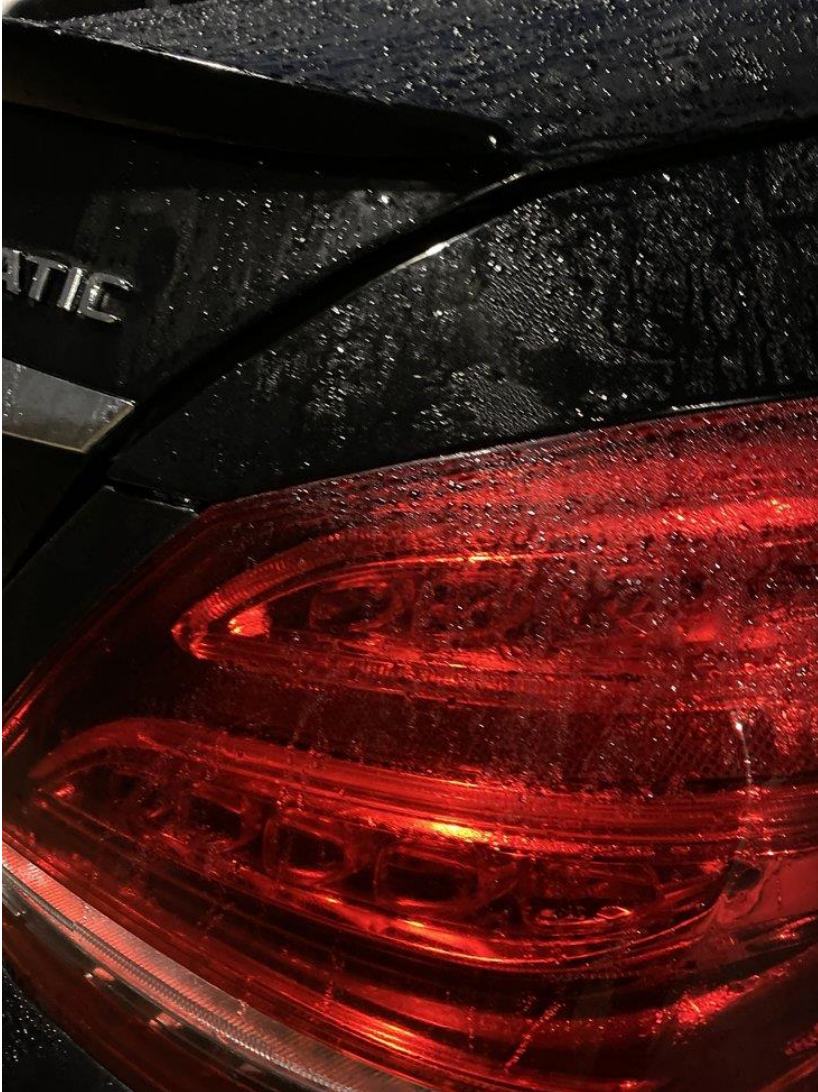
The issue. Power assist trunk / boot does not fully shut, leaving this unsightly gap:

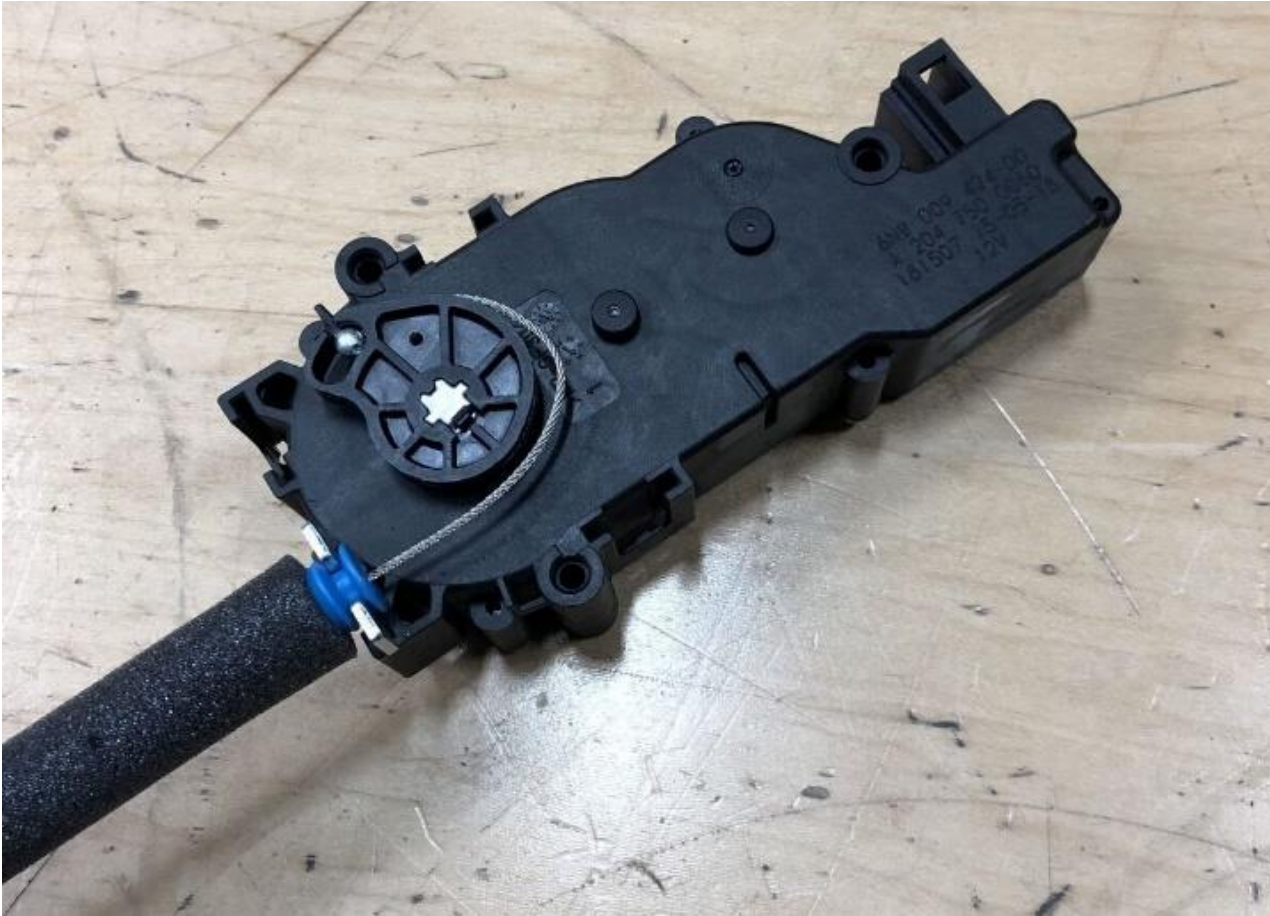
The likely culprit. This motor is engaged when the trunk/boot lid has finished closing, and pulls it fully shut:

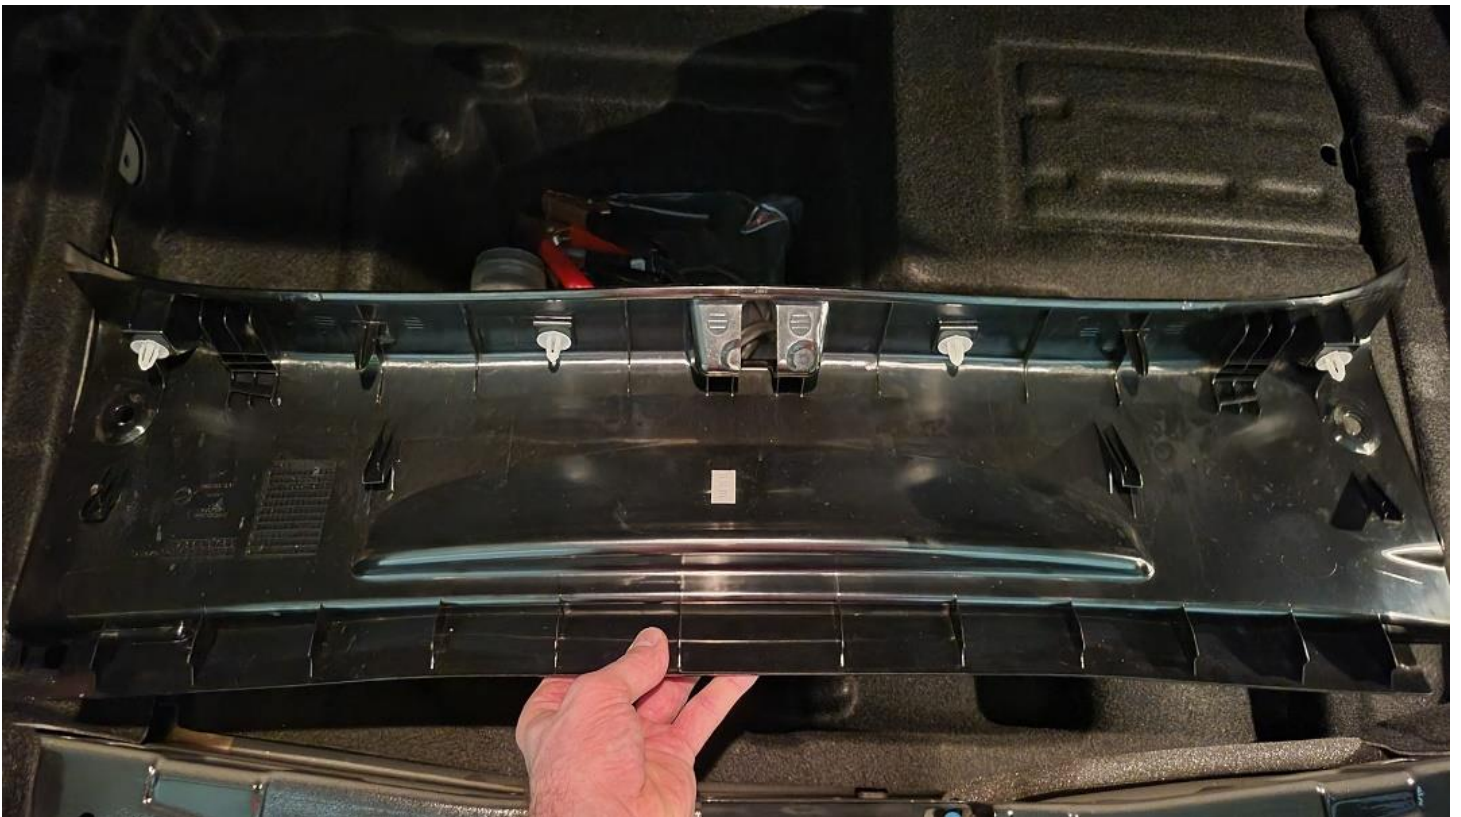
b) Once the 2 black rivets are out, pull up hard on the trunk piece and it will pop out. There are 4 white rivets that hold it down.

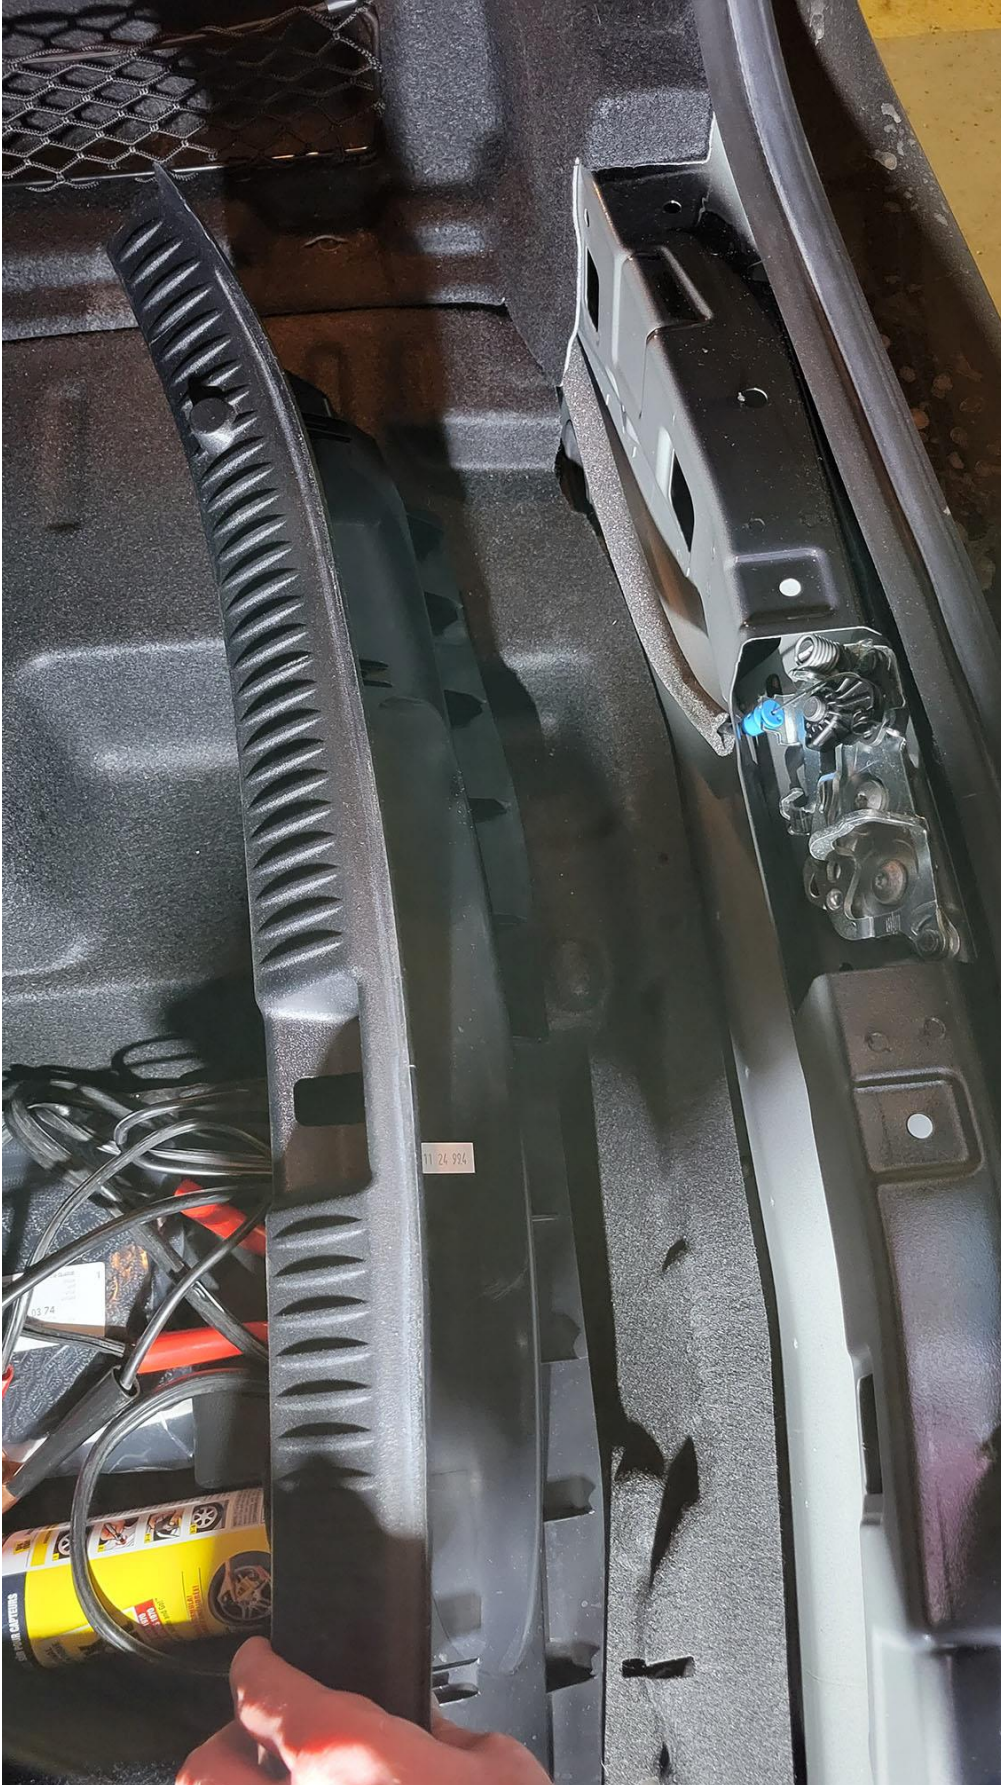
Now you can see the mechanism that gets pulled by this wire encased in foam. The wire leads to the failed component that we'll be replacing.

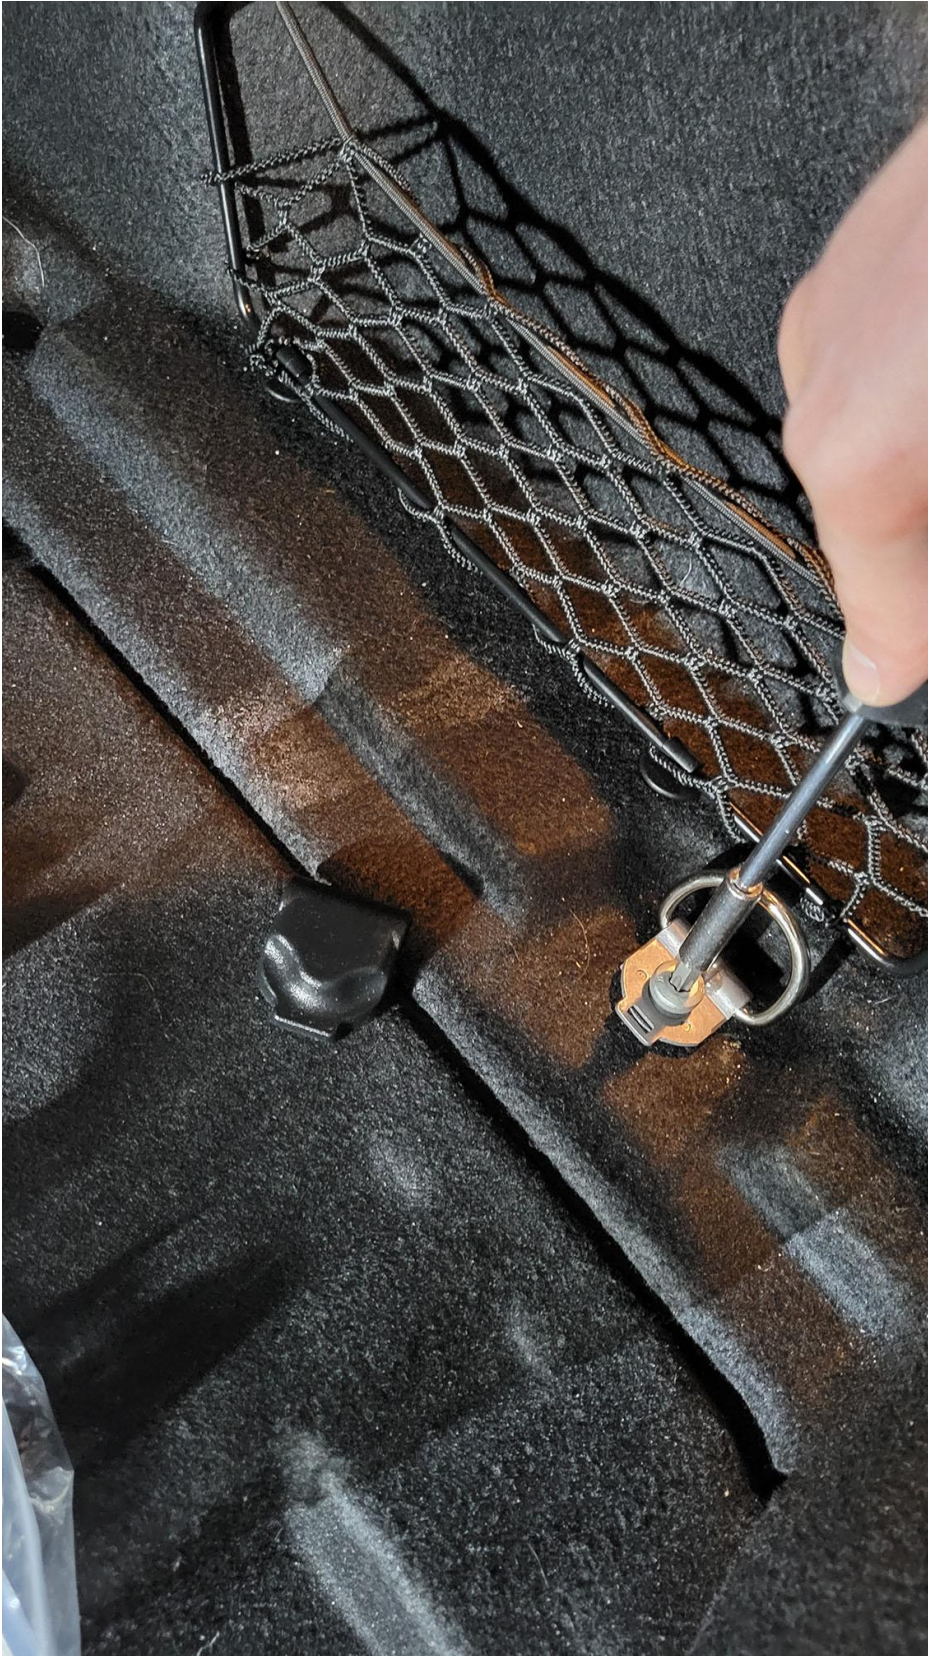
a) Remove the tie-down latch with torx screwdriver (plastic top easily pops off)

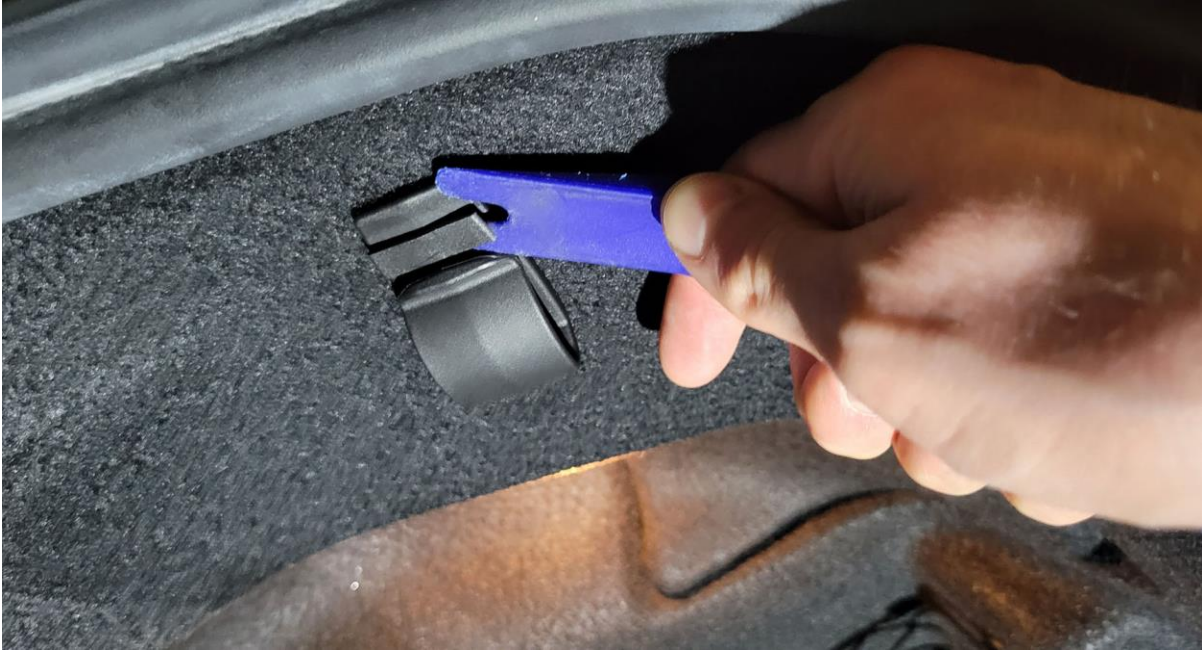
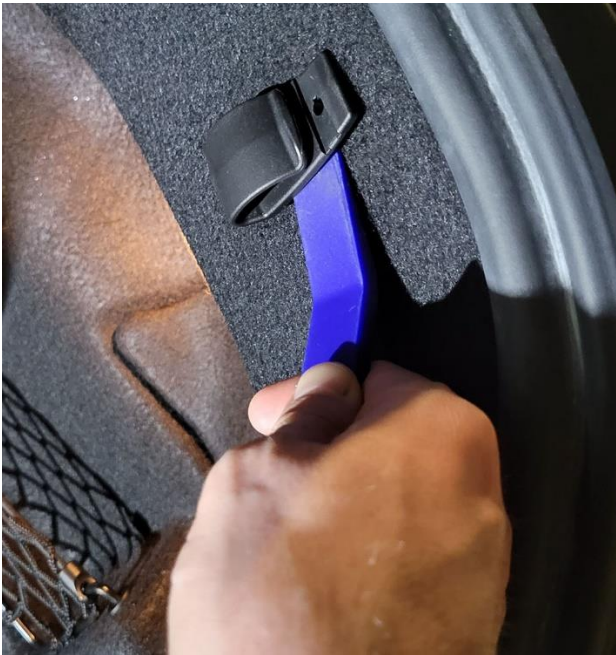
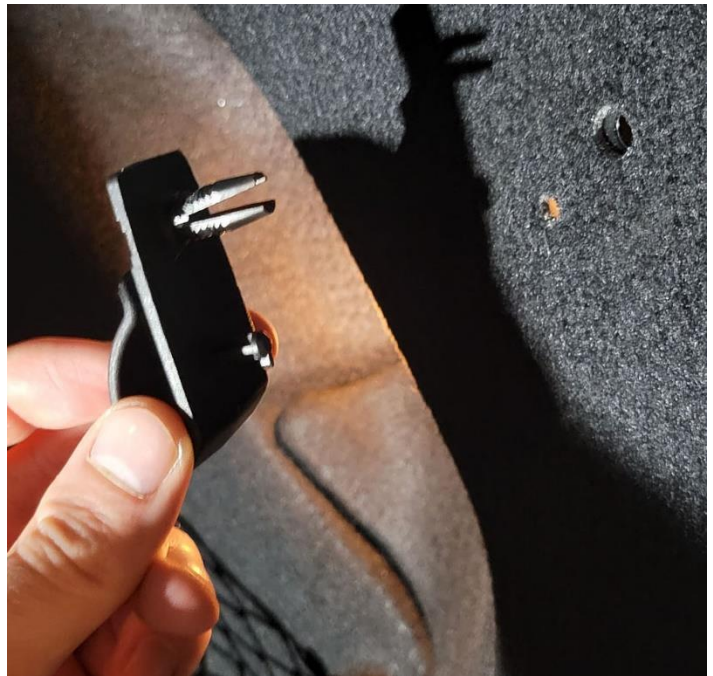
b) Remove plastic hanger/fastener

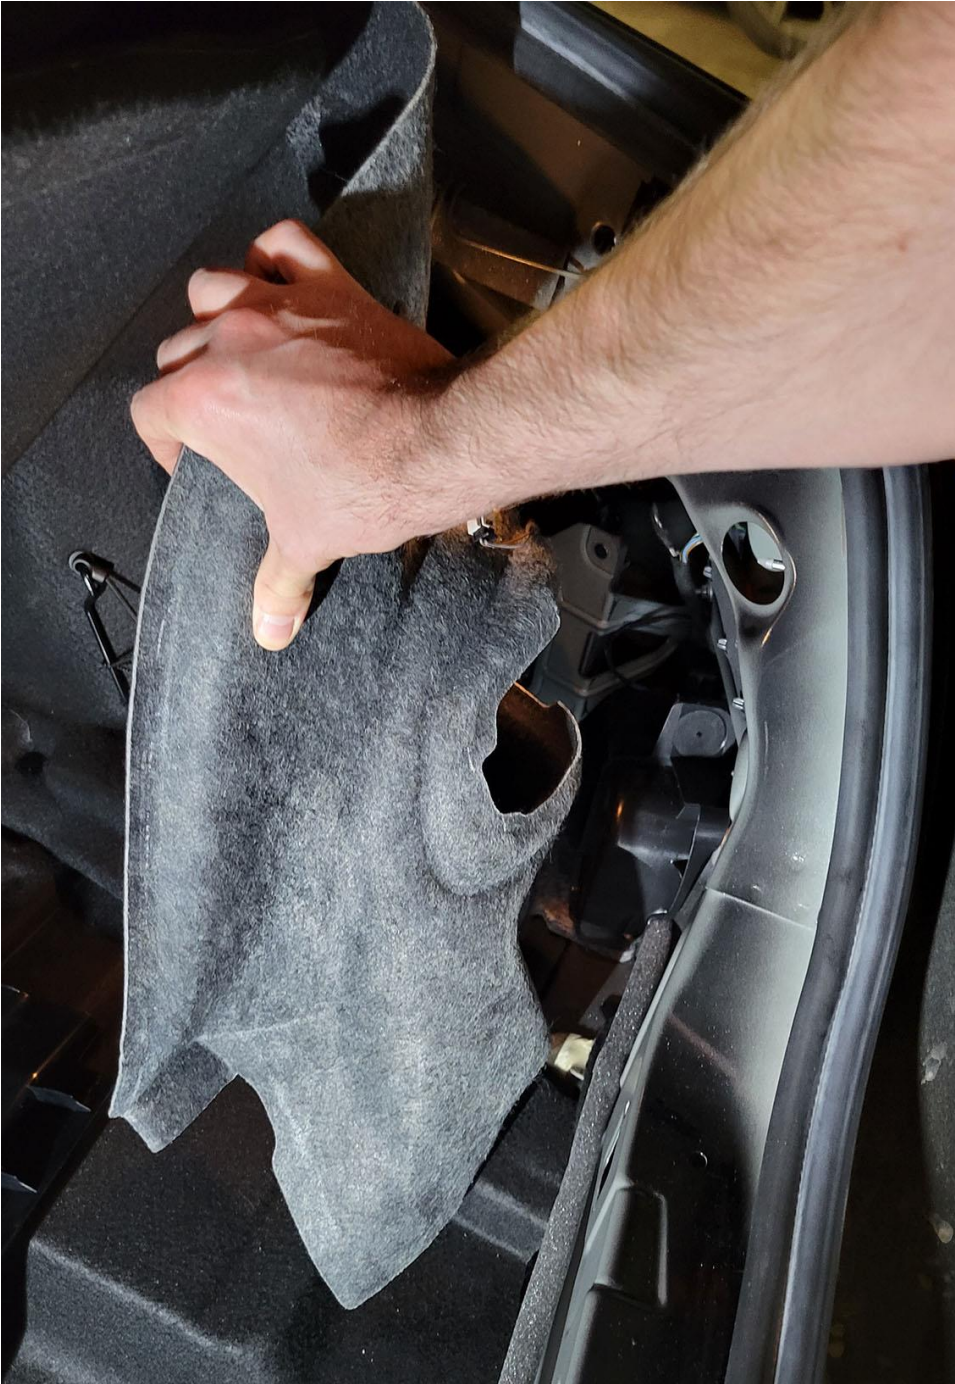
c) Pull back on trim to reveal motor unit. You may have to use a trim removal tool to pry it free.

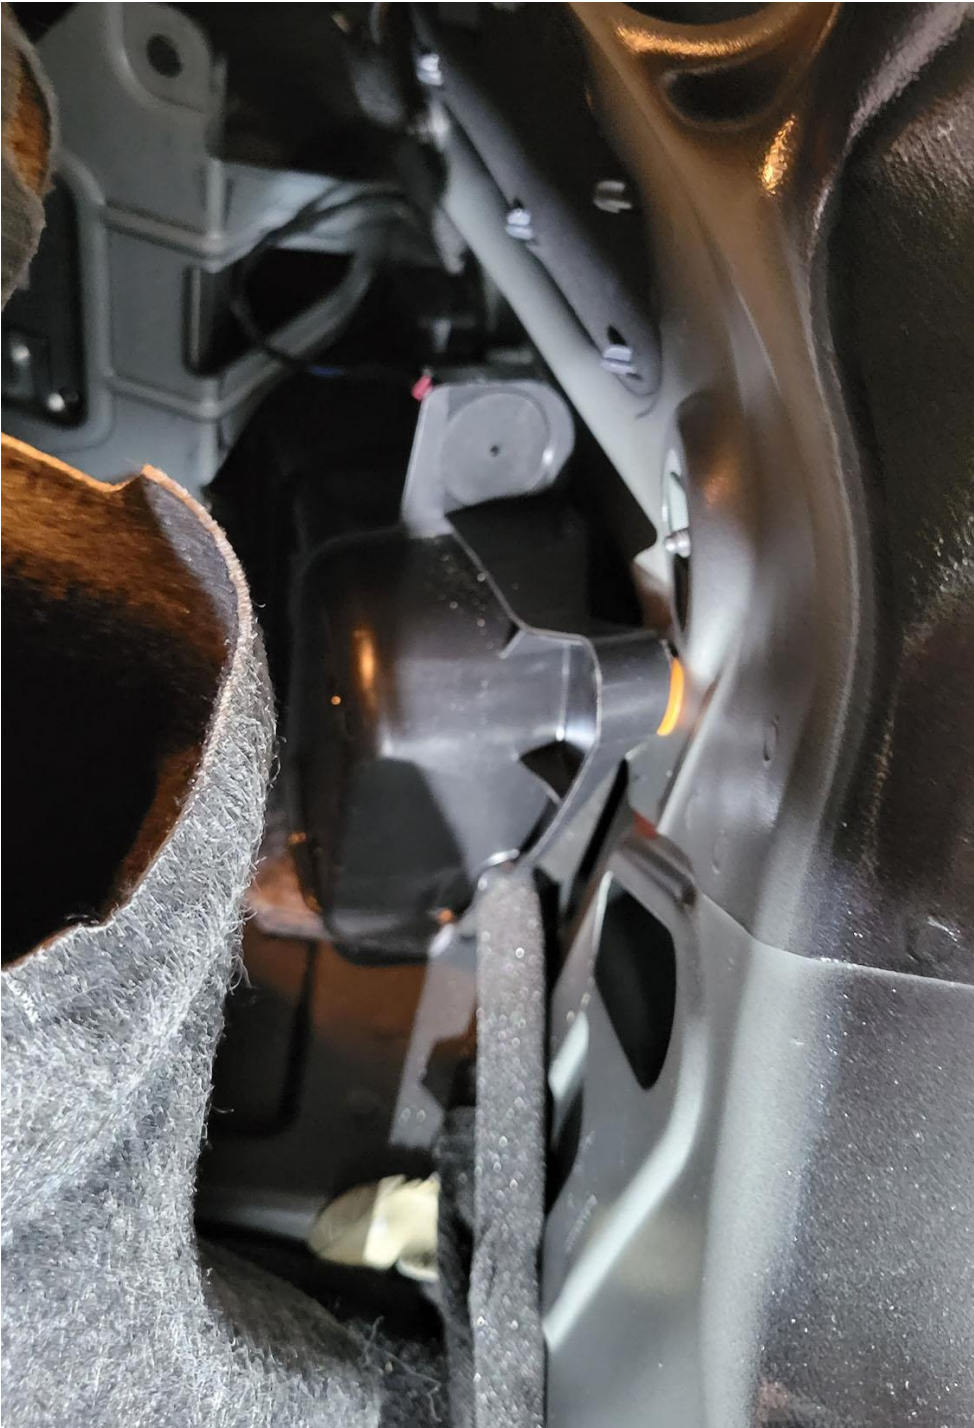
a) The motor unit is in a foam enclosure held on by an orange rivet, you should be able to pull up on the unit and it will release from the orange rivet. Then you can pry out the orange rivet with a trim removal tool.

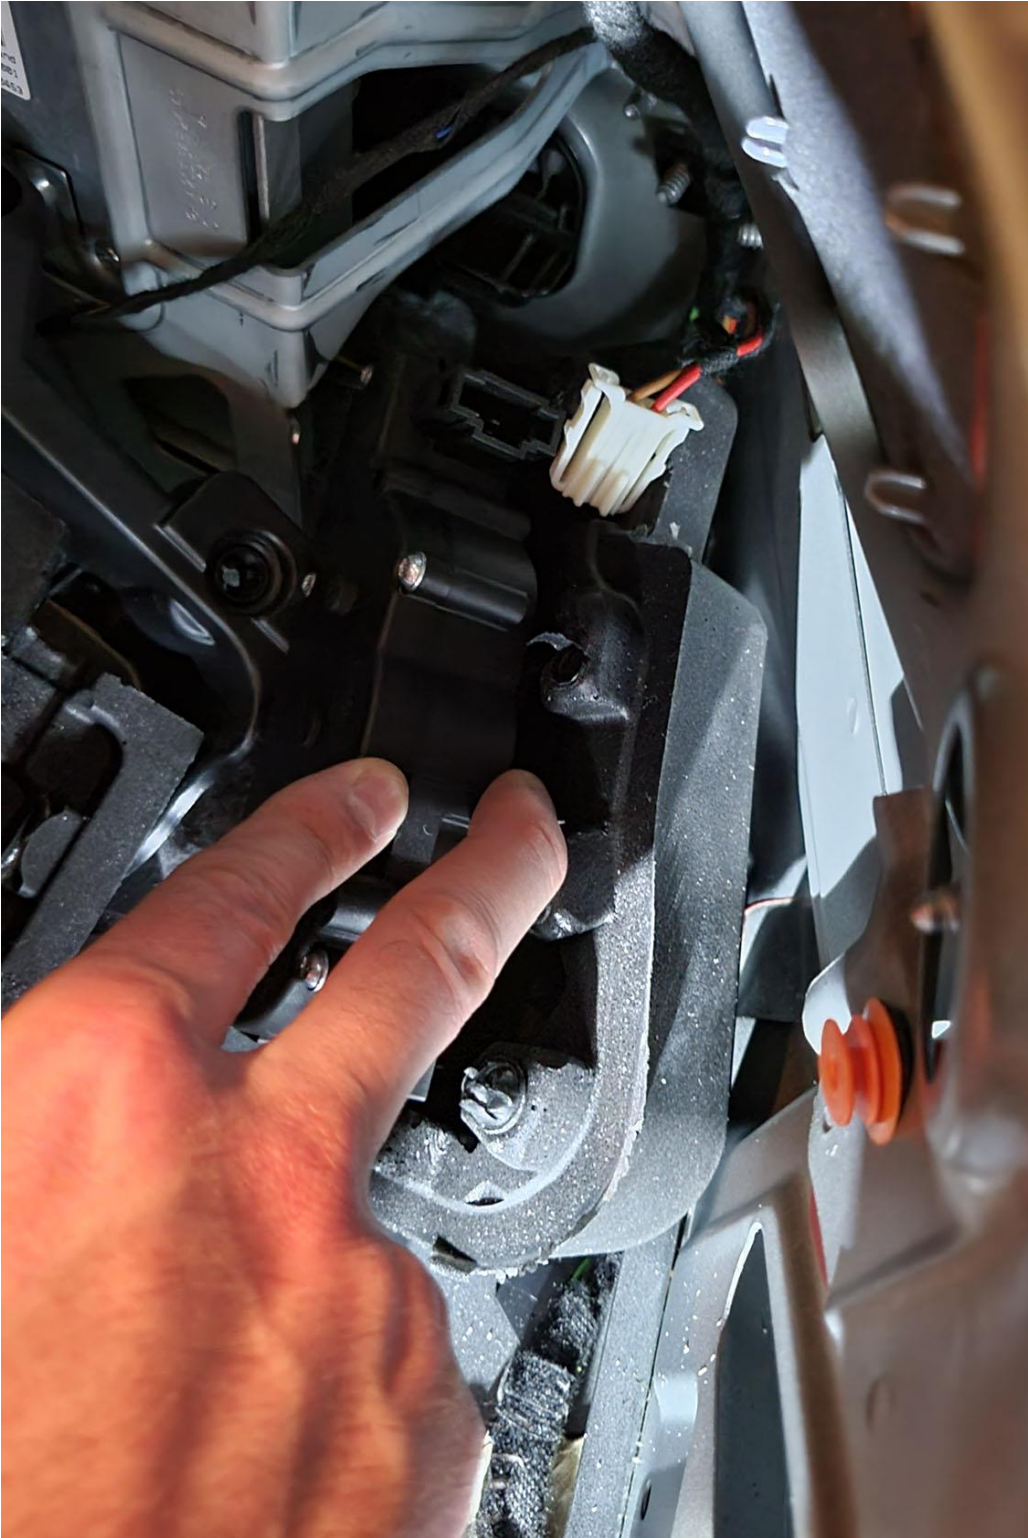
b) Disconnect the power cable.

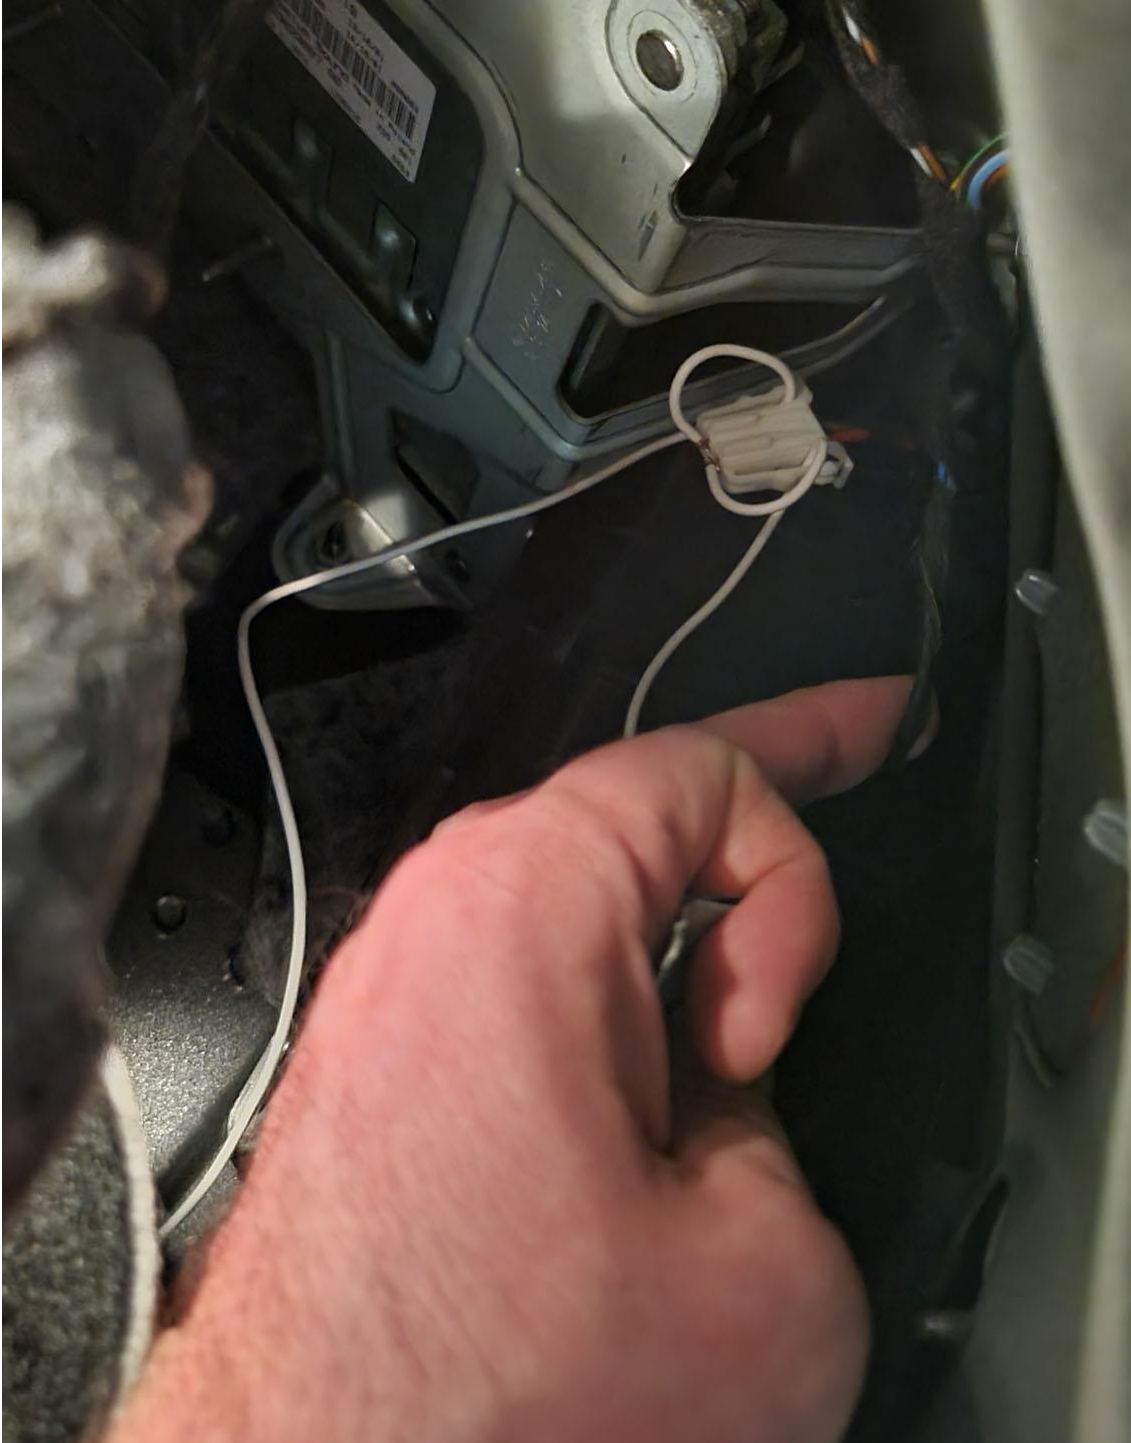
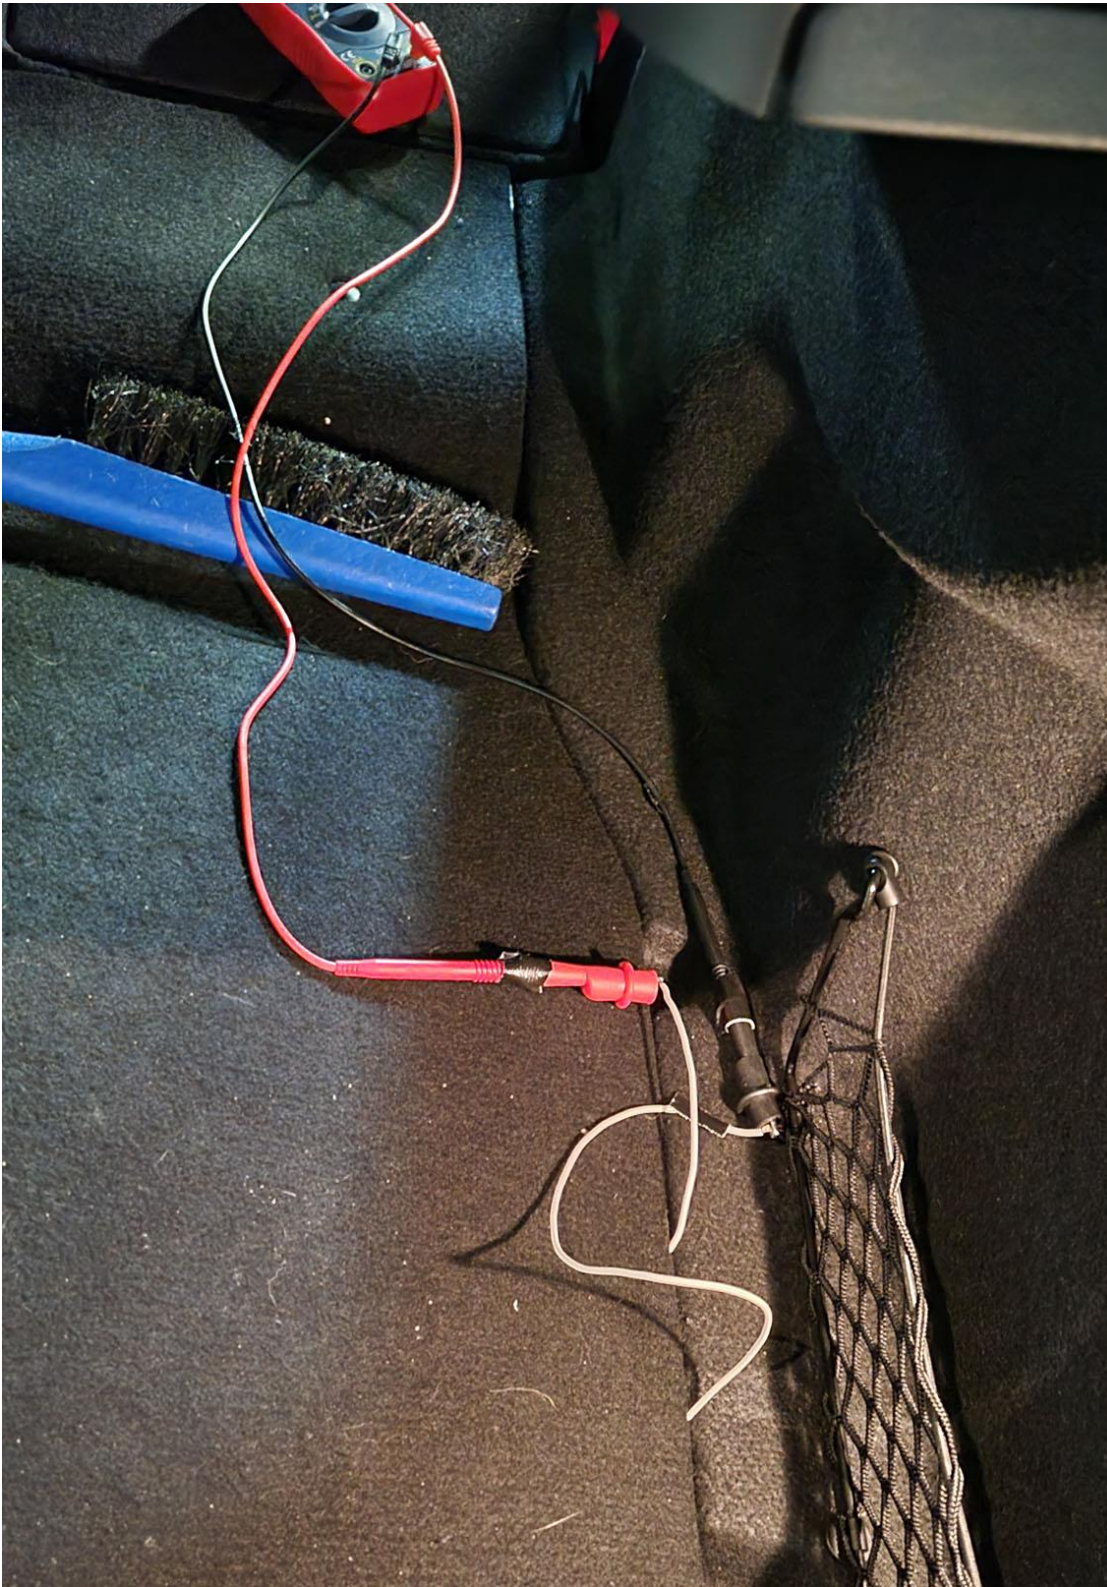
d) I'll be running some wire from the power cable to my multimeter, so I can read the multimeter from the back seat while the trunk closes. I connected some wire as shown to the trunk motor's power source, and ran it to my multimeter.

e) As the trunk closes, watch for the multimeter to show 12 volts. This means the soft-close motor is getting power to perform the soft-close. Now we know it must be a faulty motor, assuming the cable running to the latch is attached properly.

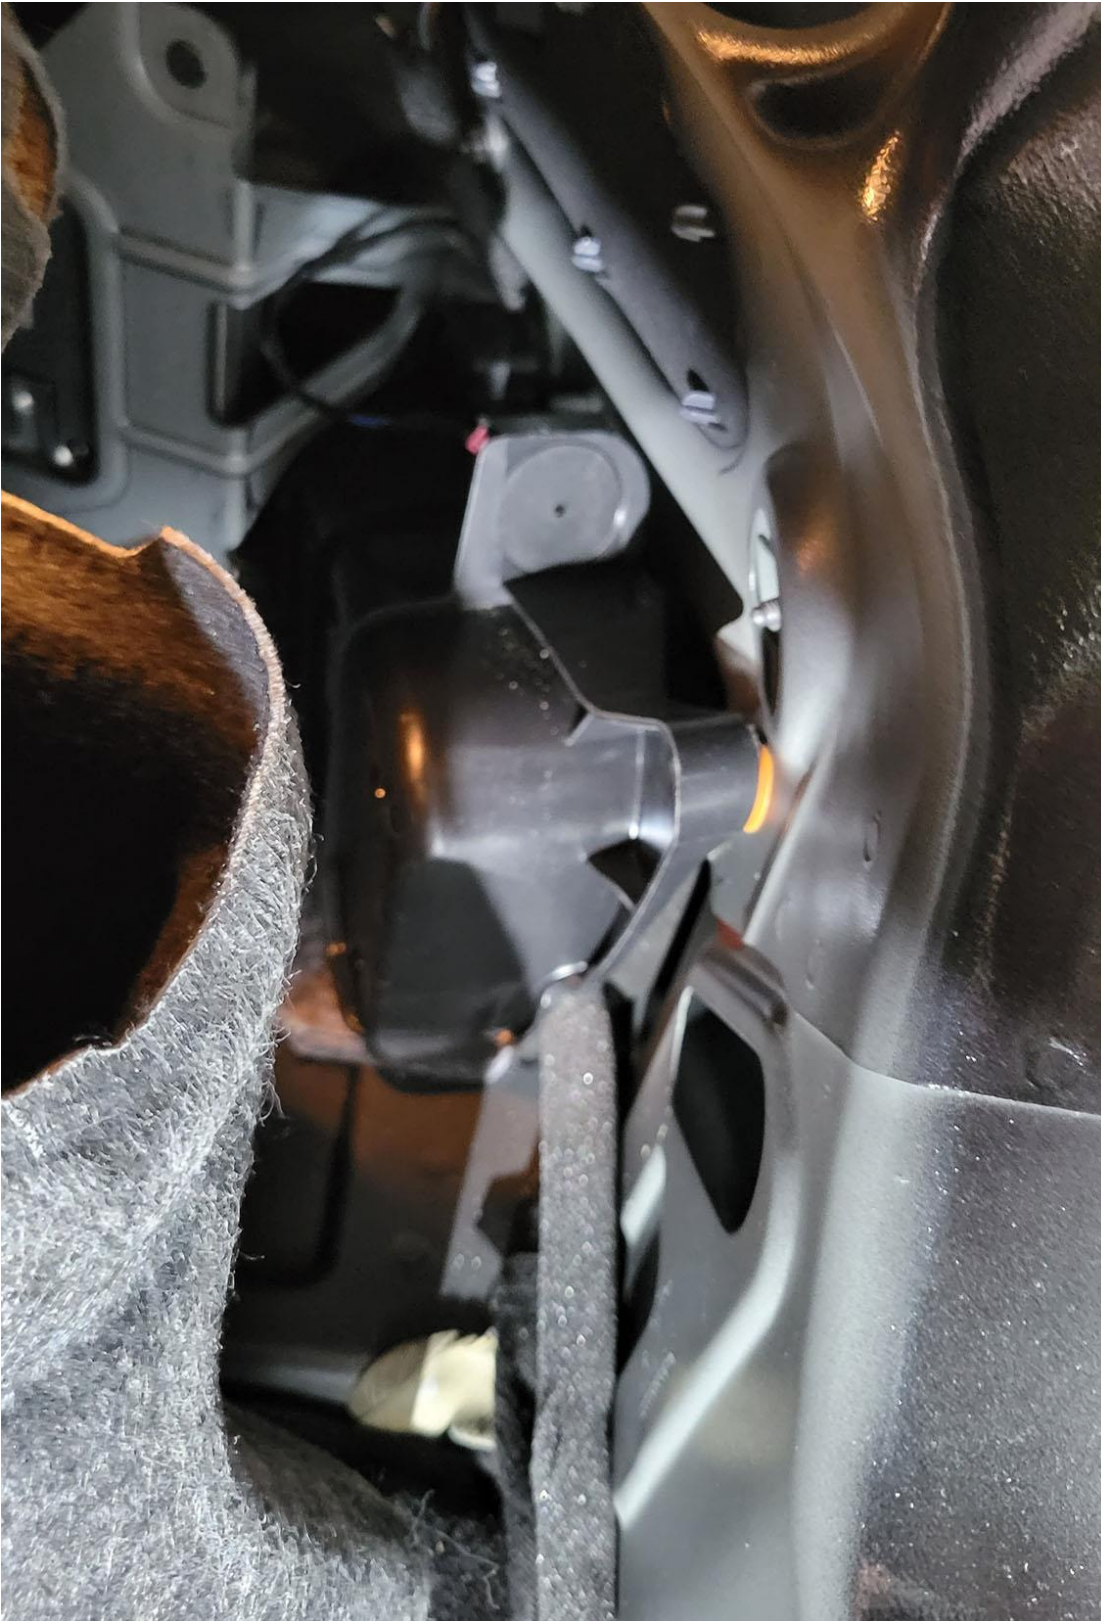
a) The motor unit is in a foam enclosure held on by an orange rivet, you should be able to pull up on the unit and it will release from the orange rivet. Then you can pry out the orange rivet with a trim removal tool.

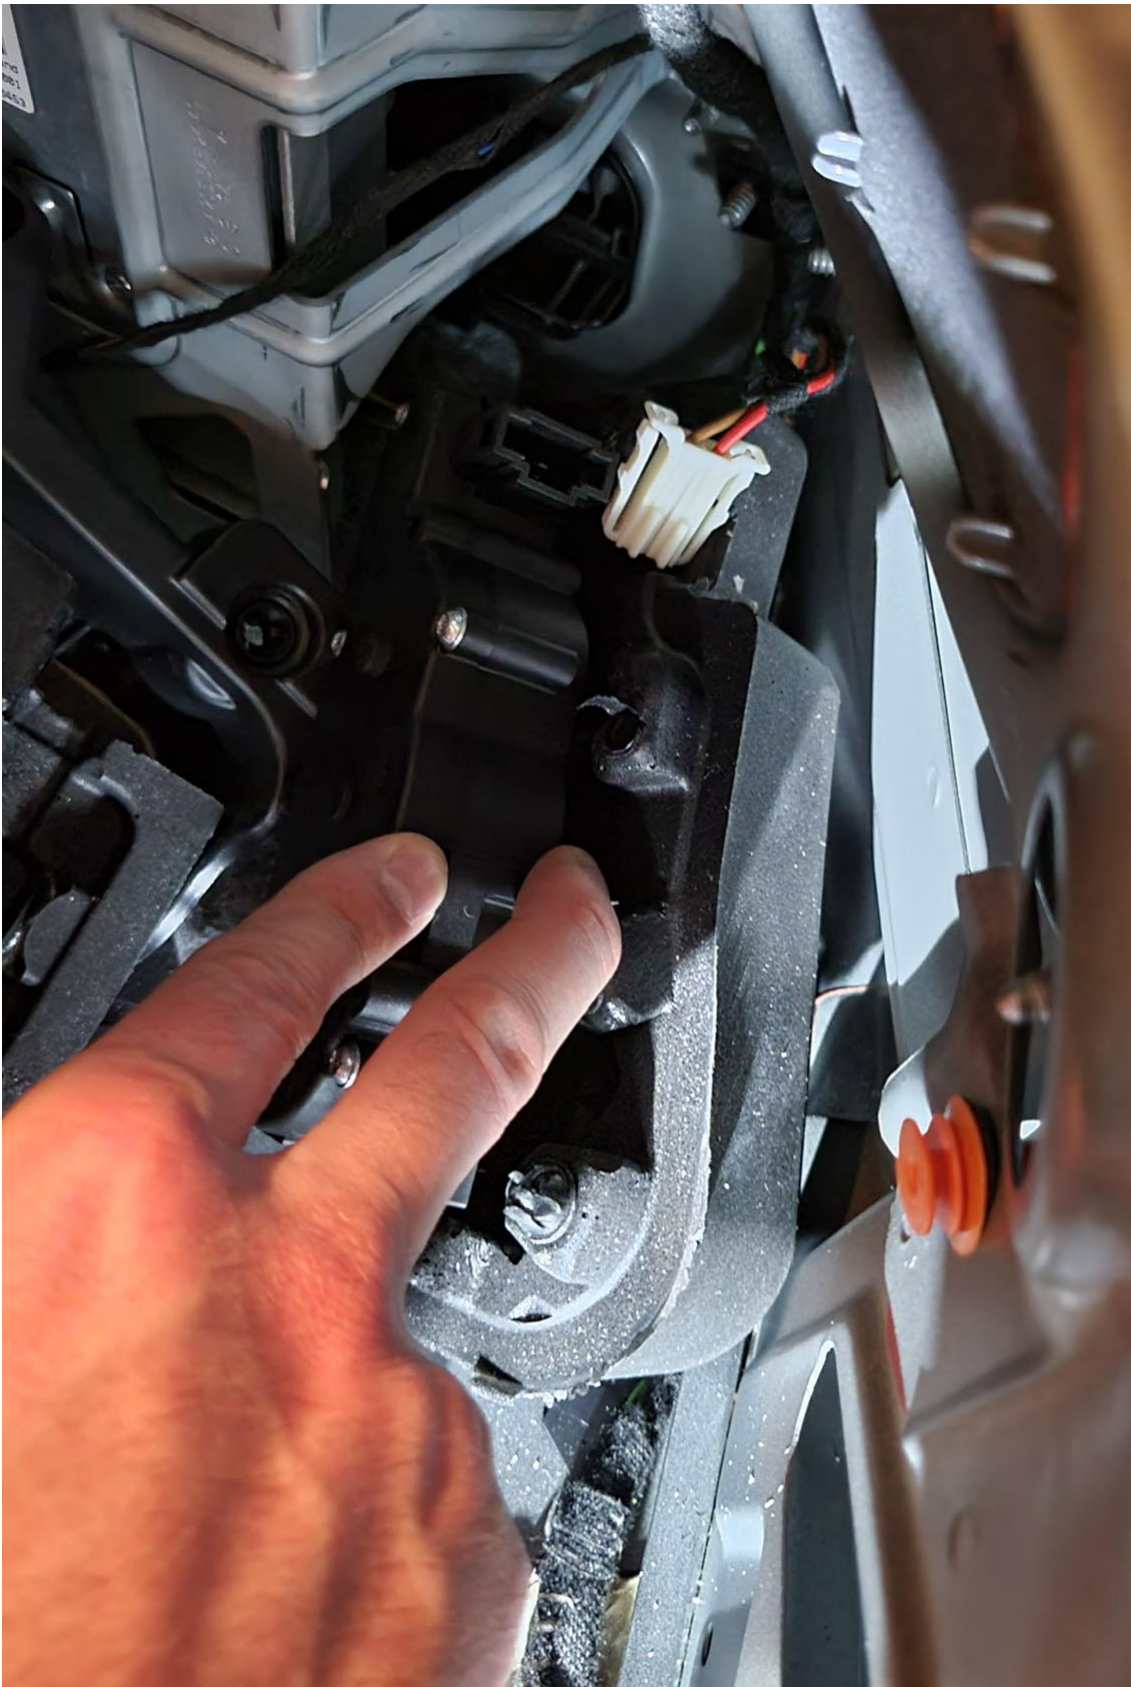
b) Disconnect the power cable.

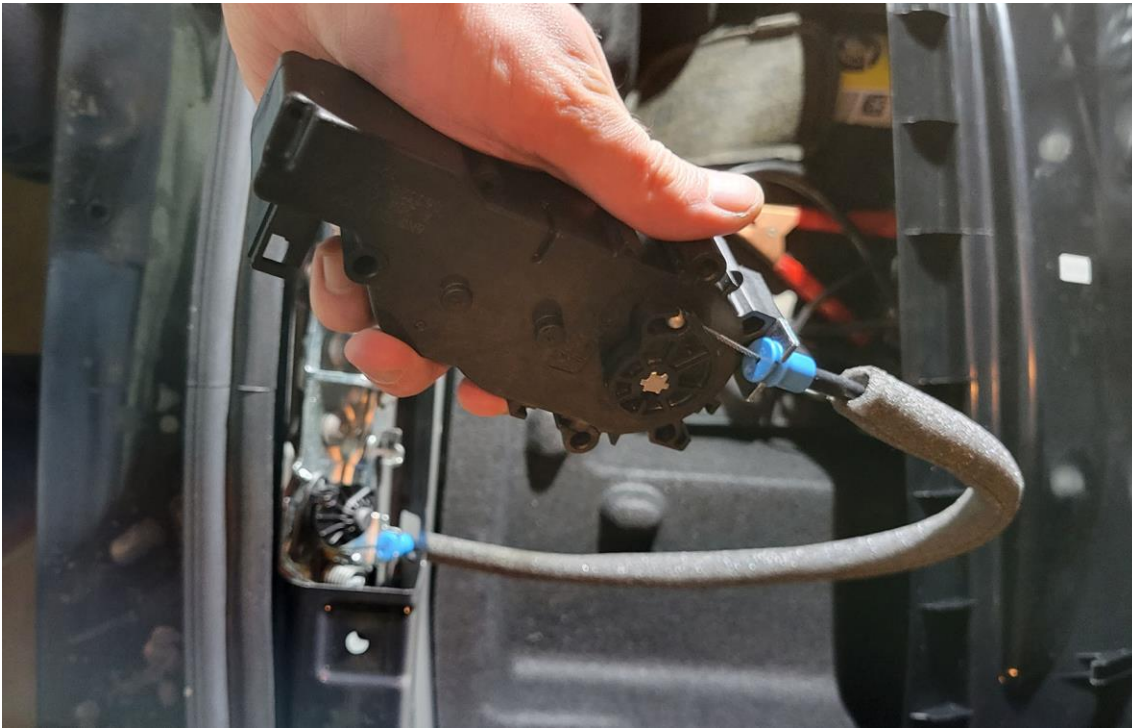
The “ball bearing” end of the wire detaches easily from the unit, along with the blue piece holding it in place

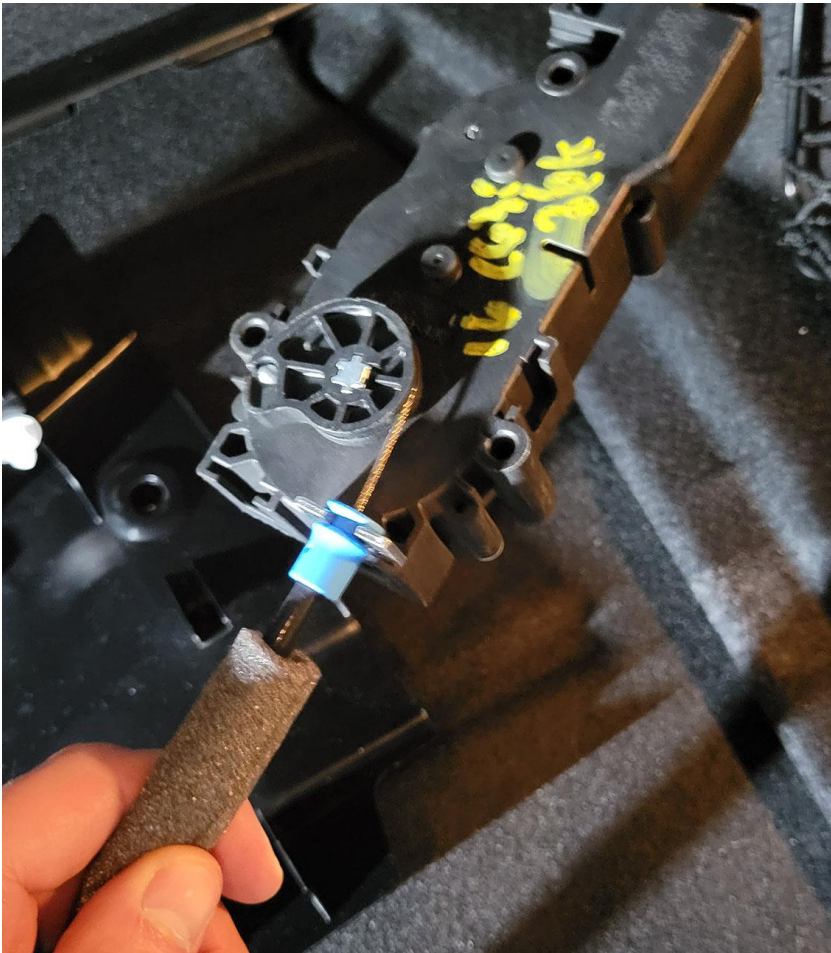
b) Attach the cable to the new motor (the cable should wrap around, and the blue piece should snap into place as shown)

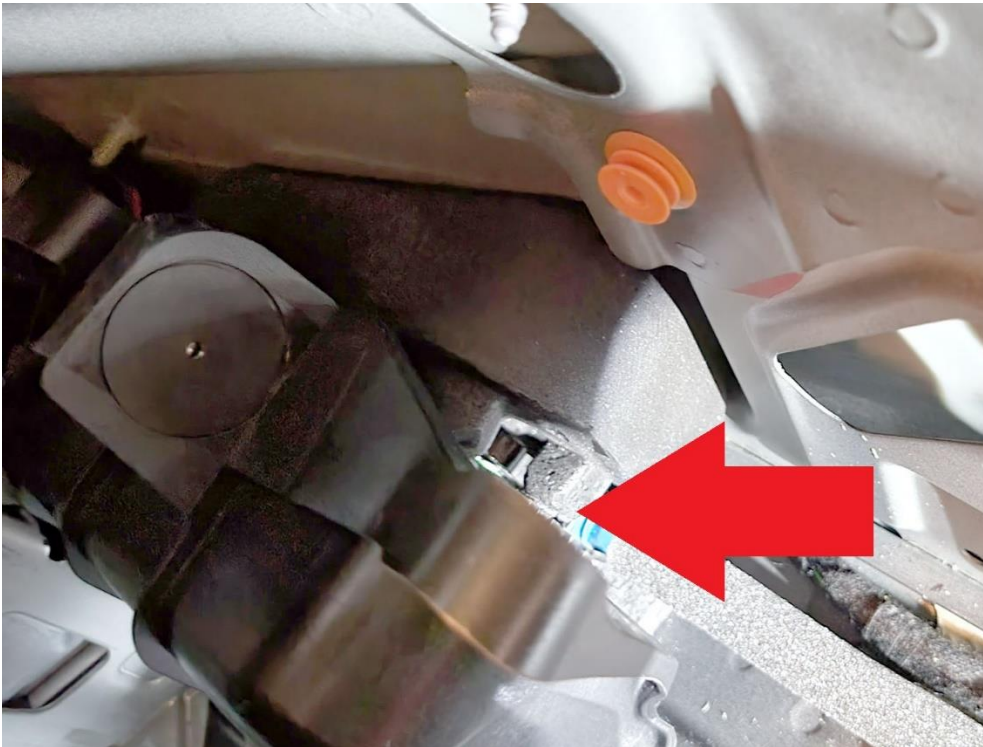
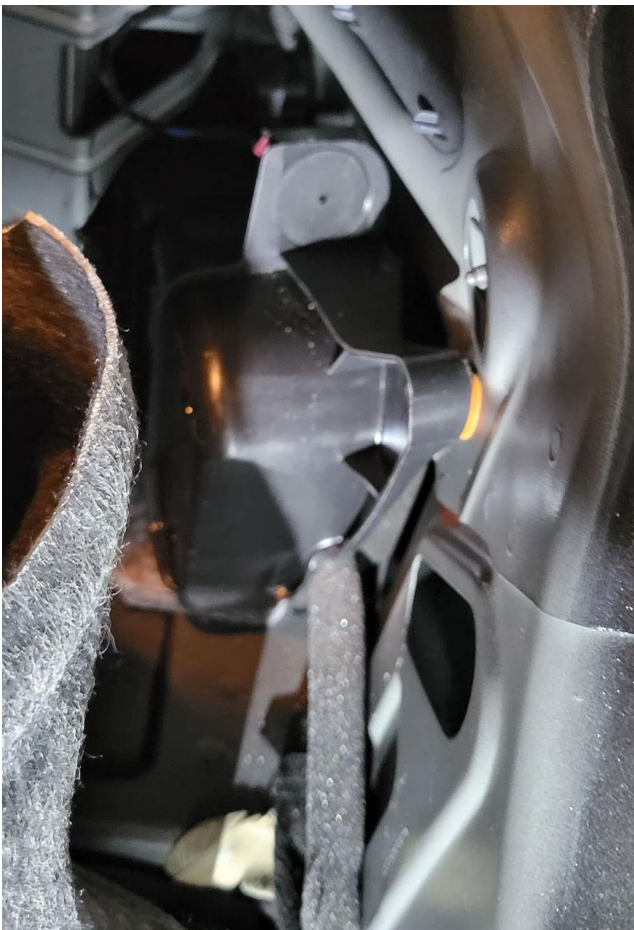
d) Pry the orange rivet out from the frame of the car, attach it to the motor enclosure, then push the motor unit with the rivet back into the frame. My apologies for not taking a pic with the rivet seated in the motor casing, but hopefully it's intuitive. Red arrow shows where the rivet should go.
