Remove and replace trunk/boot soft-close motor - Mercedes-Benz W205 (2014-2021)

This guide is for the W205, but many other models use this same motor
(<https://www.autohausaz.com/pn/MB-2047500060>)

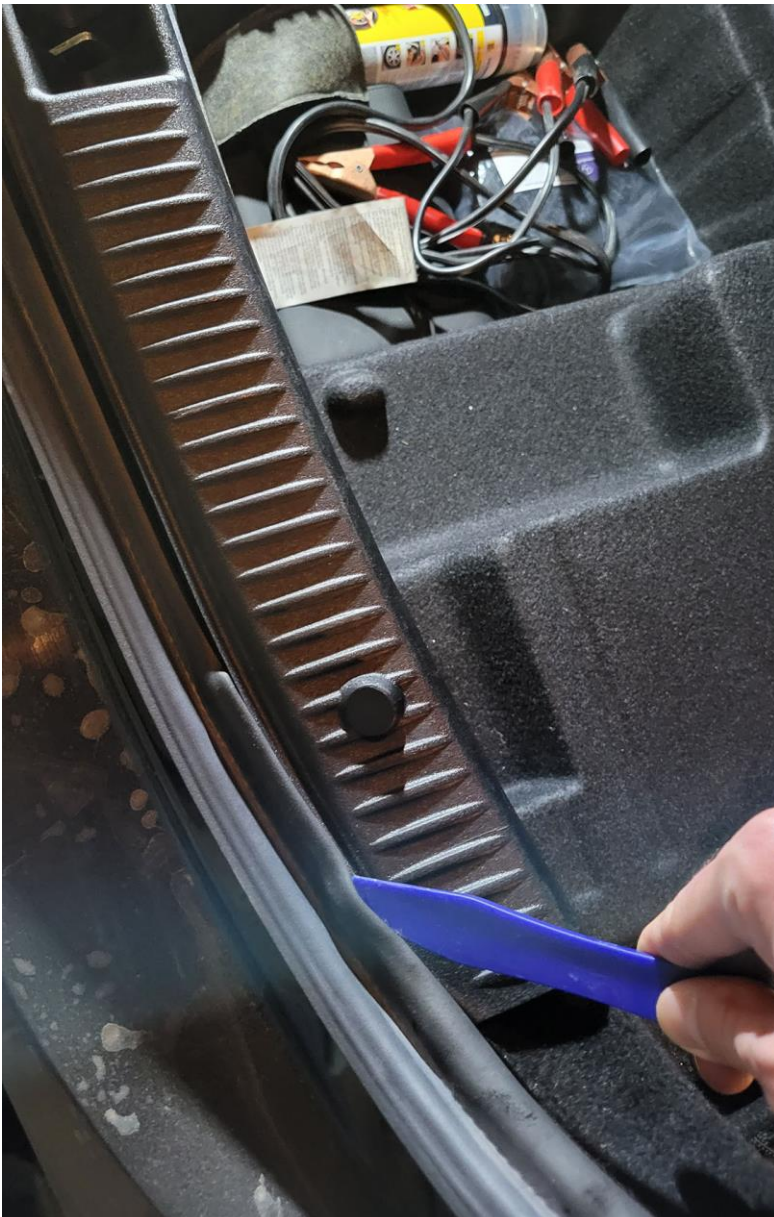
- a) Make sure the lining goes fully under the rubber trunk trim
- b) Re-attach the hanging clip, the tie-down latch, and plastic covering
- c) Re-attach lower edge of trunk, make sure all 4 rivets click back into place
- d) Make sure the rubber trim is over the edge of this trunk piece. I used a trim removal tool to run along this edge.

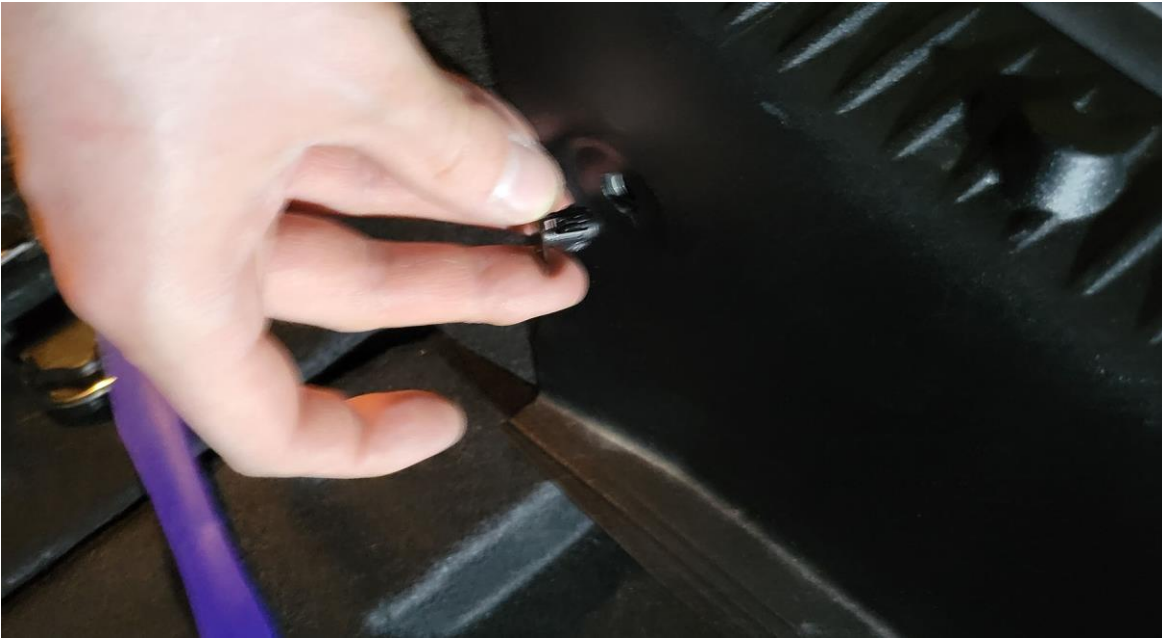
e) Re-attach the 2 plastic rivets into the trunk piece
