2003 Mercedes Benz C 32 AMG (203.065) V6-3.2L SC (112.961)

Vehicle » Technical Service Bulletins » All Technical Service Bulletins » Body - Door Frame Corrosion

Order No.: P-B-72.00/88

Corrosion Complaints Concerning Door Frames

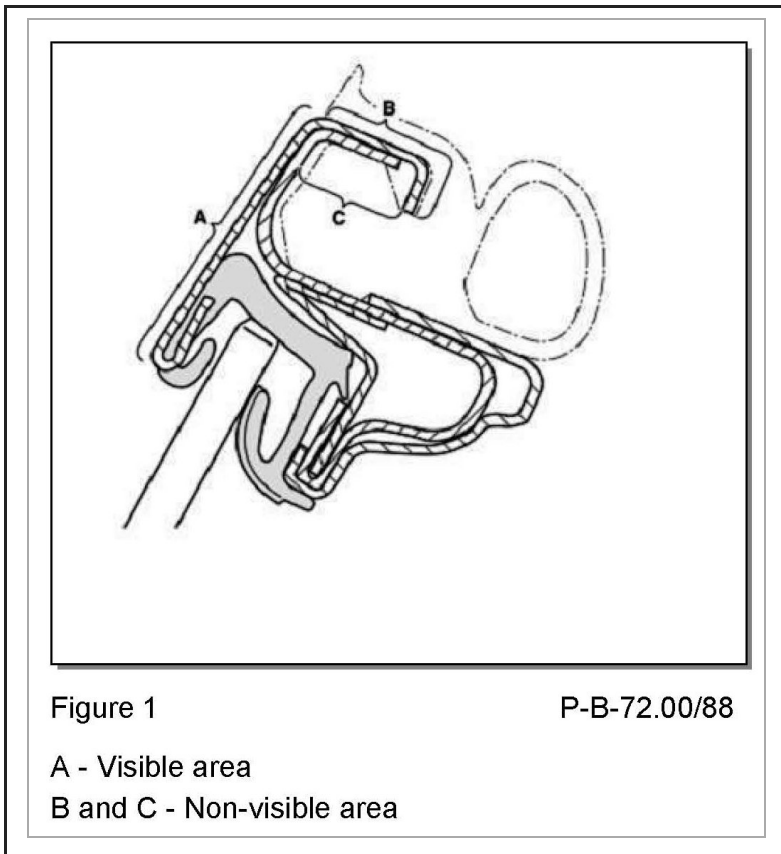
3. Perform visual inspection for corrosion (Figure 1, A and B). Select remedy according to damage profile.

4. In area Figure 1, C, use mirror to check for corrosion. Select remedy according to damage profile. (Figure 1).

1. Corrosion in non-visible area (Figure 1, B and C) under rubber seal, refer to WIS document AR97.00-P-1001F (repair stage 1).
2. Corrosion also in visible area (Figure 1, A) where **paint** can be touched up, refer to WIS document AR97.00-P-1002F (repair stage 2).
3. Corrosion also in visible area where **paint** cannot be touched up on outside door panel near door handle and central trim strip or spot corrosion on lower inside of door, which can be touched up with a brush with no additional painting work, refer to WIS document AR97.00-P-1003F.

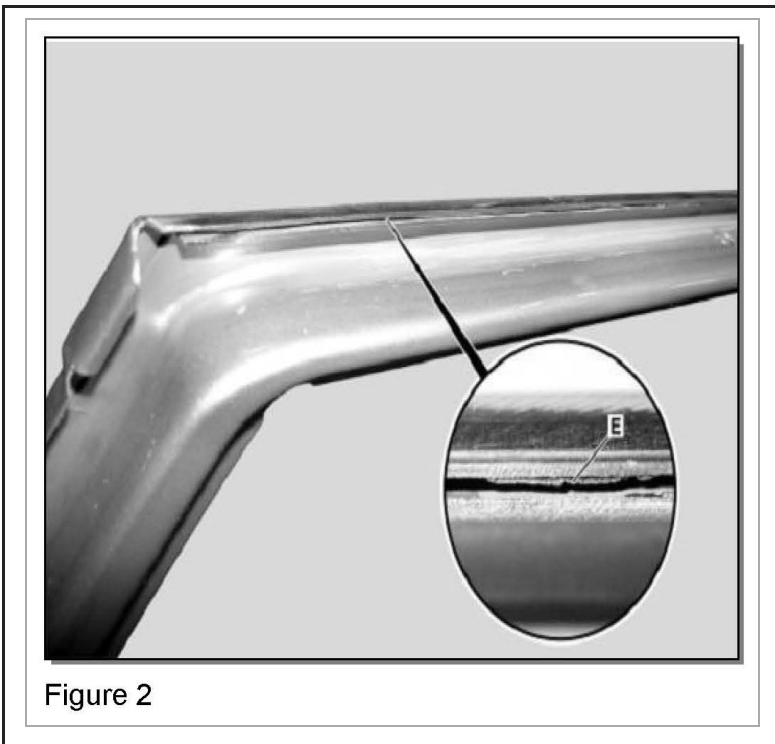
4. Corrosion effects in area (Figure 2, E) after cutting off the fold or in visible area where **paint** cannot be touched up on outside door panel and corrosion on lower inside of door which cannot be touched up with a brush. (Figures 3 & 4), doors must be replaced. Wax inside of door frames and window frames then install rubber seals.
