Air Conditioner / HVAC W203 Stepper Motor Repair PART 2 OF 3

Upper Dash Removal page 25

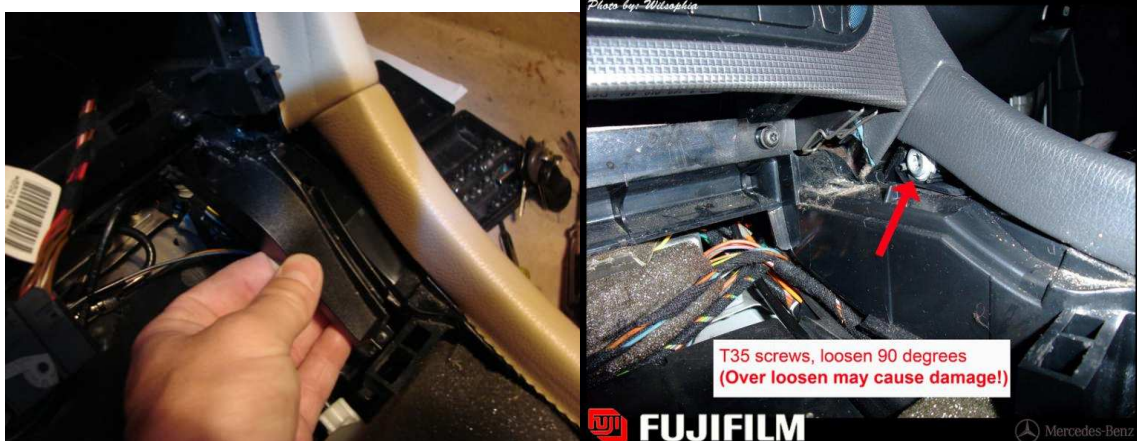
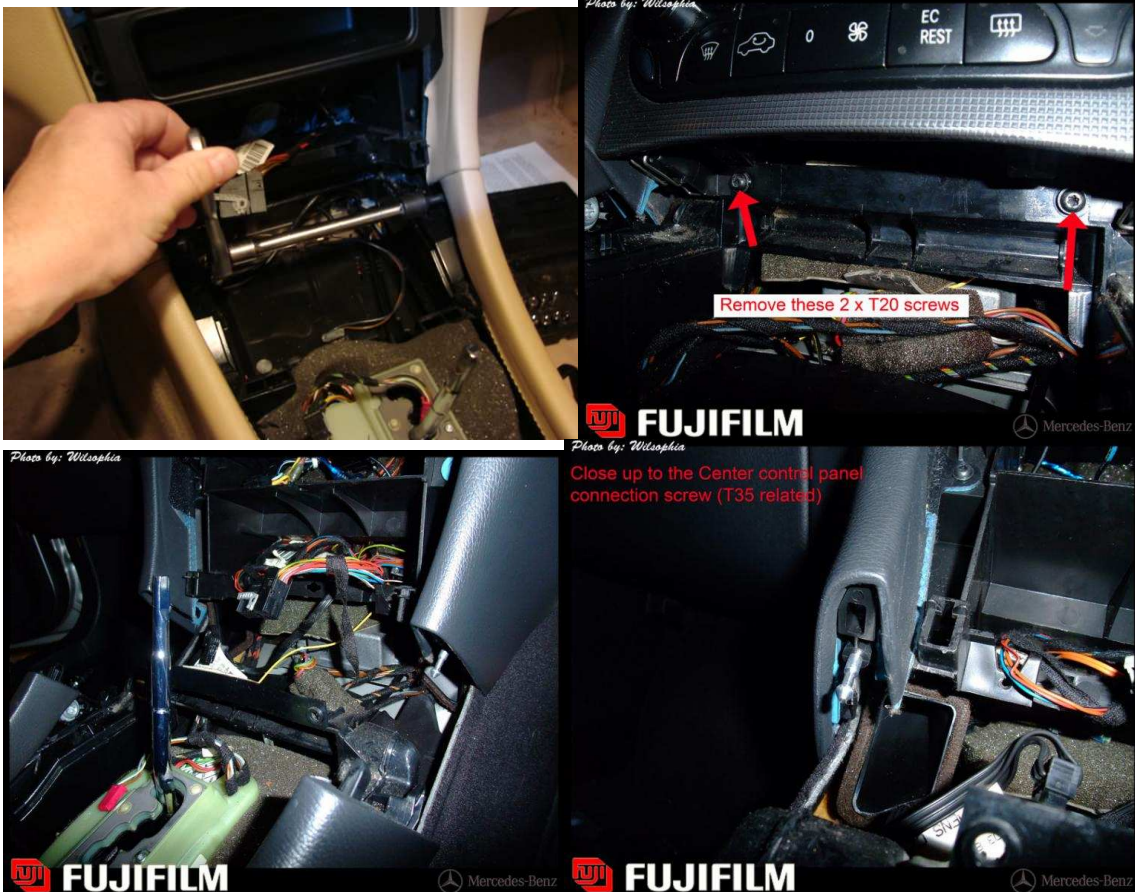
9. There is a small black plastic hump shaped cover under where the ashtray sat. Use your fingers to pull them off and that will expose the T35 screws. Be very careful in this next step to not damage your interior. Using the T35 socket on your ratchet, set it to loosen and turn the screw approximately 90 degrees. Once you start feeling resistance, then you need to stop because that is far enough. If you continue to try to loosen these screws past this point, you will damage the center console. Using the flashlight again, you can look under the a/c controls and you will see or feel (2) screws. Using the T20 torx screwdriver, you should remove them. This will allow you to pop the center console loose and move it back and out of the way. You will not have it completely out of the way, just enough to maneuver around it.

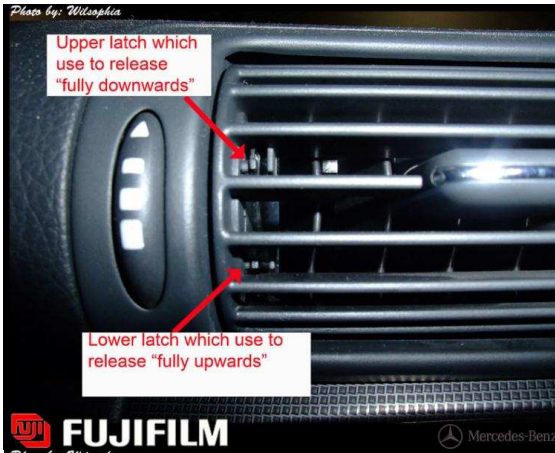
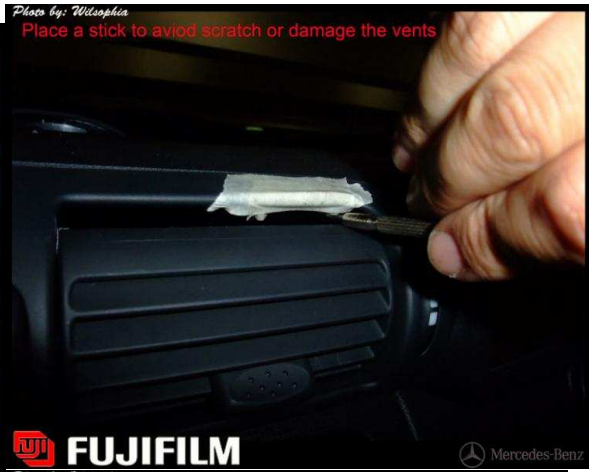
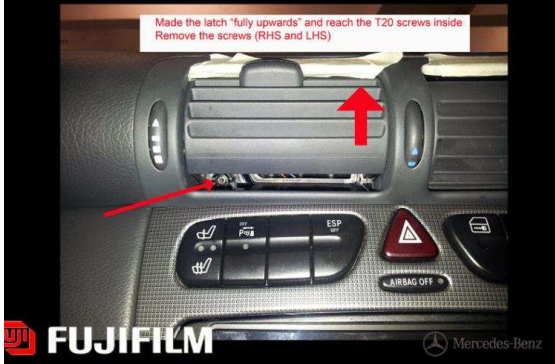
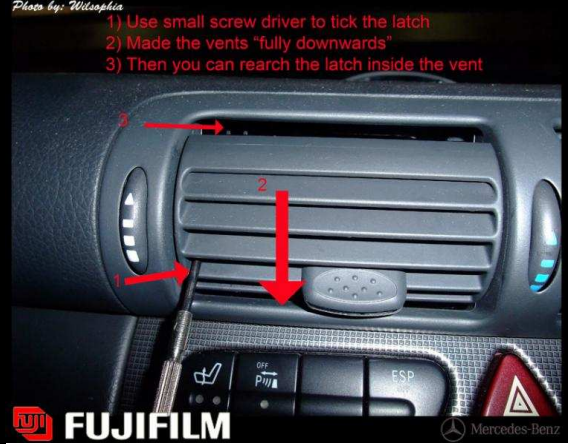
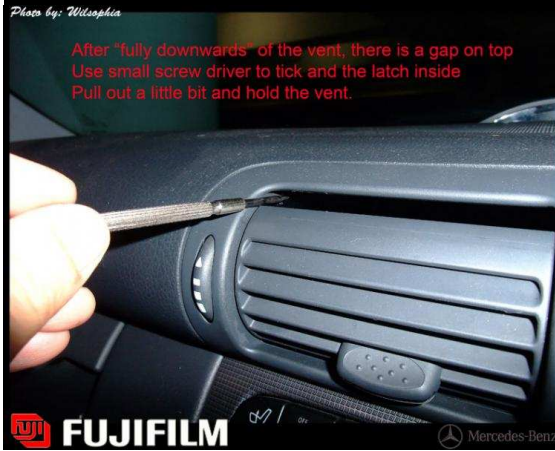
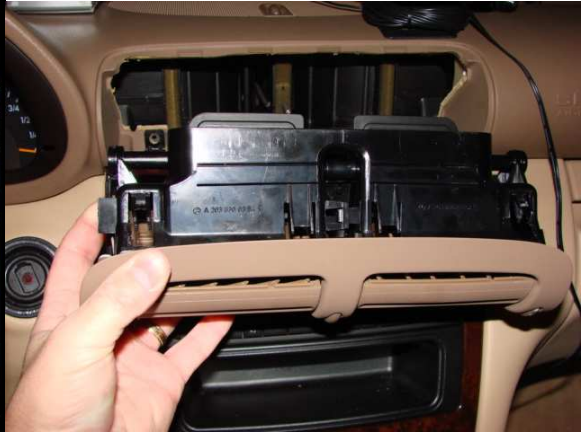
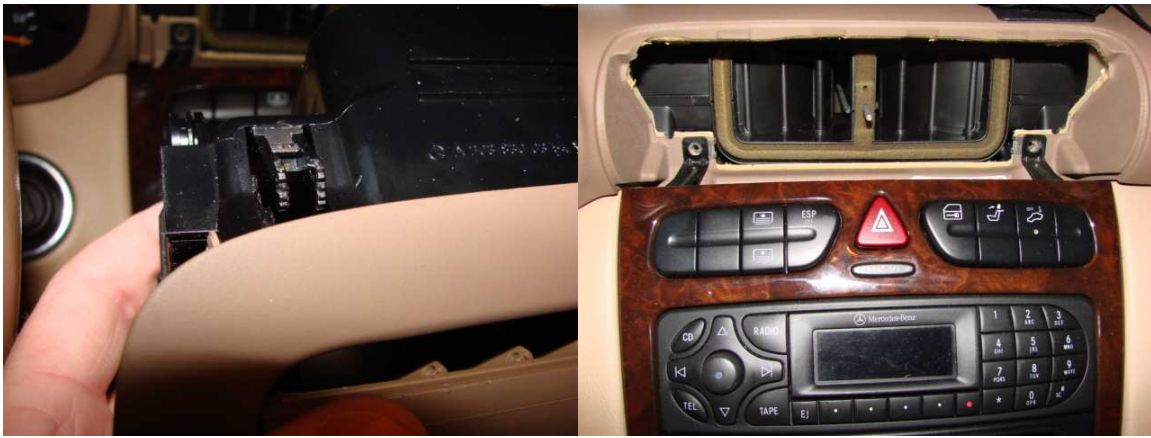
10. Next, look into the center A/c vents on the dash above all the buttons above the radio. On the left side of those vents, you will see small plastic tabs. Using the small flat tipped screwdriver, GENTLY pry the lower tab on each side and why holding it away from its proper placement, rotate the vent up until it completely stops and exposes a thin open slit under the vent. Repeat for the other center vent. Using the flashlight, look under the vents and at each side you will see a small torx screw. Now using the T20 torx screwdriver, loosen both screws but DO NOT remove them. They should be held into place by the A/c vent assembly. However, if they do come completely out, just try to push them back into place or use a small magnet to remove them. Now pop the center A/c vents back into their normal positions. Again, using the small flat tip screwdriver, now GENTLY pry against the top tab pressing away from the side and rotate the vent completely down again exposing a small slit but not on the top side of the vent. Grab the flashlight again and look into this area. You will notice small tabs/slits on the top of the a/c vent assembly on the inside. Grab the small screwdriver again and GENTLY pry downwards on the small section closest to you and at the same time, start pulling the A/c vent assembly out of the dash. Sometimes you have to pull those tabs a bit further down than you would think. Also, if you have the illuminated thumb wheels for the vents, you will now have to unplug this one, but don't forget about it.

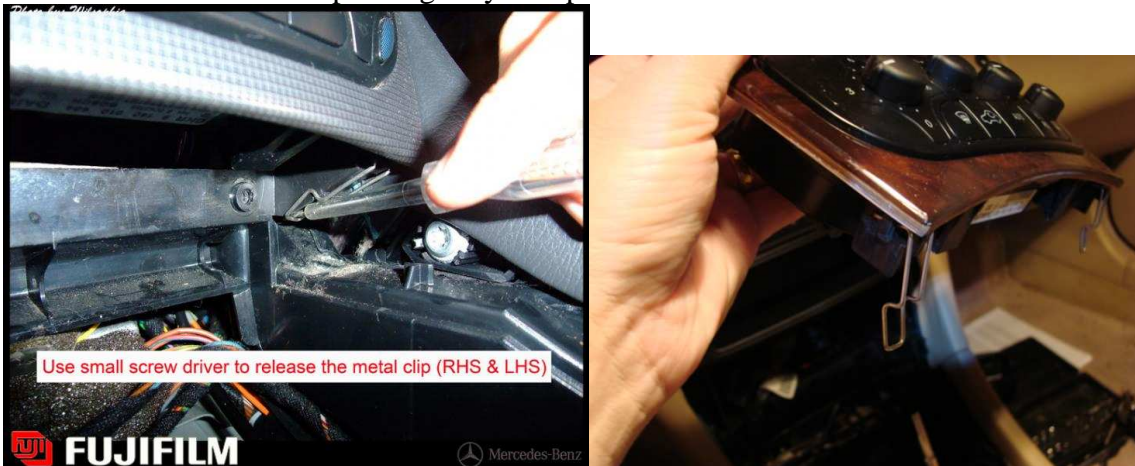
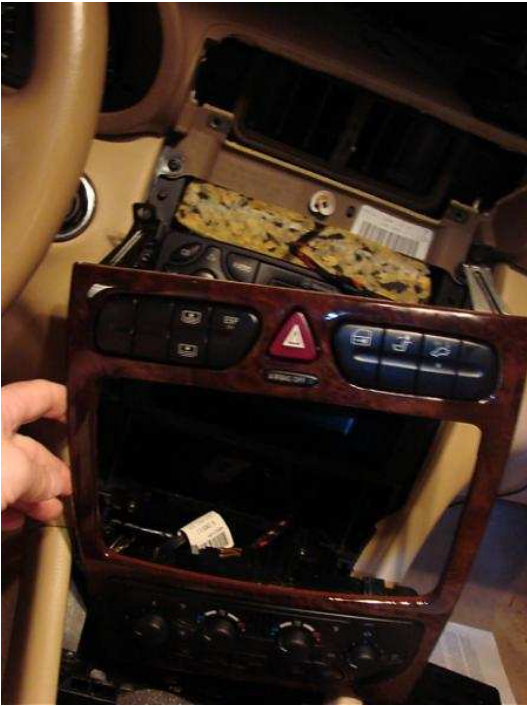
11. Again, grab the flashlight and now look under the remaining section of the wood trim around the Radio/Command. You should be able to see a small metal loop on either side. Use one of the screwdrivers to pop each one down but not completely out. Doing this, should release the remaining section of the wood trim around the radio. Unplug each connector, but again, mark or remember where each connector came from. There should be atleast 3 connectors depending on your options.

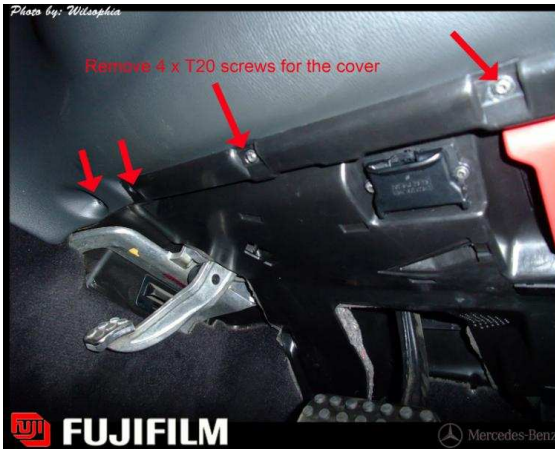
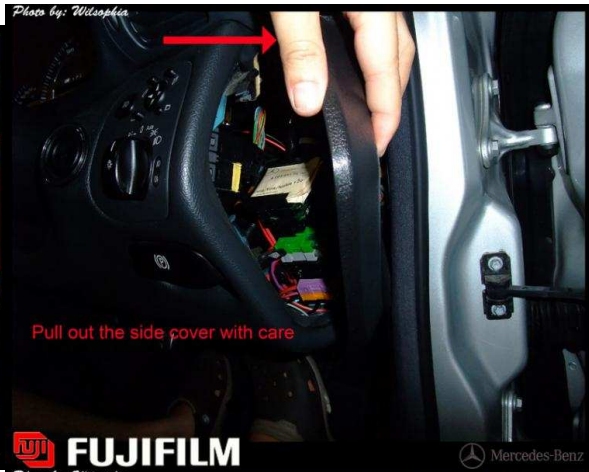
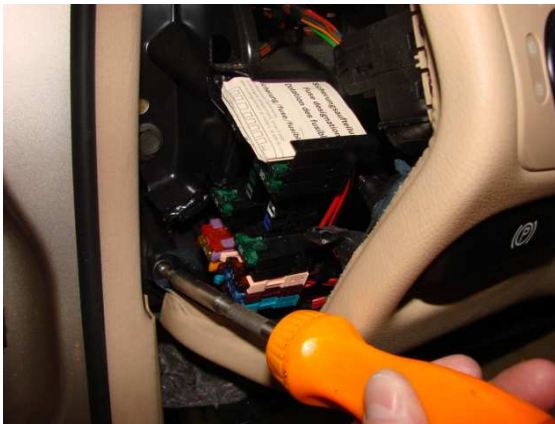
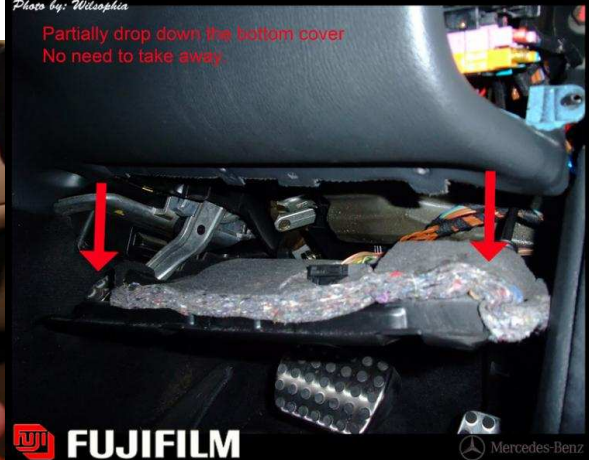
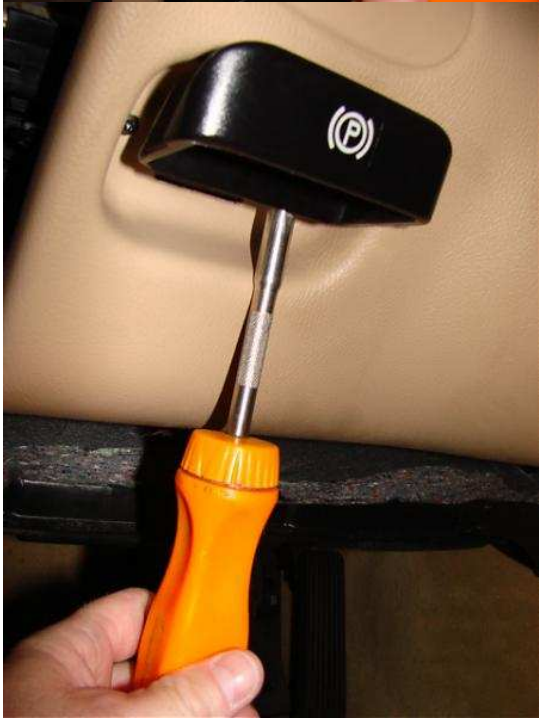
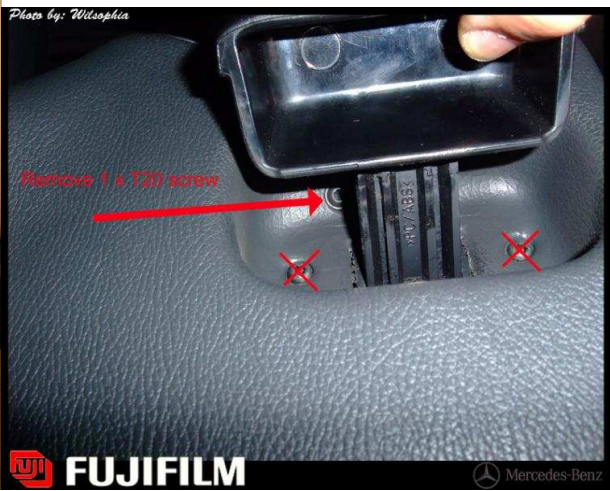
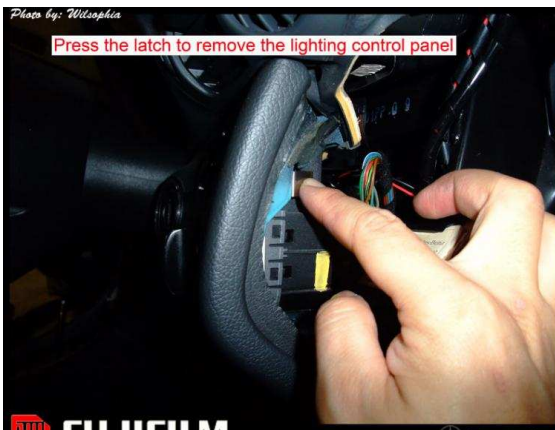
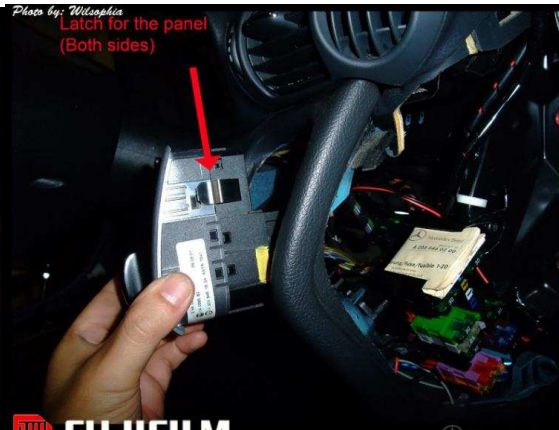
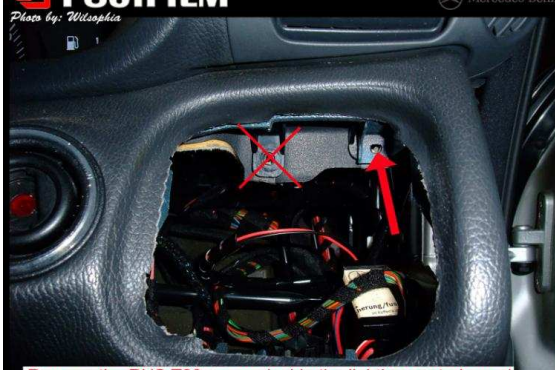
12. Grab a short stool or sit down on the drivers door sill plate. Take the T20 torx screwdriver and reach up under the bottom side of the dash on the drivers footwell area. You should be able to feel a total of (4) screws straight across. Remove them. Now pop down the plastic cover but do not remove it. This will expose the remaining (1) screw attached to the bottom of the dash. Remove it. Using the plastic wedge, pry off the side cover to the dash where the drivers door would meet the dash. There will be a few more screws, remove them. Take the gear shifter and place the vehicle back into PARK. Pull the E-brake handle out to release the brakes and you will find another screw under there but above the handle, remove it. There will be a small metal tab on the side of the Light switch, press it in and remove the light switch after unplugging it. This will expose another (2) screws in the top of this opening. Pulling out the E-brake release handle again, you can pop the cable loose, but PLEASE take care in how this fits on. Now taking the small flat tipped screw driver or the special tool to remove the plastic ring around your Ignition switch, Carefully do so. Again, I take no responsibility for you scratching up your own interior.

The plastic ring around the ignition switch rotates counter-clockwise and spins off the threads on the switch.

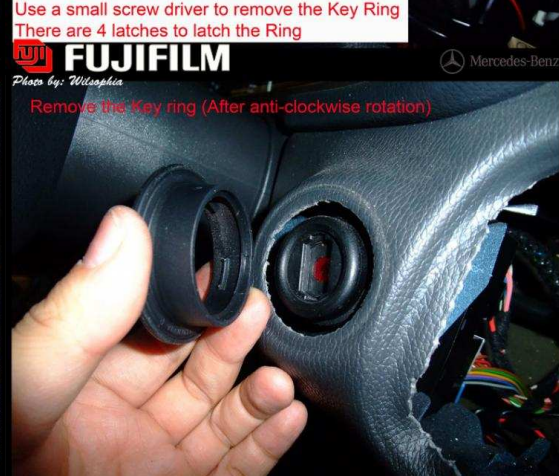
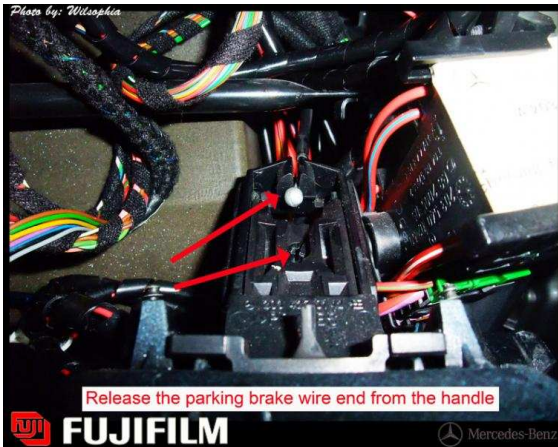
Anti-clockwise to loose the Key ring
Use a small screw driver to remove the Key Ring
There are 4 latches to latch the Ring

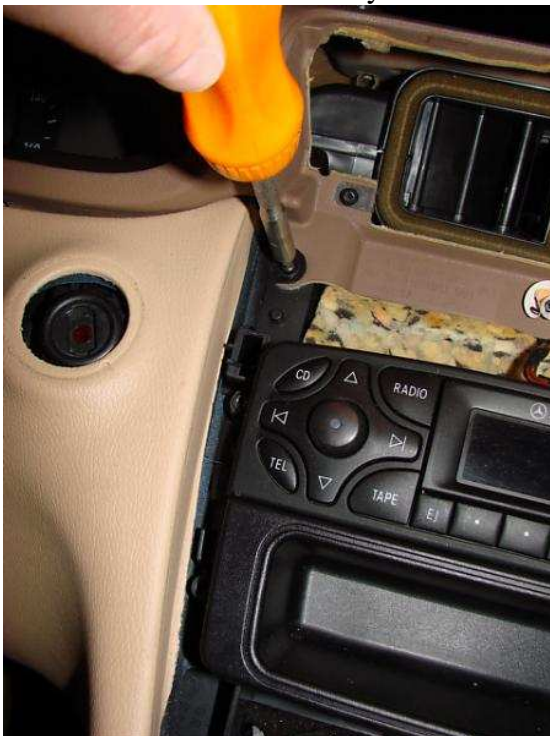
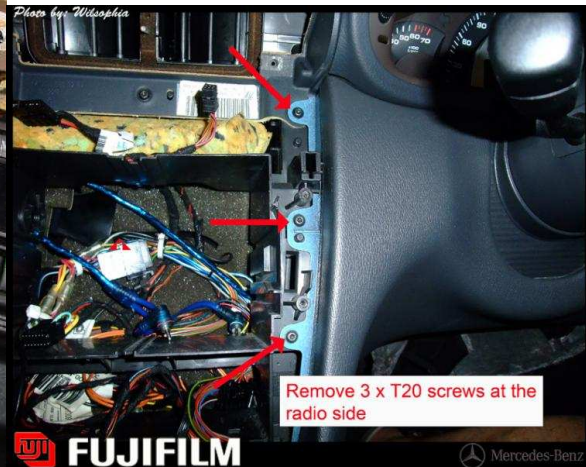
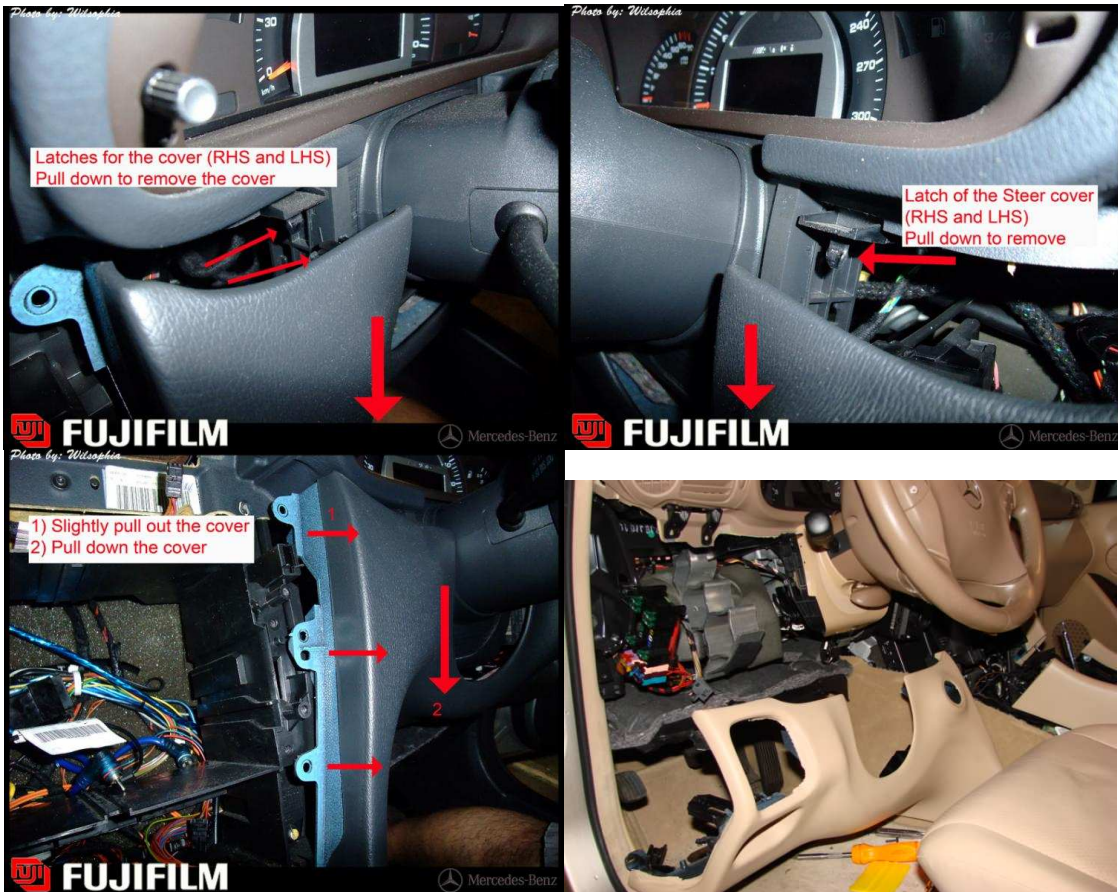
13. Back to the radio area. Take the torx screwdriver and remove all remaining screws from around the radio and dash pieces in this opening. If you have followed the directions up to this point, you will have (9) screws remaining. Remove them all. At this point, you will be able to pop the lower dash section under the instrument cluster/steering column area down and out of the way.

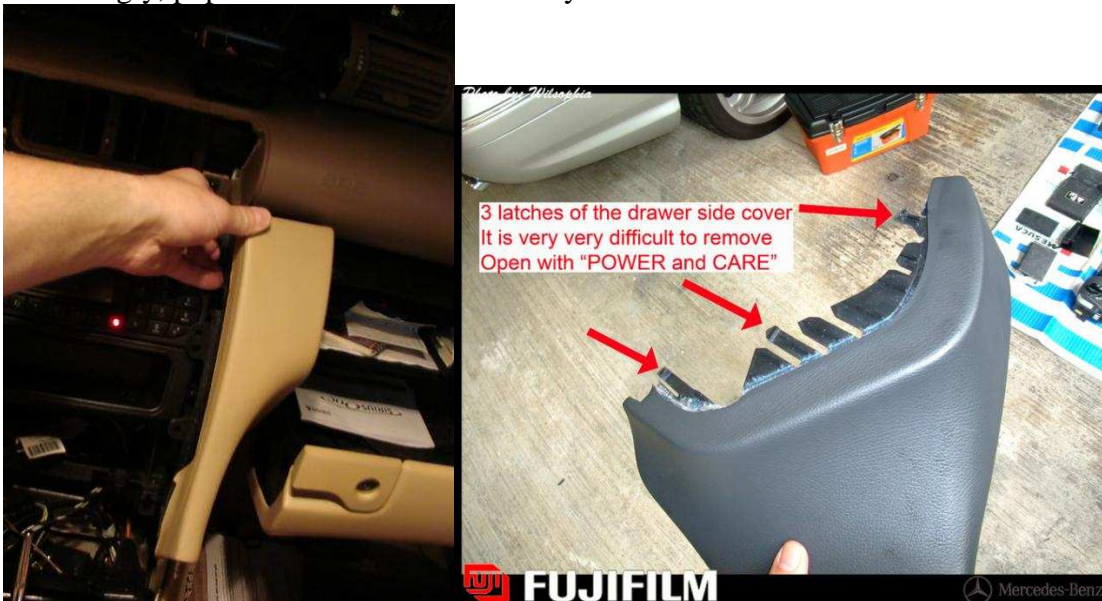
14. Now open the glovebox and there will be a small section of dash remaining between the glovebox opening and the large opening where the radio used to be. You should be able to pry up one of the exposed edges by where the radio used to be and sharply but not too strongly, pop this section loose and away from the dash.
