Air Conditioner / HVAC W203 Stepper Motor Repair

PART 3 OF 3

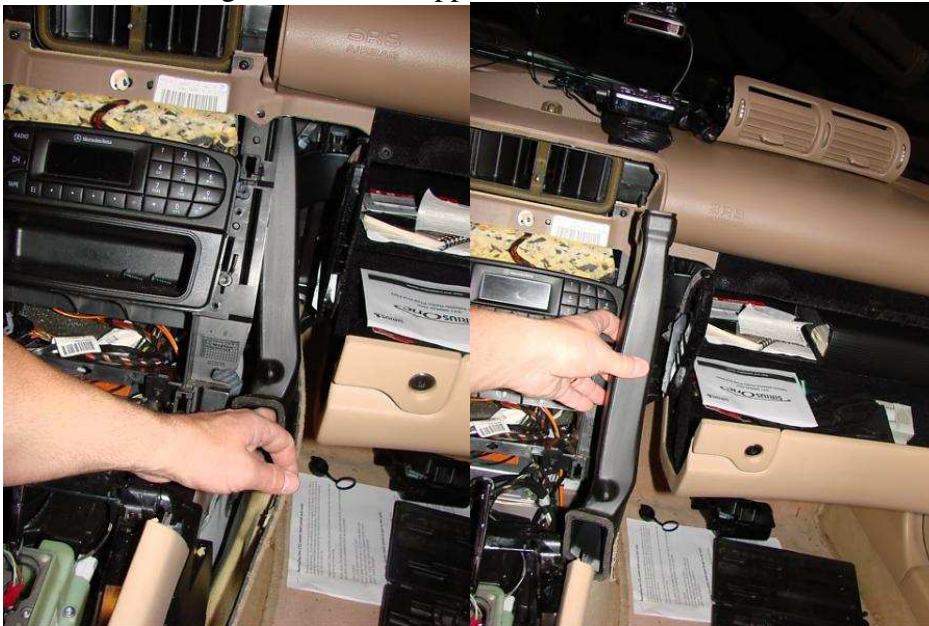
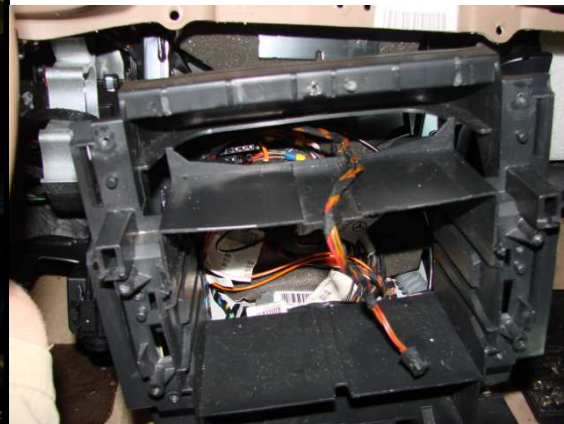
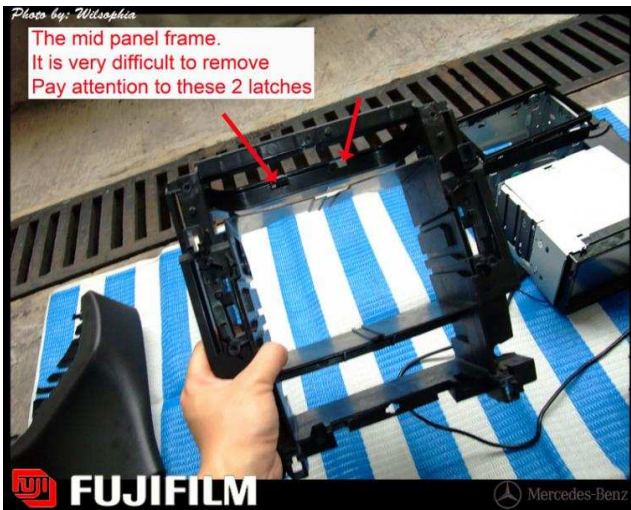
15. By doing this, you can now remove the vents on each side of the center console and set them aside. They are long black plastic air tubes. Now taking the flat tipped screwdriver (you may need a slightly larger/longer one), you can pop the two tabs that hold the black cage to the dash support. Remove it and set it aside.

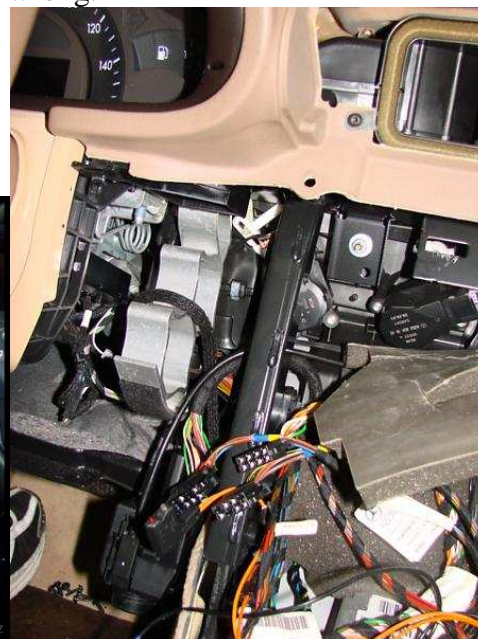
16. Now if you are in a well lit area, you can see the A/c stepper motor now exposed behind the inner dash support/brace on the left side. Picture where the radio was and now look up and left of it and behind the brace. It is held in place with (3) small silver screws and has the broken linkage between it and the main A/c / heater case. Remove the screws and you should be able to maneuver it around and unplug it. Remove it and you will find that the linkage is either cracked where it connects to this stepper motor or will have fallen off already and shown you what was wrong.

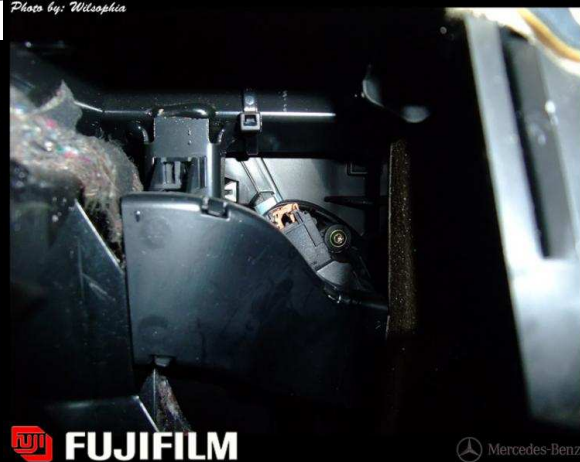
This is one of the stepping motor. Don't be happy.....

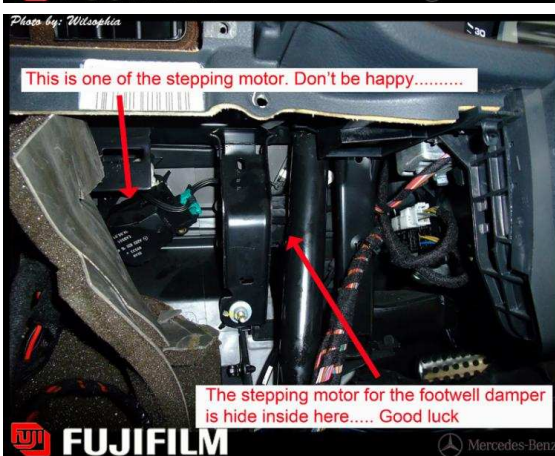
The stepping motor for the footwell damper is hide inside here..... Good luck

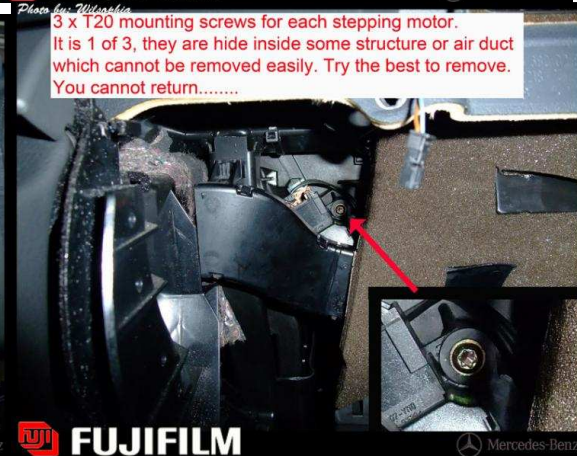
3 x T20 mounting screws for each stepping motor. It is 1 of 3, they are hide inside some structure or air duct which cannot be removed easily. Try the best to remove. You cannot return.....

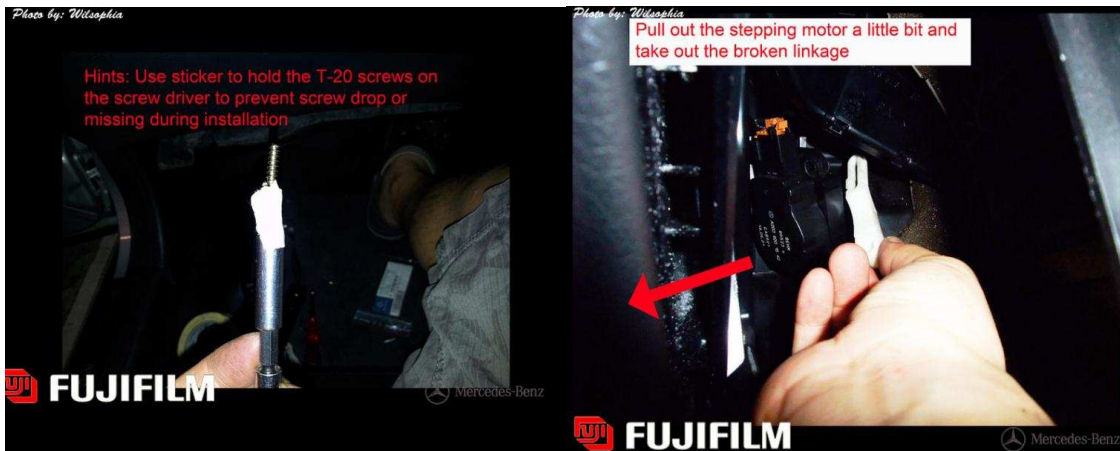
17. After reinstalling everything, and getting everything back together, make sure you have no extra screws and that everything is functioning as normal. To normalize the A/c stepper motors, hold down the Recirc and Front windshield buttons for about 10 seconds or until they both start flashing back and forth. When they are done flashing and you have confirmed everything is working, you are done.

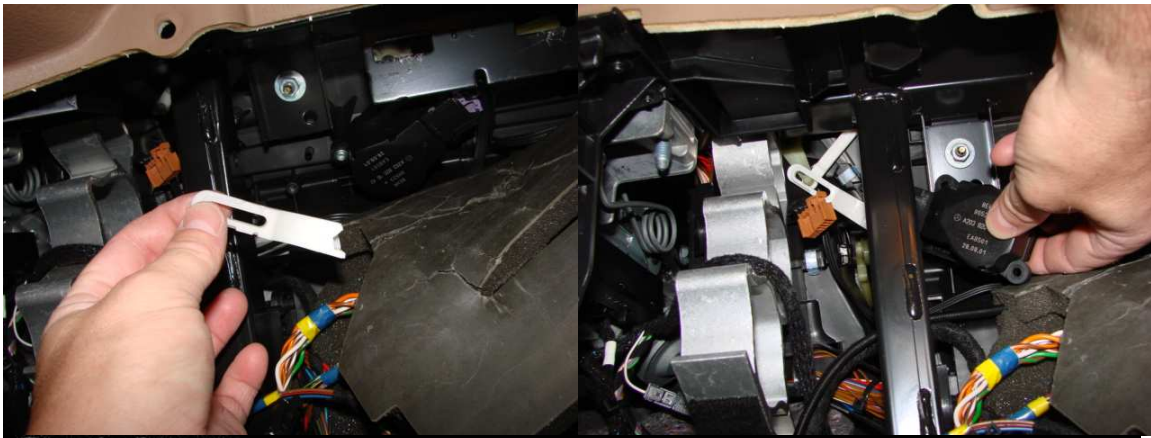
After replace the linkages, Connect the AC panel (2 plugs). Turn the ignition key to "On" position ,Re-sync all the dampers by pressing and holding both "Fresh air" and "Windscreen" buttons for 10 secs. They will flashing for 30 secs and stop Turn off the ignition key and wait for 2 mins. Restart the Car and AC to function test on all the dampers. See if anything wrong. There is no harm to turn on the ignition if you manage all the wiring well..... Good luck

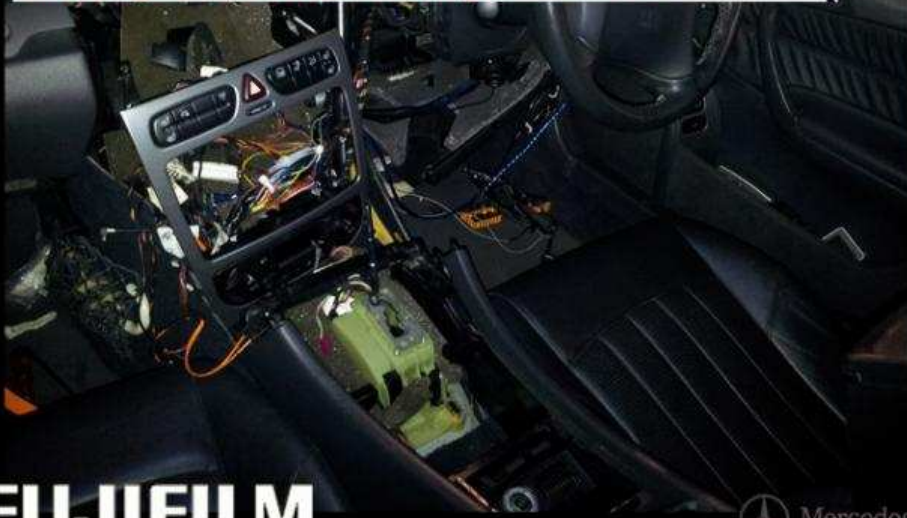
Stepper Motor M2/19 With the Purple Connector and the one with the Green Connector Located Right Behind Your Headunit doesnt have a Regular Linkage like all the rest of motors-- has the Plastic Gear Thing-e! (Actually called Linkage -- Footwell flaps PN A203-830-00-32)

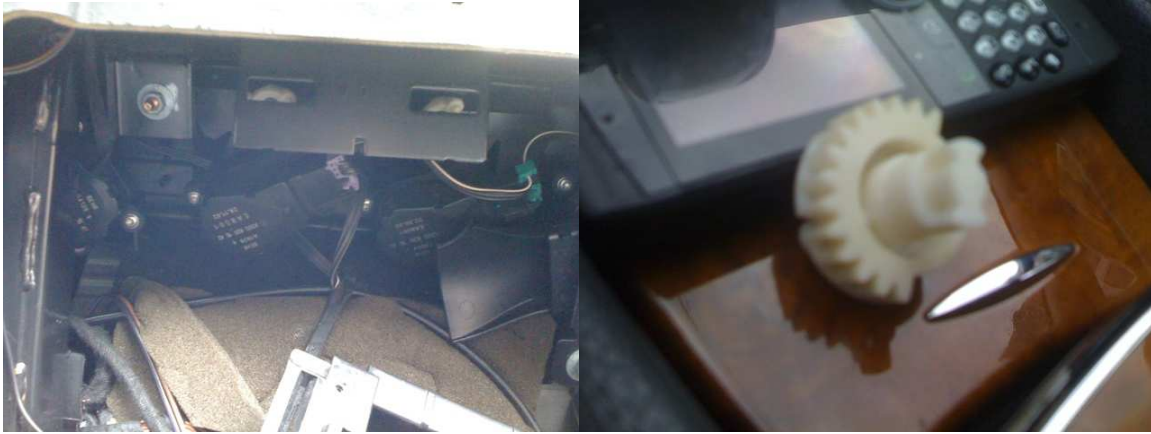
Broken linkage

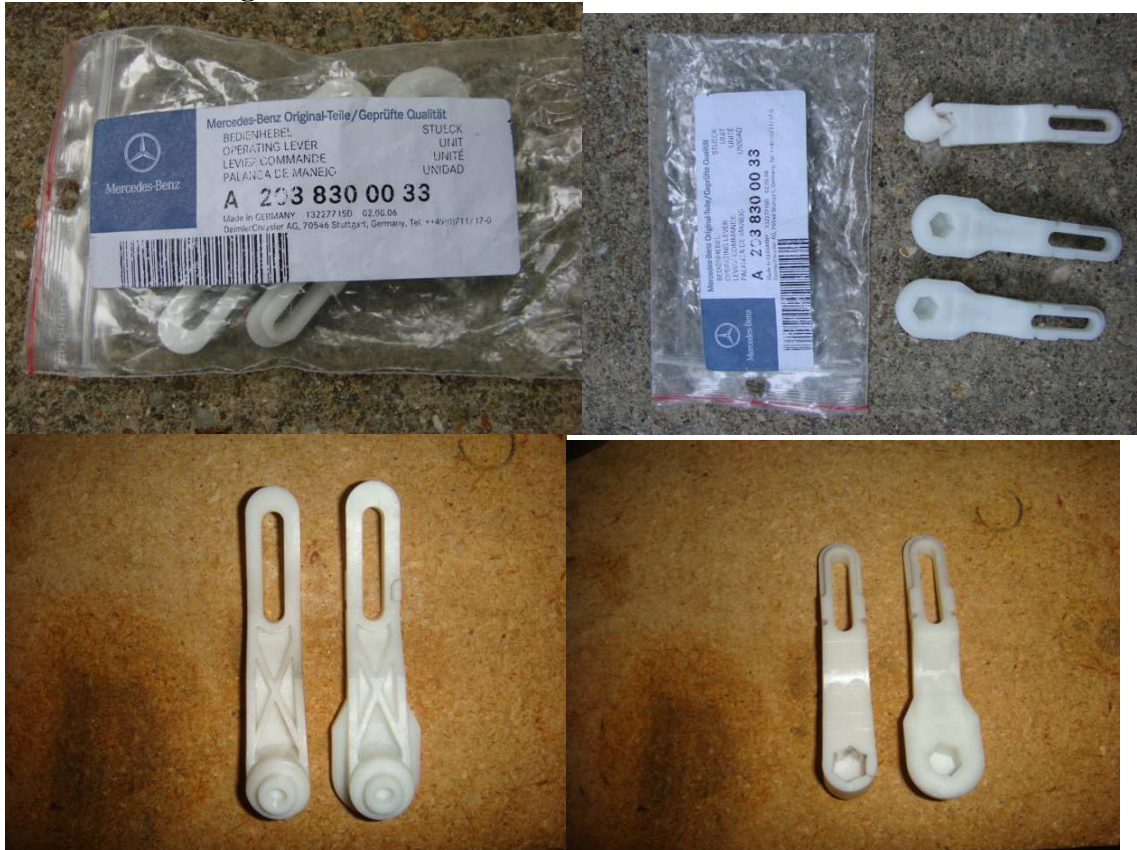
Old vs New linkage arms as of 12/2010
