Spark Plug Indexing for Direct Injection Engines

QEC / ES

John Dahlquist
June 19, 2014
Version 3

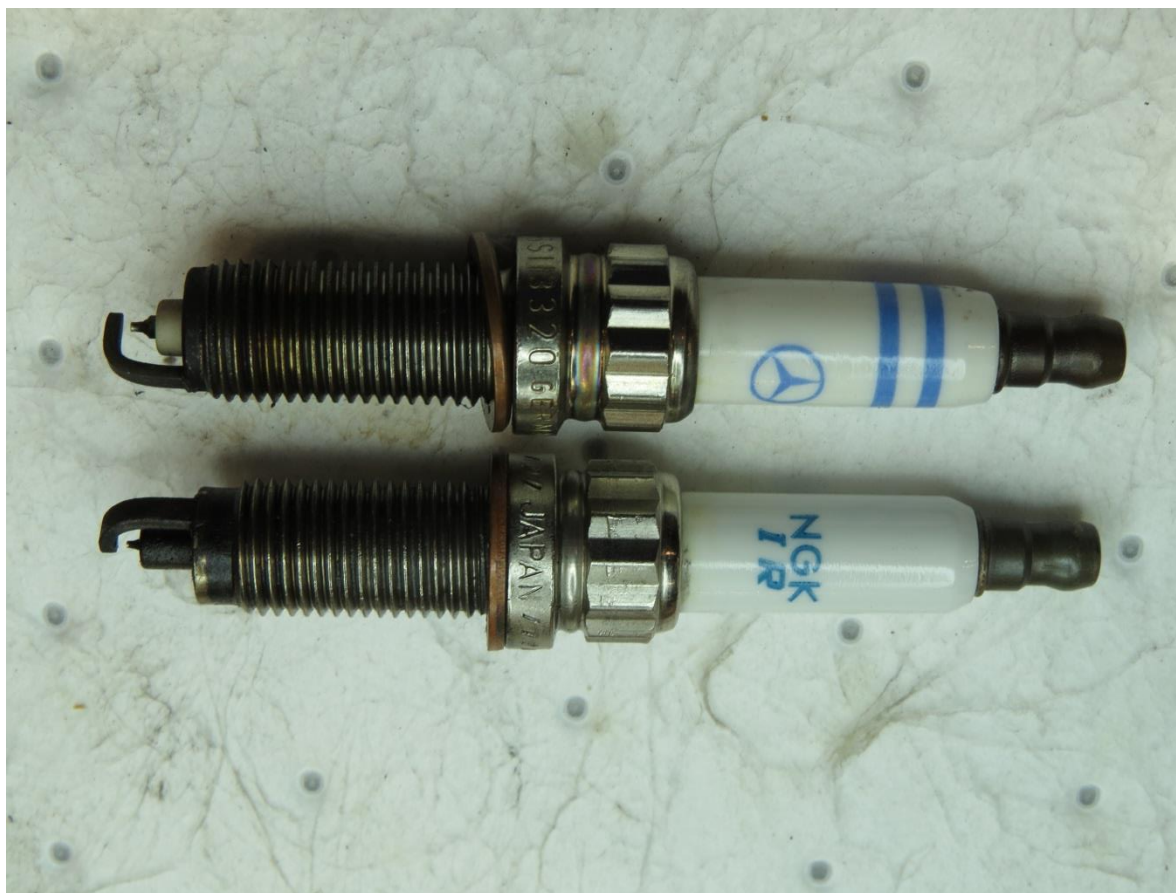
In the picture, an NGK unapproved spark plug is compared to a Mercedes approved spark plug. The NGK plug does not have the correct thread length for proper indexing and it isn't the correct heat range.
