AR68.30-P-4780Q

Remove/install side paneling in rear

MODEL 209.3

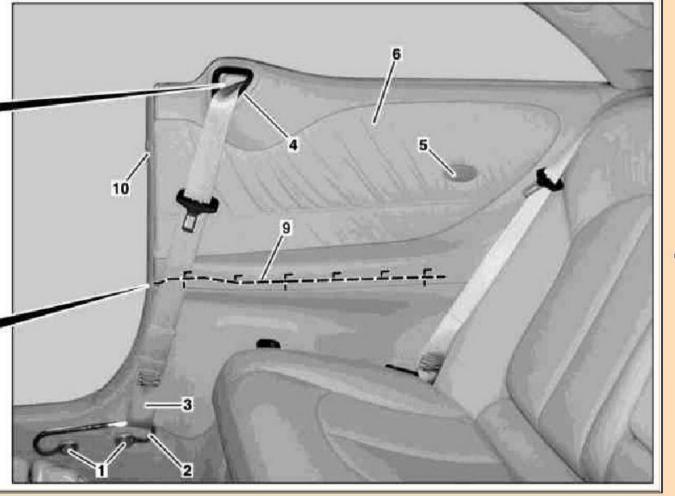
- 1 Bolts
- 2 Seat belt end fitting
- 3 Seat belt
- 4 Rosette
- 7 Side bolster
- 8 Bottom side paneling

S21/3 Left rear power window switch S21/4 Right rear power window switch

- 5 Sidebag sticker (with code (293) Sidebag in left and right rear)
- 6 Upper side paneling
- 9 Locking strip

- 10 Edge guard
- 11 Seat belt extender
- 12 Catch hook

XX	Remove/Install		2 8
1	Completely move left and right rear side window downward		
2	Unclip left and right door sill molding and remove		
3	Remove edge guard (10) in area of upper side wall paneling (6) and lower side wall paneling (8)

4.1	Unscrew bolts (1) and remove belt end fitting (2)	On vehicles with code (494) USA version: Not when removing right upper side wall paneling (6) or lower right side wall paneling (8). Installation: Fit seat belt (3) without twisting. Otherwise proper function of seat belt (3) is not ensured	BA91.40-P-1001-01A

5.1	Remove belt tensioning sensor	On vehicles with code (494) USA version: When removing right upper side wall paneling (6) or lower right side wall paneling (8). i See: Remove/install seat belt with emergency tensioning retractor	AR91.40-P-0630Q
6	Pull seat belt extender (11) out of upper side wall paneling (6) until catch hook (12) is accessible.		
7	Unclip seat belt extender (11) by pressing catch hook (12) and remove		
8	Unclip rosette (4) from upper side wall paneling (6).		
9	Remove seat belt (3) through rosette (4)

10.1	Unclip sidebag sticker (5) and unscrew bolt below	On vehicles with code (293) Sidebag in left and right rear	
11	Hook removing and installing tool into eye (arrow A) and pull locking strip (9) to stop in direction of arrow (arrow B)	i This unlocks the upper side wall paneling (6) from the lower side wall paneling (8). i Installation: Slide locking strip (9) to stop. Ensure that the locking strip (9) connects the upper side wall paneling (6) correctly with the lower side wall paneling (8).	116589016200
12	Remove upper side paneling (6) upward		
13	Remove side upholstery (7)		AR91.12-P-1710P
14	Unclip lower side wall paneling (8)	i Installation: Replace damaged retaining clips.	
15	Unclip left rear power window switch (S21/3) and right rear power window switch (S21/4) and install through installation opening with lines connected and lay down to side.		
16	Remove lower side wall paneling (8)

14	Unclip lower side wall paneling (8)	i Installation: Replace damaged retaining clips.
15	Unclip left rear power window switch (S21/3) and right rear power window switch (S21/4) and install through installation opening with lines connected and lay down to side.	
16	Remove lower side wall paneling (8)	
17	Install in the reverse order	
18	Check seat belt (2) for free motion
