2004 C230 Sport Coupe Kompressor Mass Air Flow Sensor Removal

The Check Engine Light came ON on my C230 Kompressor Sport Coupe; the fault code was P0170 which is Fuel Trim Malfunction fault. The Mercedes CD repair manual was a bit vague as to what to replace. An archive search of the Benz World forums indicated that the Mass Airflow (MAF) sensor could be dirty or need to be replaced. So I thought I would clean it. In order to remove the MAF it's necessary to remove the air filter box. In hind sight if all you really want to do is clean the MAF sensor it is possible by simply taking the top of the air filter box off and removing the air filter and spraying through the MAF screen at the sensor components. If however you would like to remove the MAF or want full accessibility to clean it then follow the steps below.

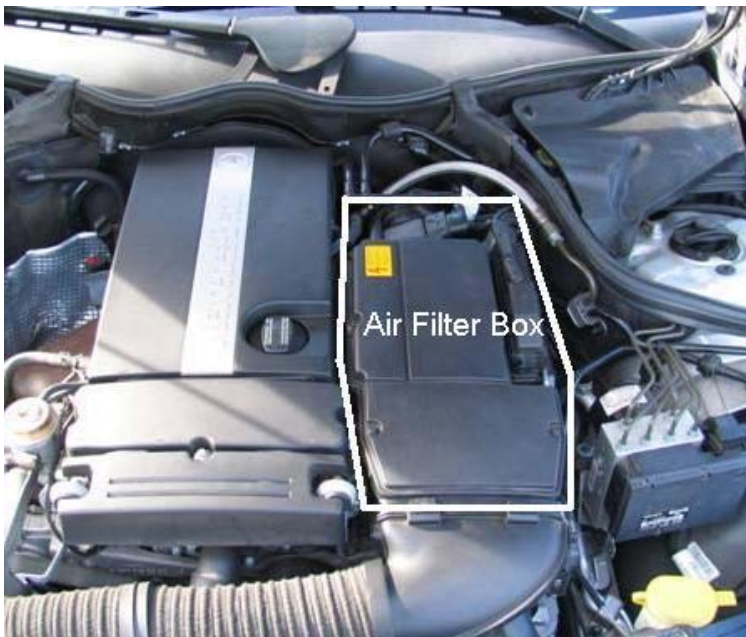
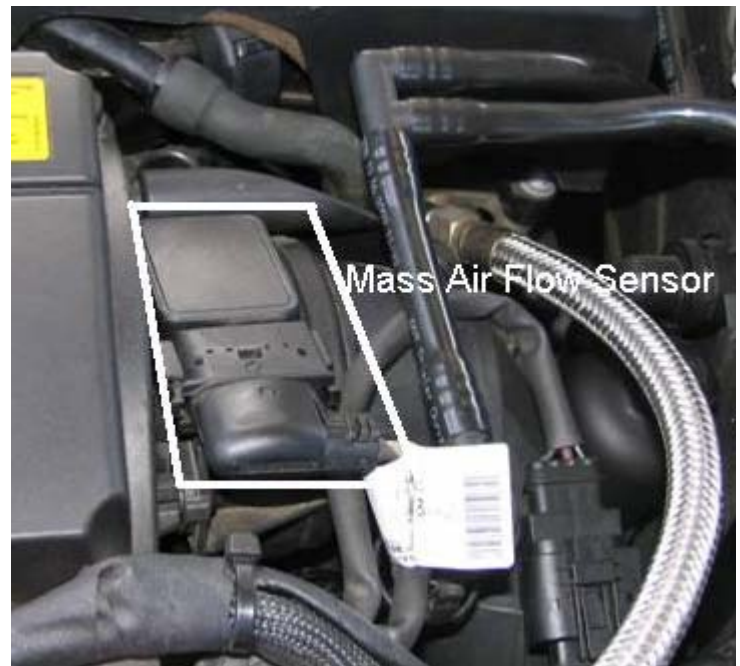
To get to the Mass Airflow sensor you need to remove the air filter box. It is held in place by two bolts toward the rear and two rubber bushings in front. Other items that are attached to it are a flex duct going to the supercharger, various electrical connectors, crankcase ventilation tube and also a vacuum line that needs to be disconnected for clearance.

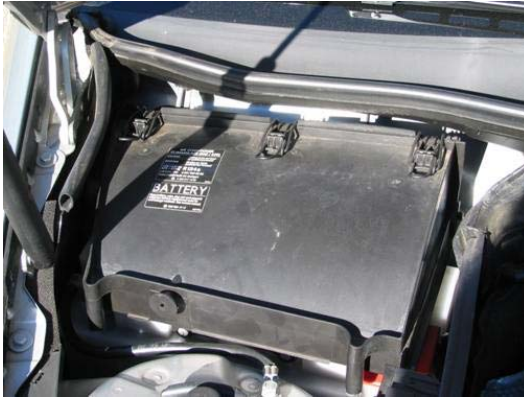
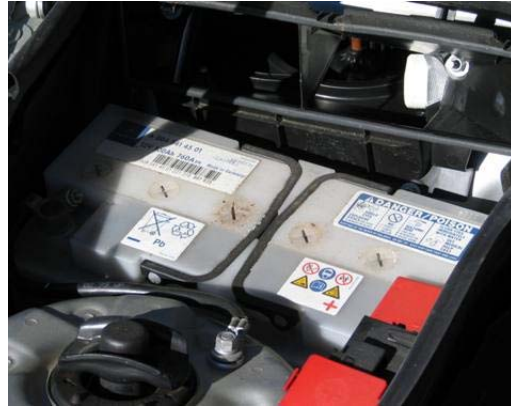
1. Disconnect the battery ground cable since you'll be disconnecting several connectors. The battery is underneath the cover/filter for cabin air. You will need to resynchronize the windows and panorama sun roof.

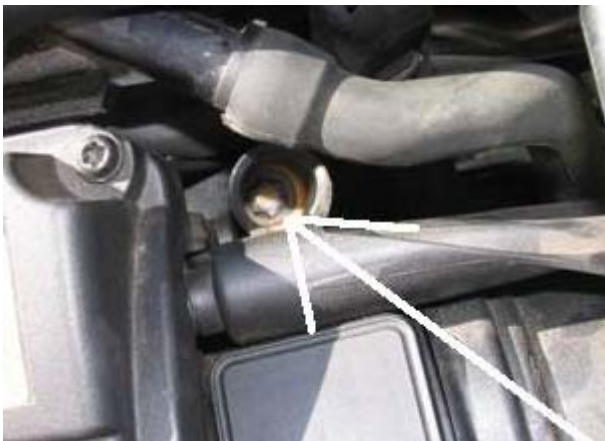
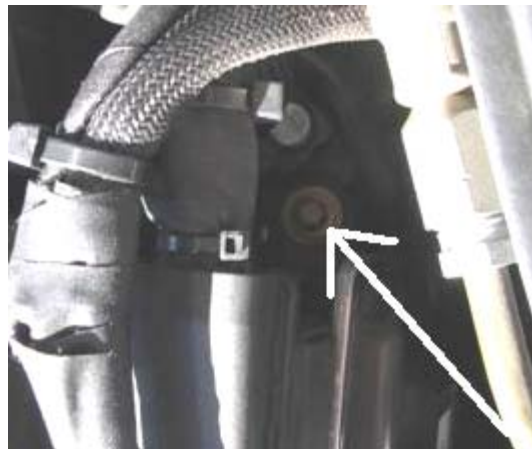
2. There are two bolts that have to be loosened.

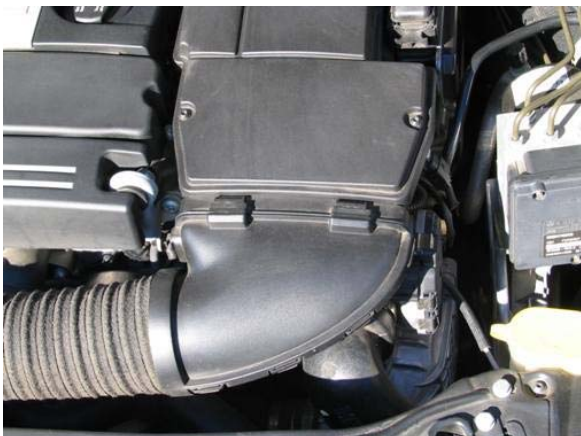
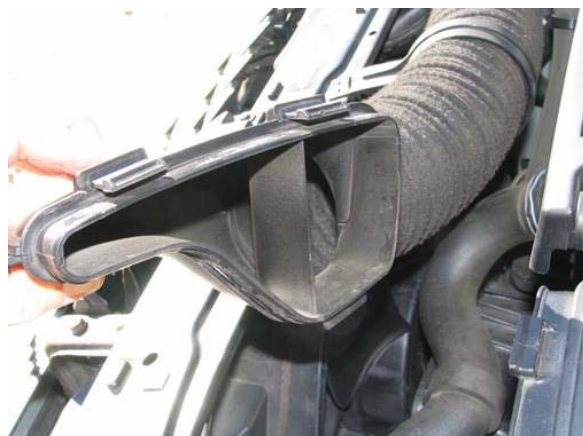
3. Disconnect the inlet air duct, there's a tab on the bottom that can make it difficult to disconnect.

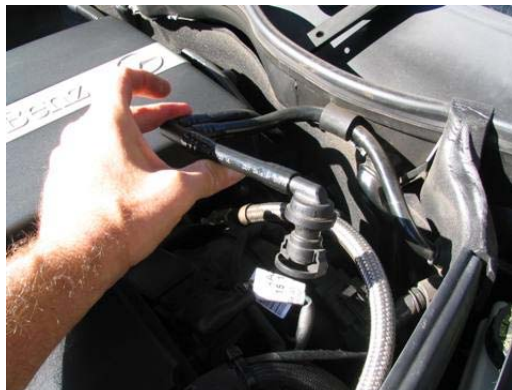
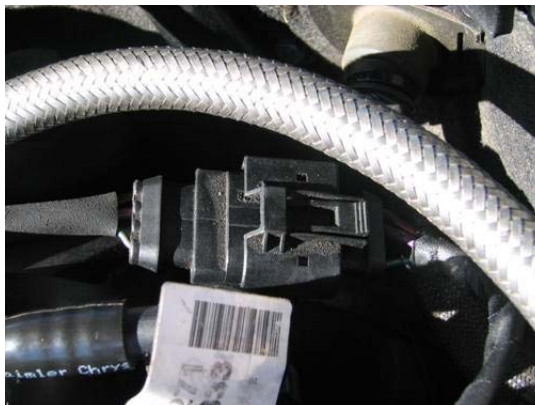
4. Disconnect the vacuum line by gently pressing on the outer ring and lifting. Also disconnect the nearby connector and detach one half of the connector from the stand-off bracket.

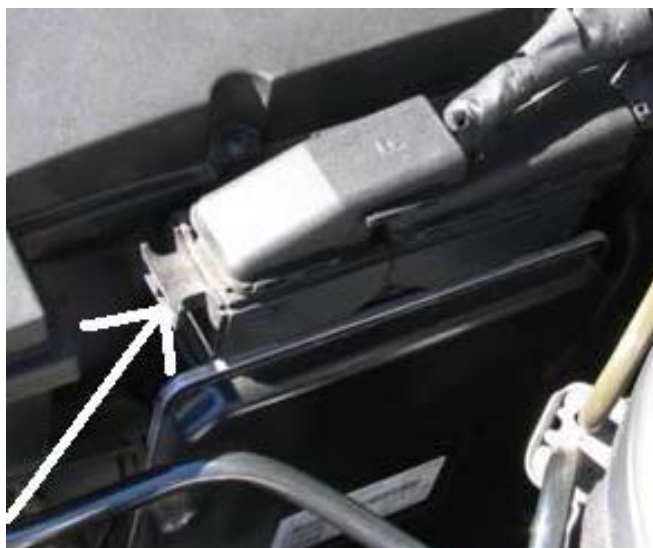
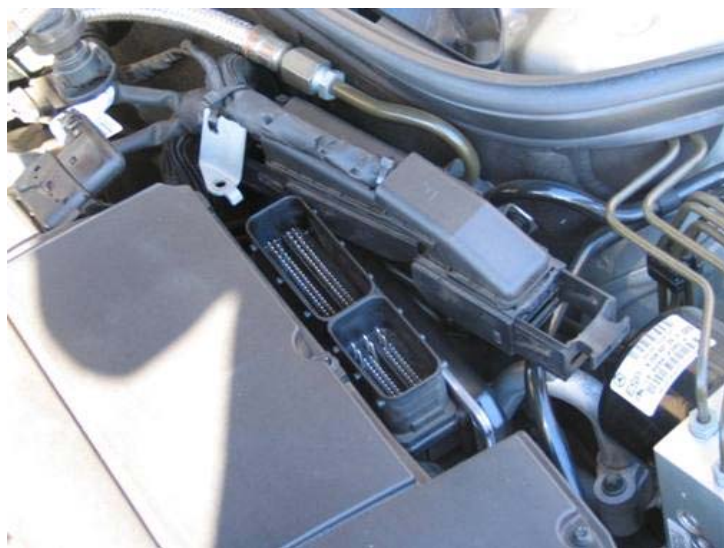
5. Disconnect the electrical connectors by pulling on the "T" handles at the front and rear of the connectors. Also unscrew the small bracket that they are zip tied to or cut the zip tie.

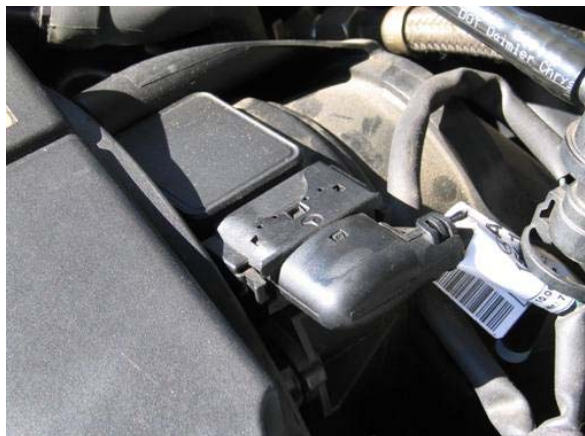
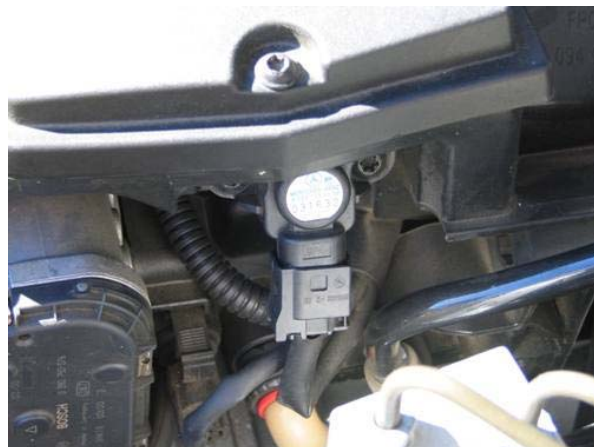
6. Disconnect the connectors from the mass air flow (MAF) sensor and the altitude sensor.

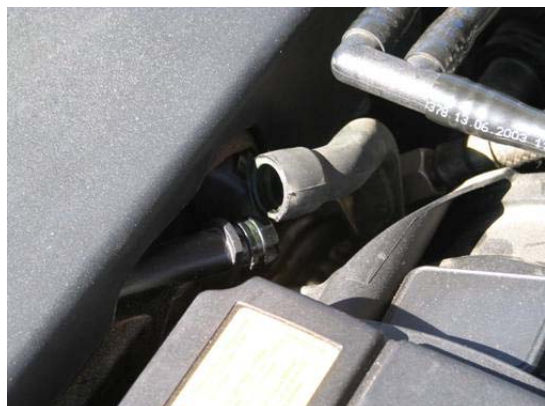
7. Disconnect the crankcase ventilation tube.

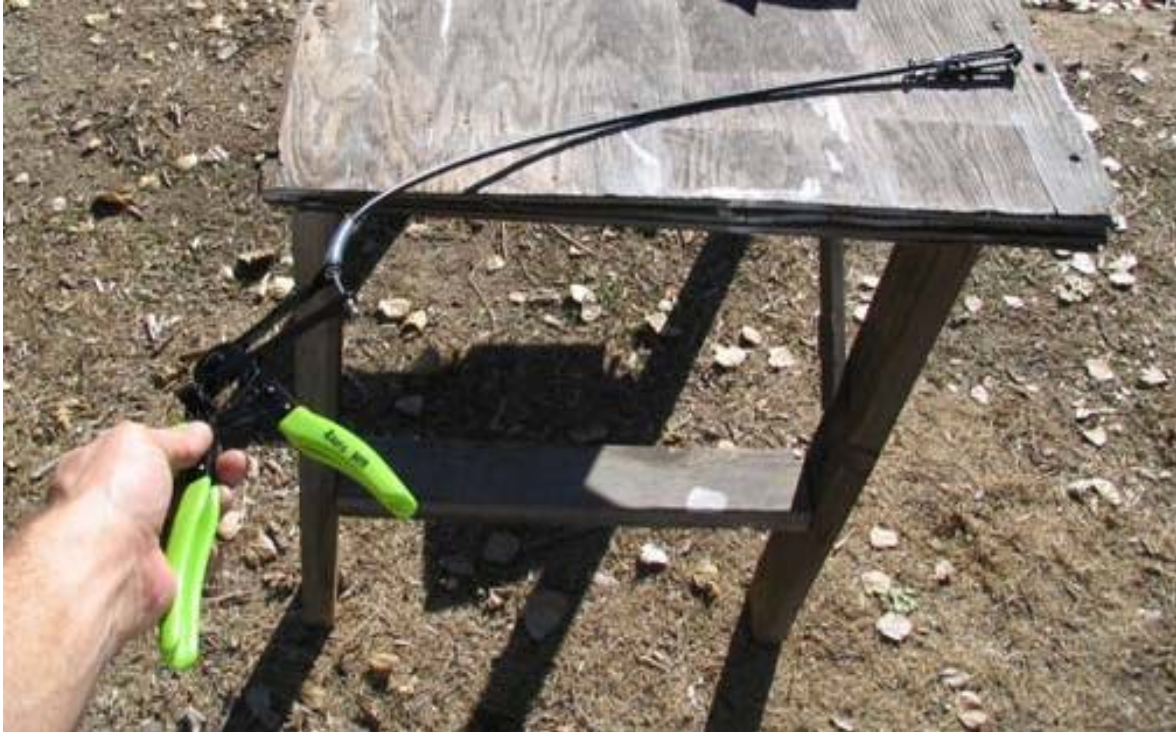
8. You will need a tool like this to be able to loosen the hose clamps on the flex duct that connects the air filter box to the supercharger, because there's no room to get your hands in there. It's essentially hand pliers with cable actuated pinchers. I got mine from [Jack-X-Change](#) for about \$30.00; it is Astro Pneumatic tool number 9409.

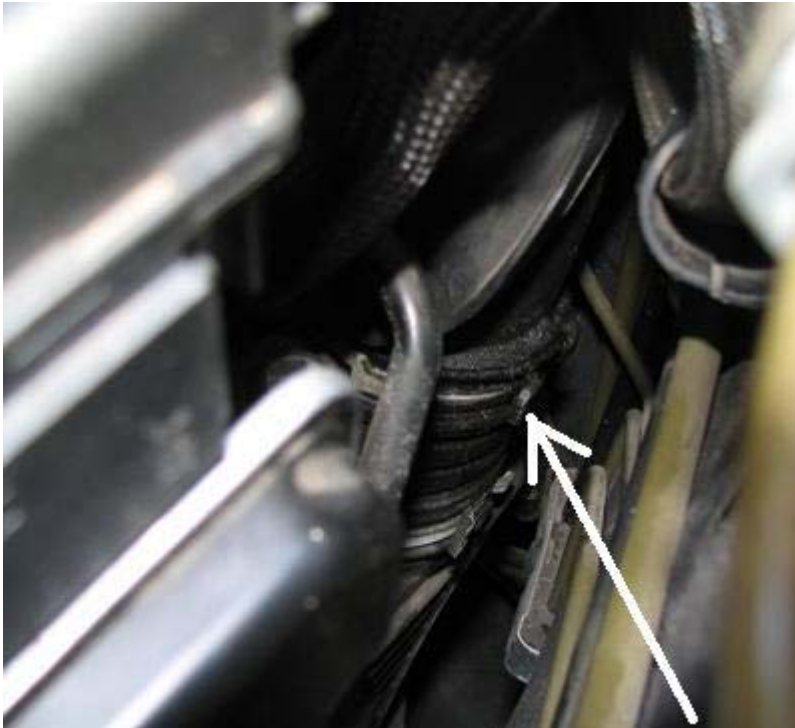
9. Loosen the flex duct hose clamps with the special tool.

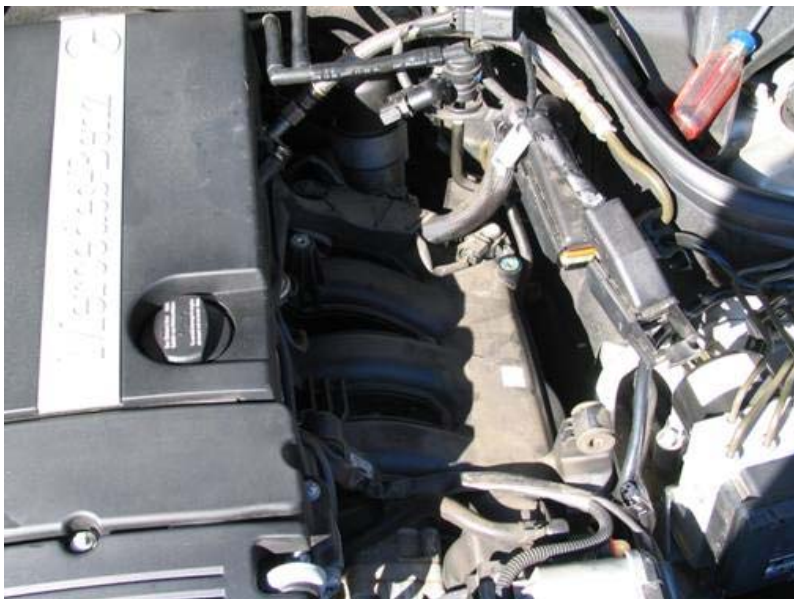
10. Everything is now disconnected that needs to be, it takes a bit of pushing aft and twisting towards the left to get it out. The filter box has two pins at the forward end that holds it in place with rubber bushings. The main thing is to keep all the connectors and hoses out of the way and it will come out with a bit of effort. You can actually see the intake manifold now.

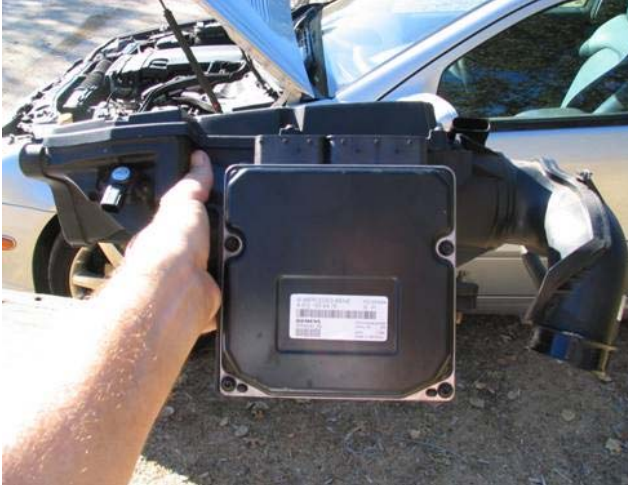
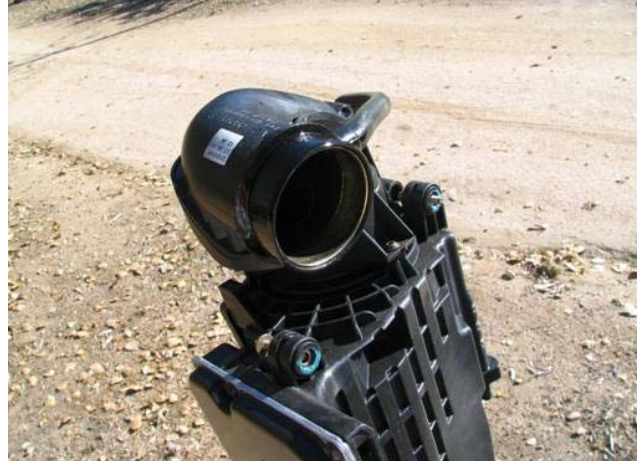
11. This is what the air box looks like out of the car.

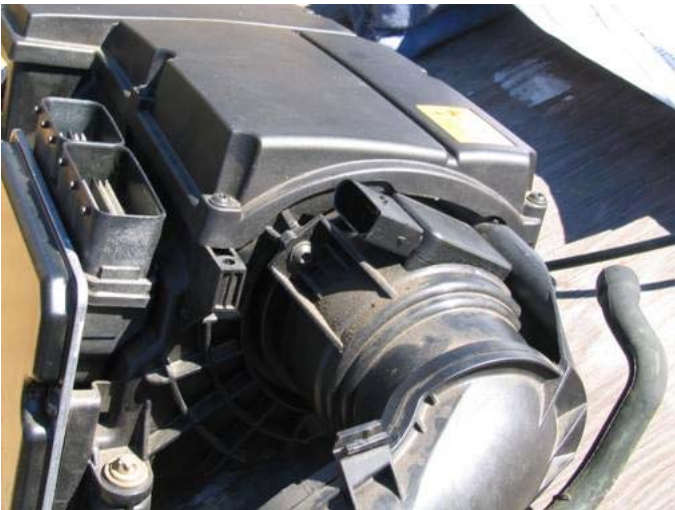
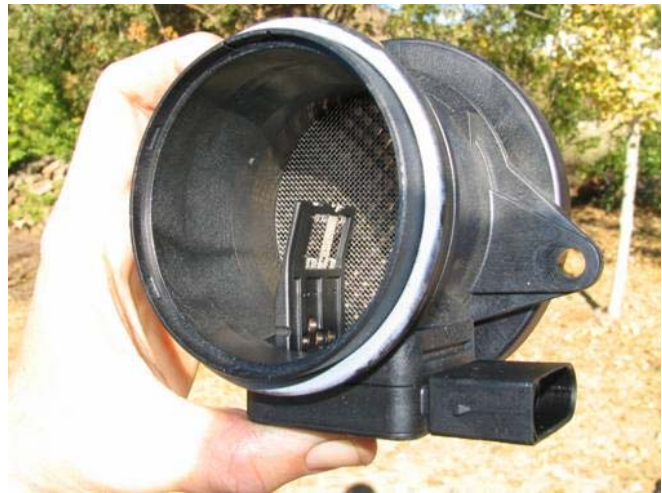
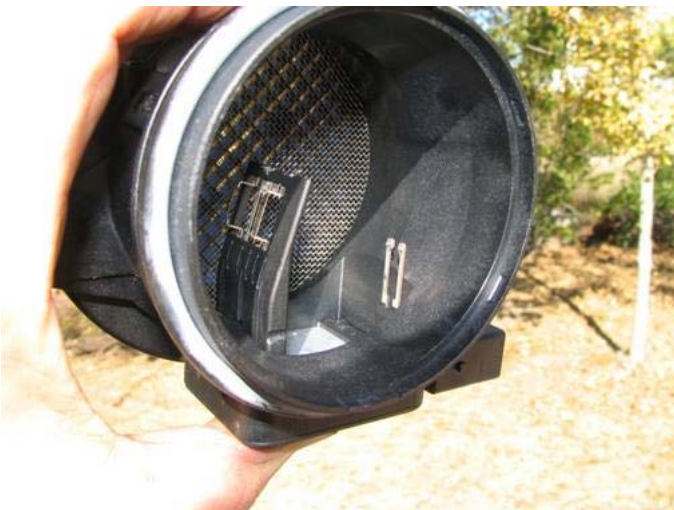
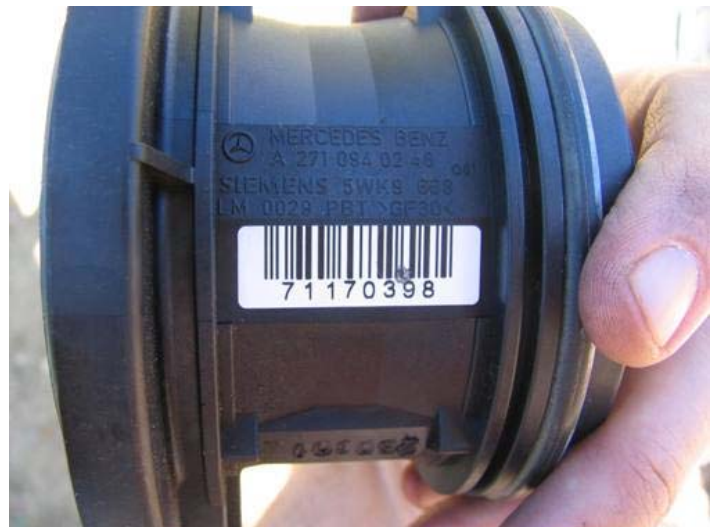
12. This is the end of the air box with the MAF sensor. Three screws hold it in.

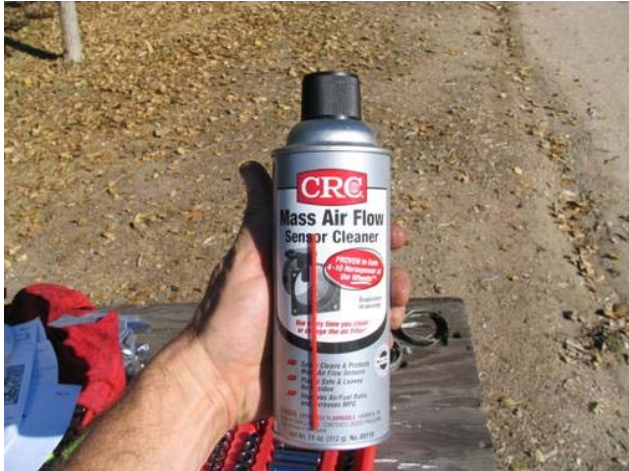
13. My motivation for getting at the MAF was to clean it since I'd gotten a Check Engine Light (CEL) with a fault code of P0170 which is the code for Fuel Trim Malfunction. The Mercedes manual doesn't give much troubleshooting information for this fault code but an internet search revealed that most experience was that the MAF needed cleaning or to be replaced. Even though mine looked clean I sprayed it with CRC Mass Air Flow sensor cleaner.

Conclusion – After putting everything back together the Check Engine Light (CEL) was still illuminated but the fault code P0170 was no longer present instead I now had P0136 and P0141 which is for the O2 sensor downstream of the catalytic converter. I replaced the O2 sensor (which is very straightforward) and the CEL is now OFF. I believe what happened was the O2 sensor was slowly failing causing the Fuel Trim Malfunction fault (P0170) and then when it finally failed completely the O2 sensor faults appeared. Had I not been so anxious to extinguish the CEL I would not have had to do all the work of removing the air filter box to access the MAF. However it was a good learning experience and I have more confidence working on my Benz.
