| Sales designation: CLK 320 | Vehicle ident. number: WDB209365* | Engine number: 112.955 | Automatic transmission: 722618 | Gr.: 68.30 | Entrv. Mod.Y.: Op. no.: |
| AR68.30-P-4780Q | Remove/install side paneling in rear | | | Full-size view | Validity OFF |

MODEL 209.3

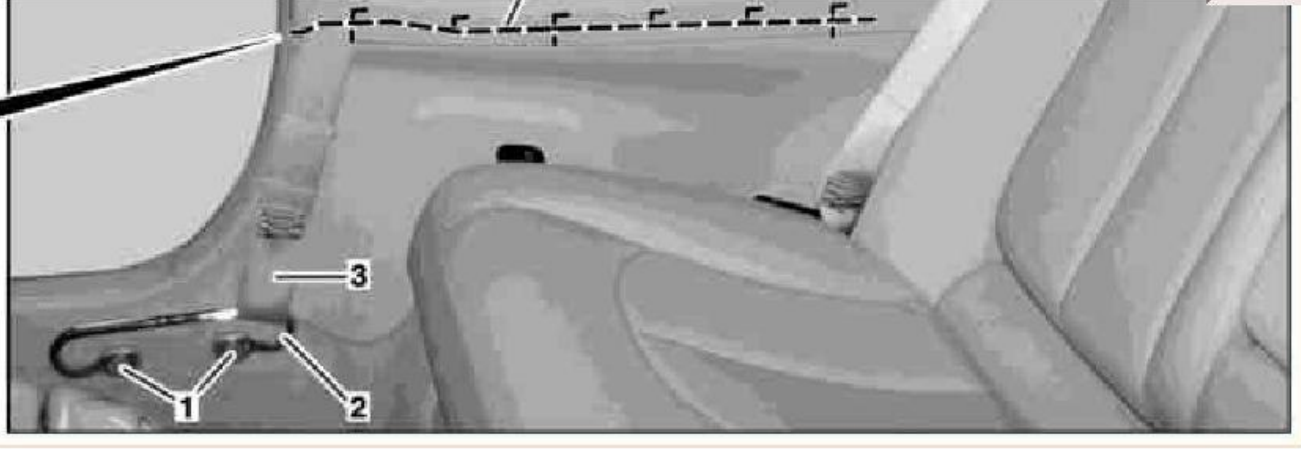
P68.30-3134-09

| 1 Bolts | 5 Sidebag sticker (with code (293) Sidebag in left and right rear) | 10 Edge guard |
| 2 Seat belt end fitting | 6 Upper side paneling | 11 Seat belt extender |
| 3 Seat belt | 9 Locking strip | 12 Catch hook |
| 4 Rosette | | |
| 7 Side bolster | | |
| 8 Bottom side paneling | | |

| | Remove/Install | | |
|---|---|--|--|
| 3 | Remove edge guard (10) in area of upper side wall paneling (6) and lower side wall paneling (8) | | |
| 4.1 | Unscrew bolts (1) and remove belt end fitting (2) | On vehicles with code (494) USA version: Not when removing right upper side wall paneling (6) or lower right side wall paneling (8). Installation: Fit seat belt (3) without twisting. Otherwise proper function of seat belt (3) is not ensured Nm | <div style="border: 1px solid black; padding: 2px;">BA91.40-P-1001-01A</div> |

| 6 | Pull seat belt extender (11) out of upper side wall paneling (6) until catch hook (12) is accessible. | | | |
| 7 | Unclip seat belt extender (11) by pressing catch hook (12) and remove | | | |
| 8 | Unclip rosette (4) from upper side wall paneling (6). | | | |
| 9 | Remove seat belt (3) through rosette (4) and seat belt extender (11).Then remove rosette (4) and seat belt extender (11). | | | |
| 10.1 | Unclip sidebag sticker (5) and unscrew bolt below | On vehicles with code (293) Sidebag in left and right rear | | |
| 11 | Hook removing and installing tool into eye (arrow A) and pull locking strip (9) to stop in direction of arrow (arrow B) | <p>i This unlocks the upper side wall paneling (6) from the lower side wall paneling (8).</p> <p>i Installation: Slide locking strip (9) to stop.Ensure that the locking strip (9) connects the upper side wall paneling (6) correctly with the lower side wall paneling (8).</p> <p></p> | | 116589016200 |

| 12 | Remove upper side paneling (6) upward | | |
| 14 | Unclip lower side wall paneling (8) | i Installation: Replace damaged retaining clips. | |
| 16 | Remove lower side wall paneling (8) | | |
